EXECUTIVE SUMMARY

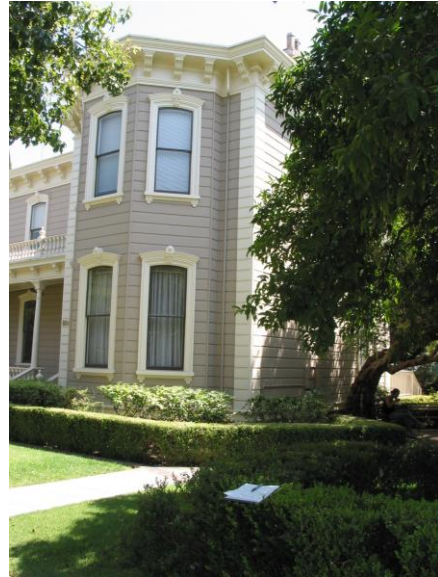
The DHBM tank house is believed to have been constructed between 1874 when the house was built and 1888 when it appears on the City's first Sanborn Map. The tank house was moved to its present current location in 1979 when the commercial development, Mansion Square, was constructed just to the south of the present parcel. Modifications were later made to add a second floor with an external stairway and windows in order to use the building as an office. It was leased for various commercial purposes until the mid-90's. In 1998, the City of Davis Building Official declared the building condemned due to structural concerns.

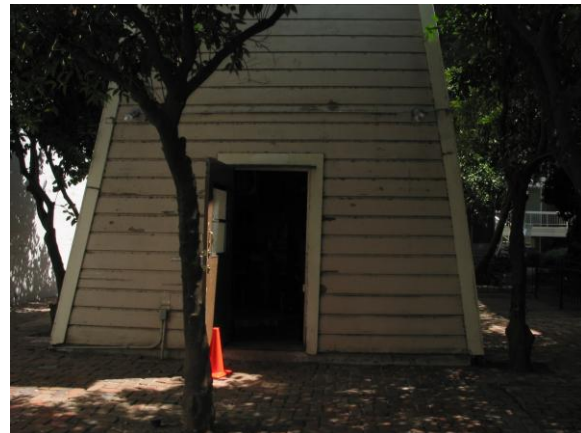
Recently the City of Davis solicited and received a proposal for development of the parcel where the Tank house now sits. The Tank house is in poor condition and S2 Architects were retained to study how and where the Tank house might be moved and/or repaired.

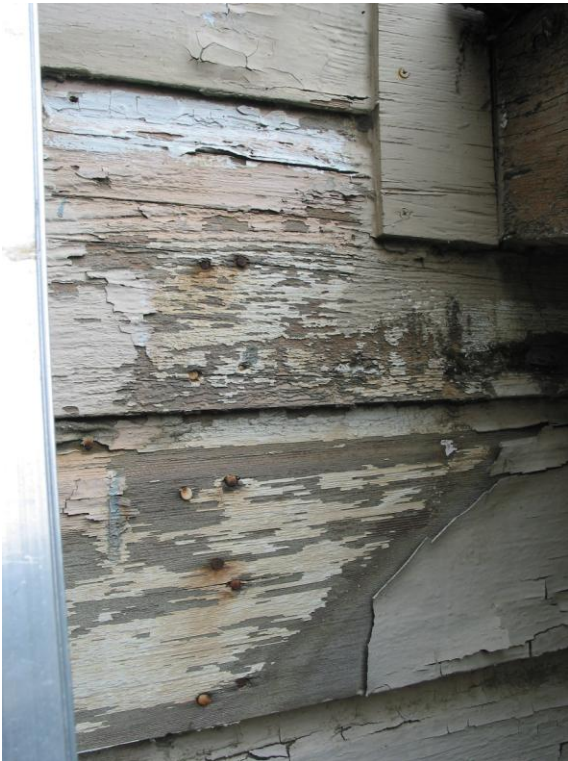
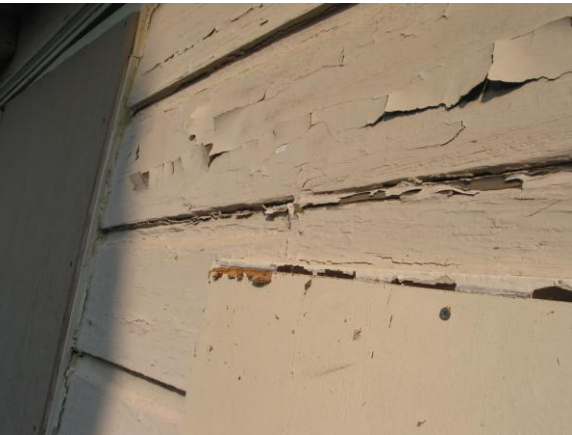
Peeling paint, siding deteriorated beneath

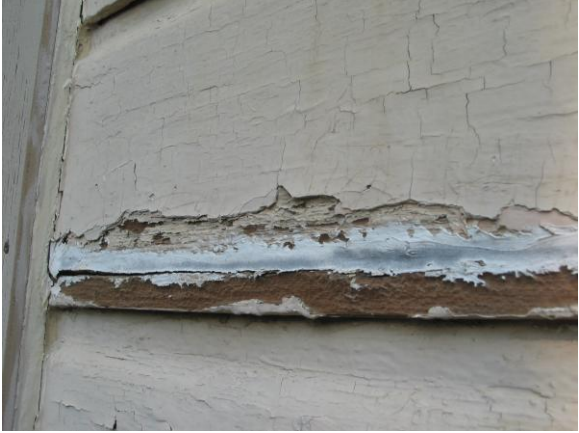
Siding, showing wood deterioration and crack

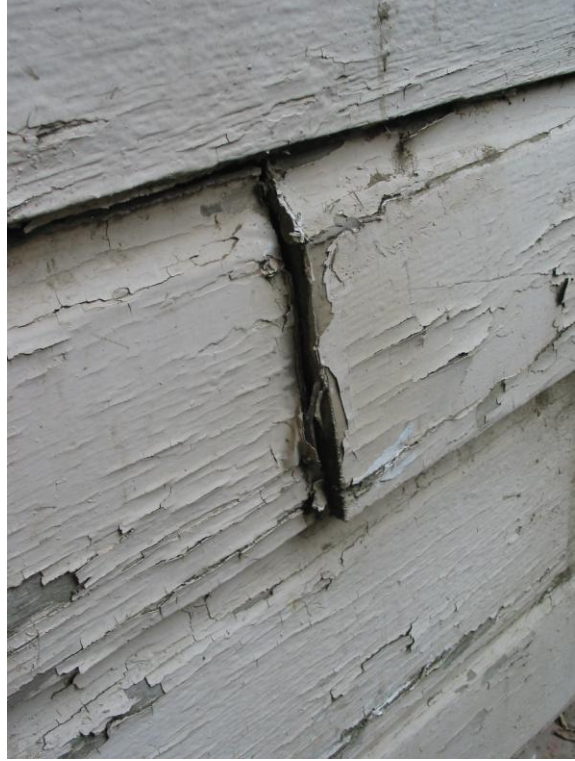
Siding, showing board pulling loose from rot

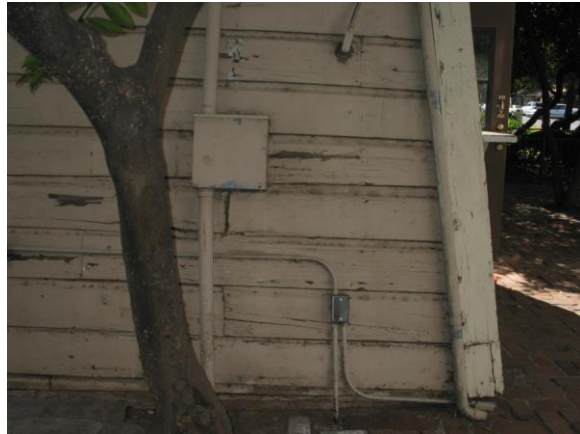
Cracked siding, electrical boxes, corner trim

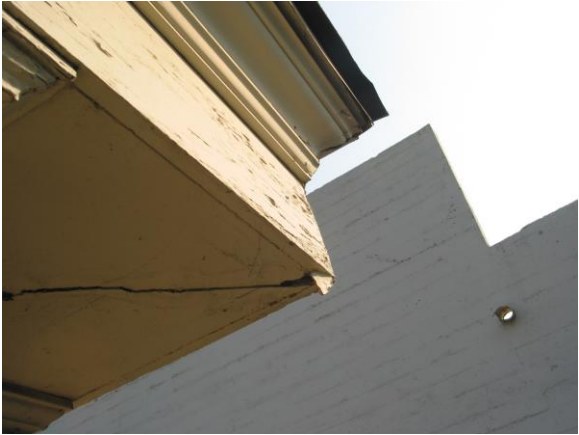
Fascia at corner. Paint flaking, but board appears to be solid.

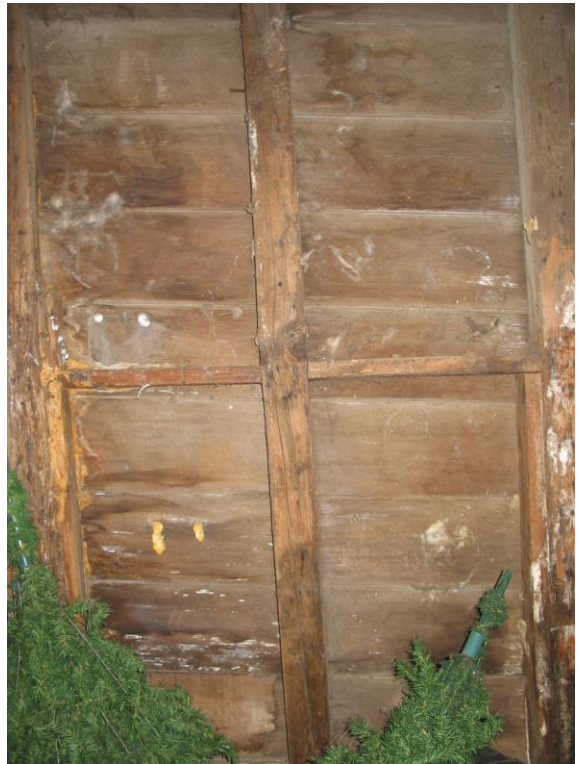
Inside studs, rotted, and in some places can see through siding joints. Note the 2X4's scabbed to inside of 4X4 studs that are now rotting too.

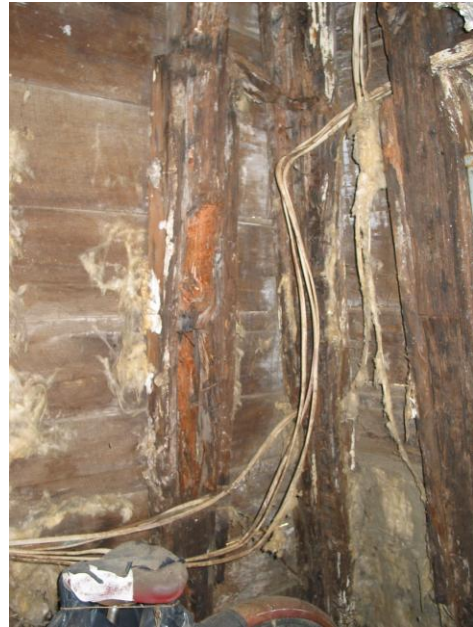
Dyrotted interior studs

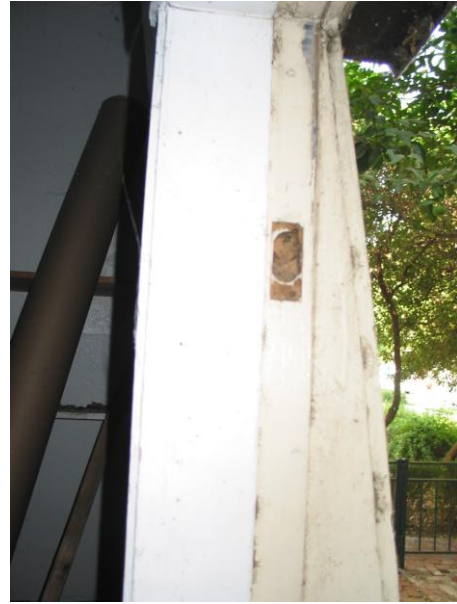
On three sides there are decorative round “trefoils”. Those on the existing north and west sides appear to be in good condition, but the one on the east side has a notch cut out when what appears to be an air conditioner was installed through it. There is no trefoil on the south side at all; perhaps it was removed when the door and window was installed at the time of the Second floor addition. We were able to reach the south facing trefoil from an extension ladder and it appeared to be sound. We feel the damaged trefoil(s) can be reconstructed to match the original and the existing ones restored.

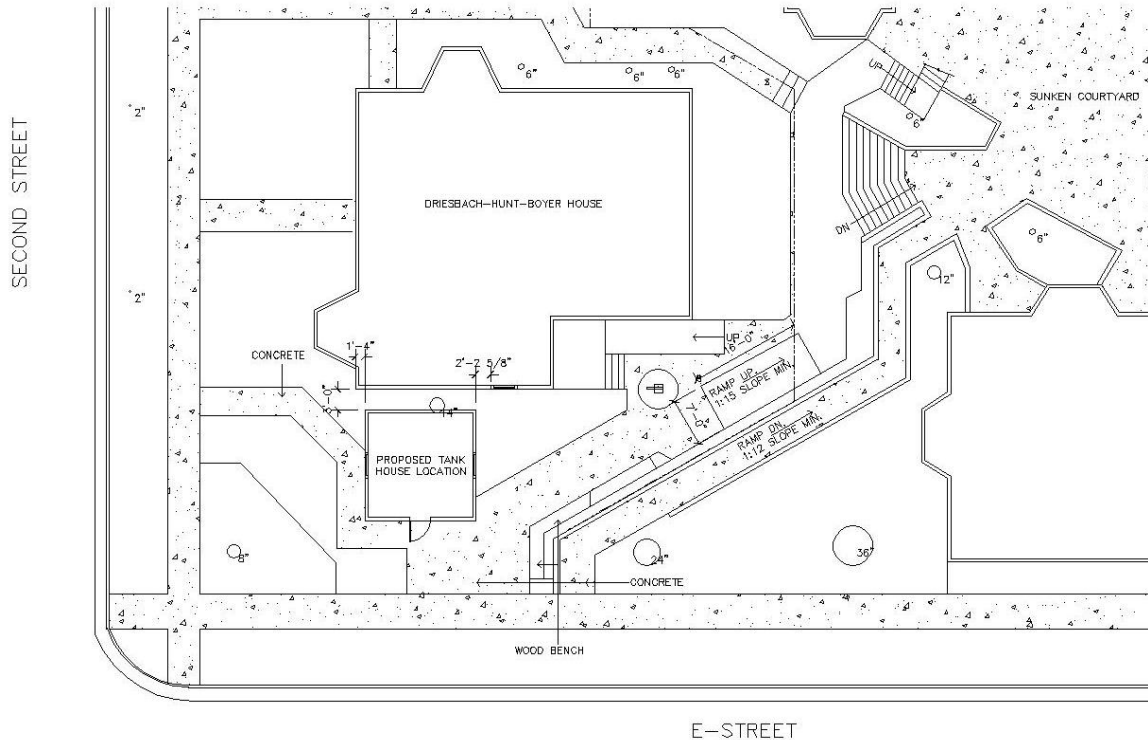
There is an existing landscaped setback of approximately 29' to the back of the sidewalk, providing enough room for the required footprint.

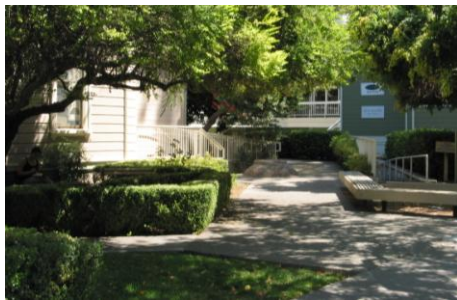
View to Mansion Square

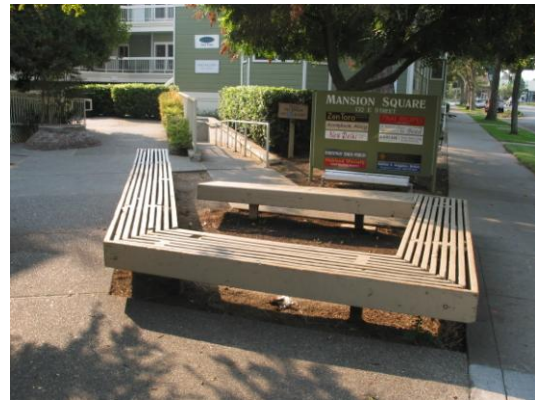
- Part of the existing planting area behind the bench at the street should be removed (the planting bed is not being used now) and the bench moved back in order to increase access to Mansion Square businesses.

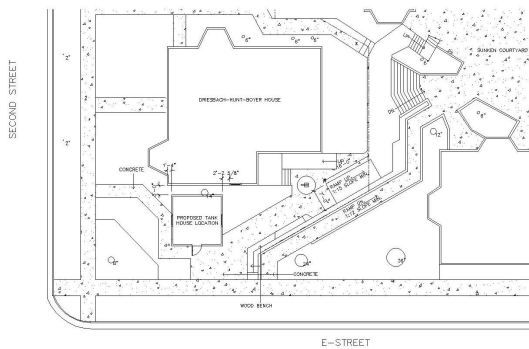
Tank House located square

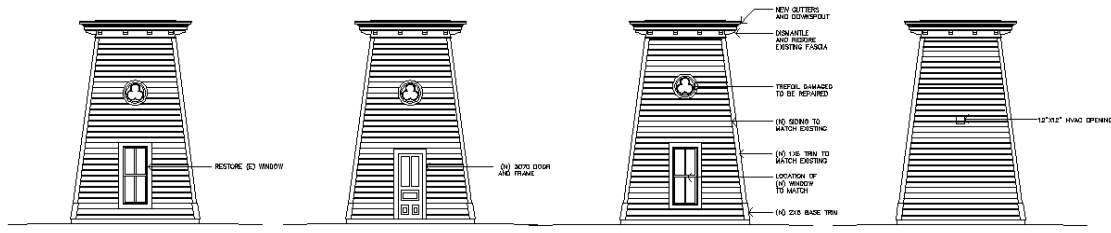
Tank House Study
City of Davis, CA
