RE: Updated Arborist Report: 3820 Chiles Road, Davis, CA

**ARBORIST REPORT
3820 CHILES ROAD
DAVIS, CALIFORNIA**

**Prepared for
SHEPARD FAMILY HOLDINGS, LLC
Davis, California**

**3820 CHILES ROAD
EXISTING TREES PLAN**

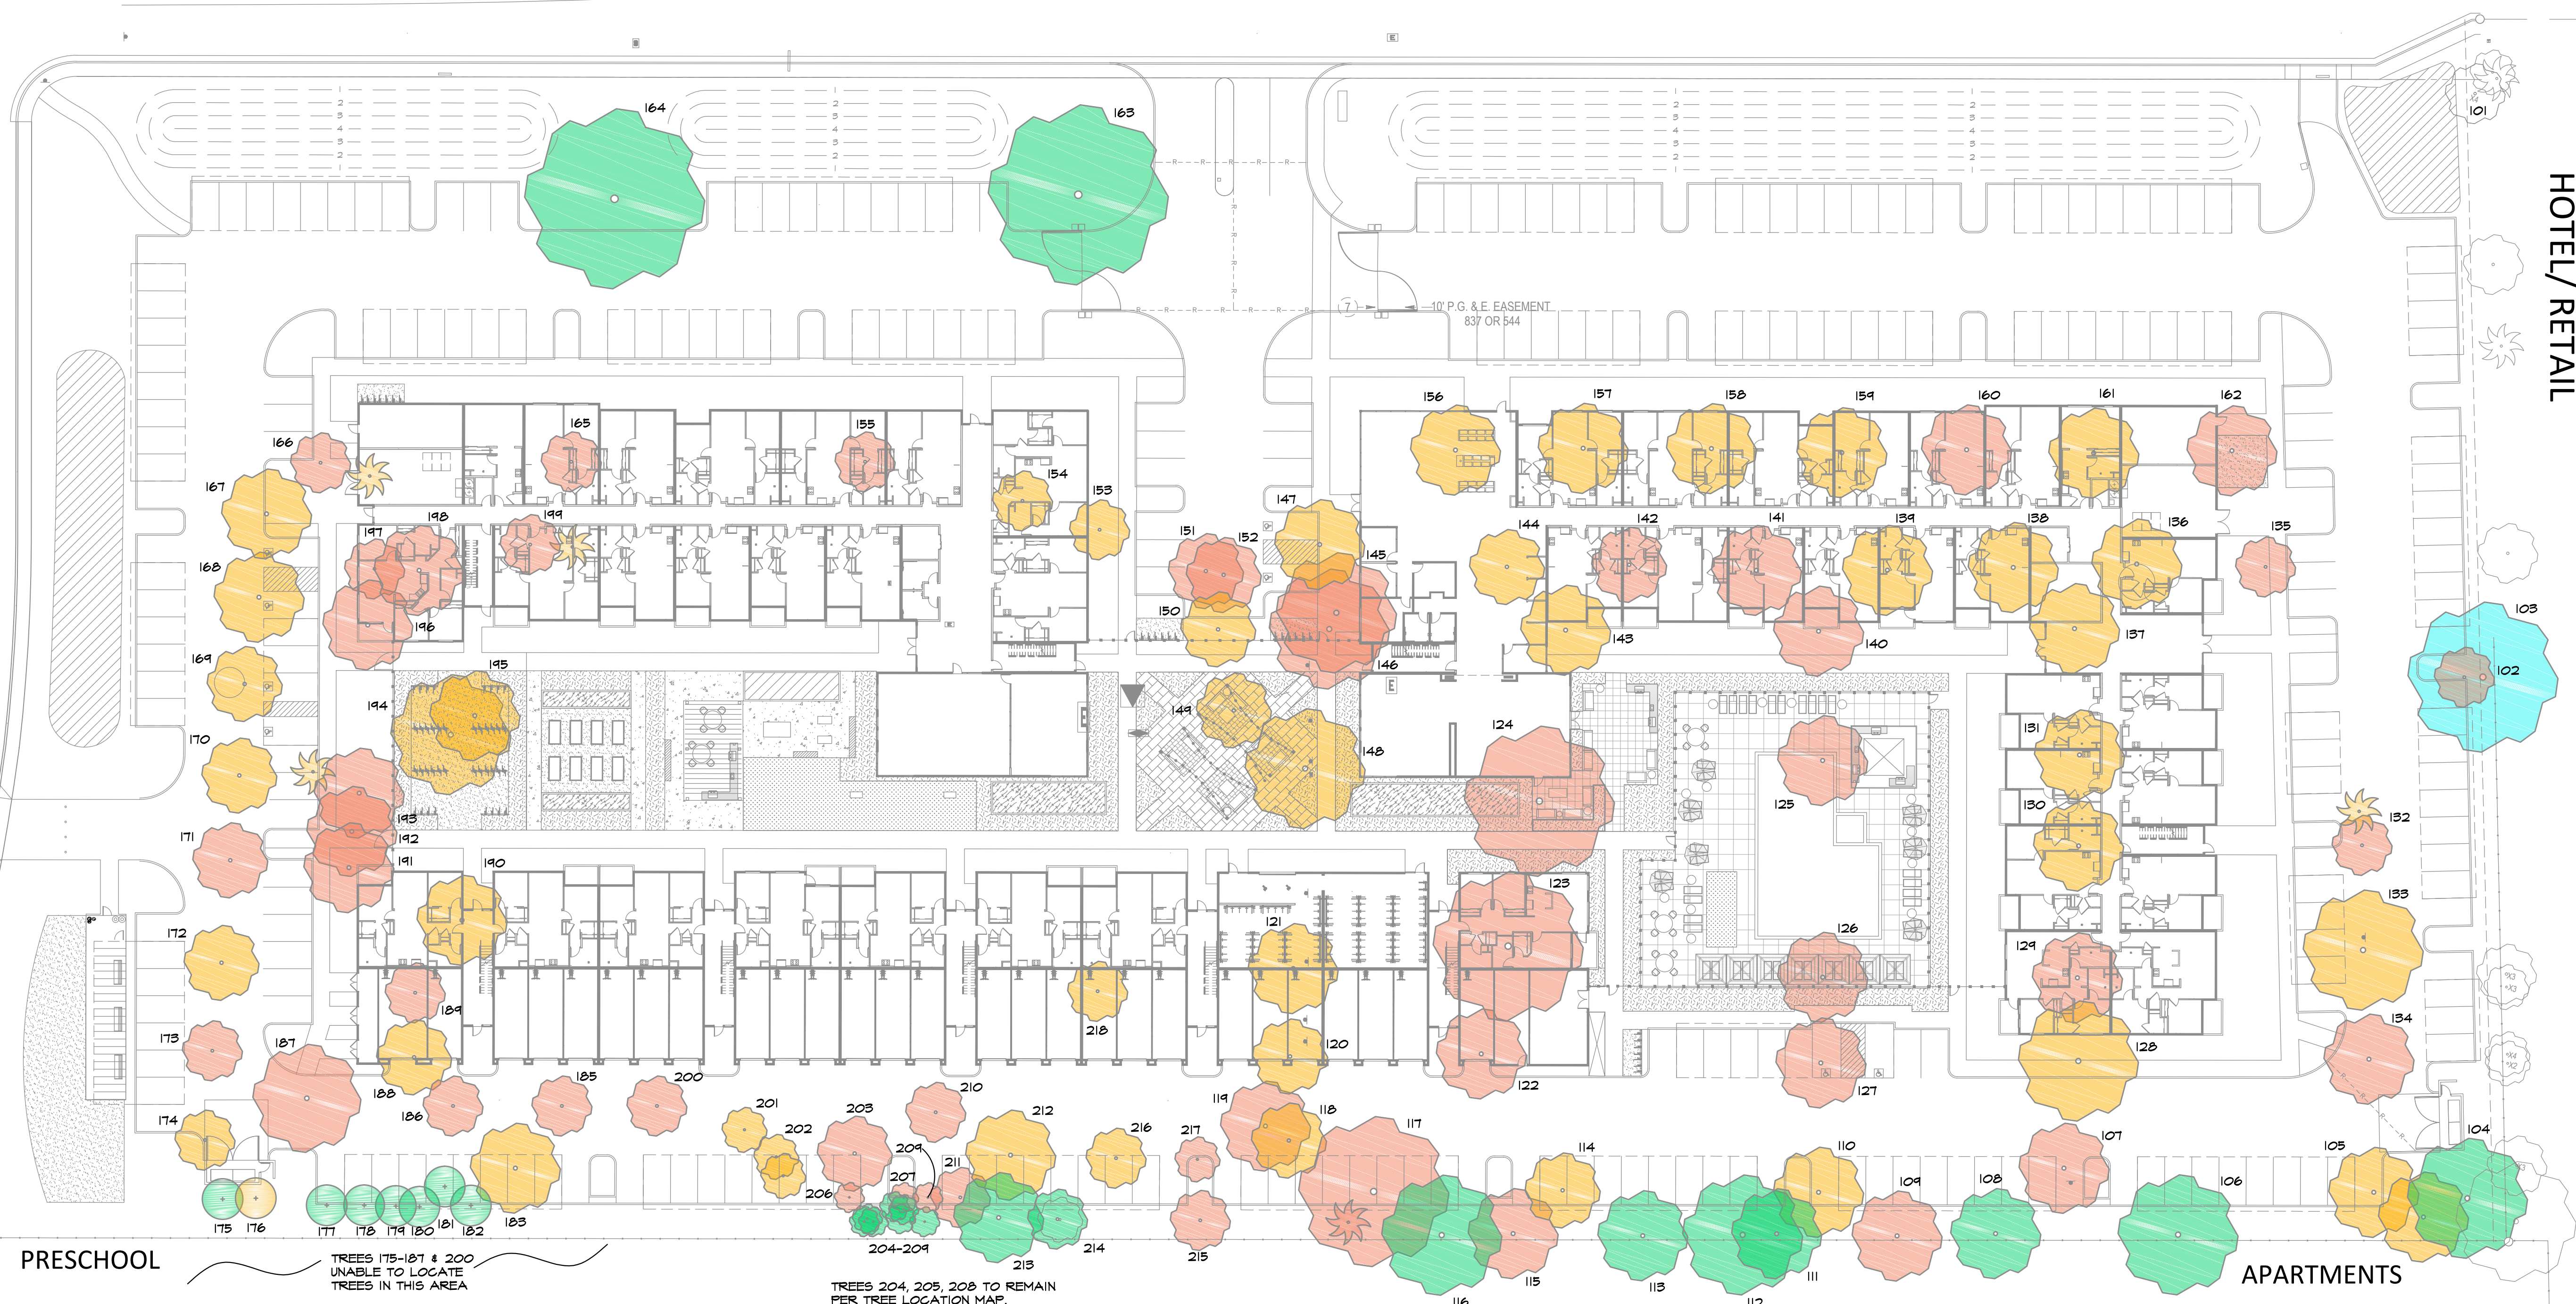
TREES 175-181 & 200
UNABLE TO LOCATE
TREES IN THIS AREA

TREE ALREADY REMOVED DUE TO LIMB FAILURE
