RE: Arborist Report: University Mall Project, Davis, CA

**ARBORIST REPORT
UNIVERSITY MALL PROJECT
DAVIS, CALIFORNIA**

**Prepared for
BRIXMOR PROPERTY GROUP
Carlsbad, California**

October 4, 2018

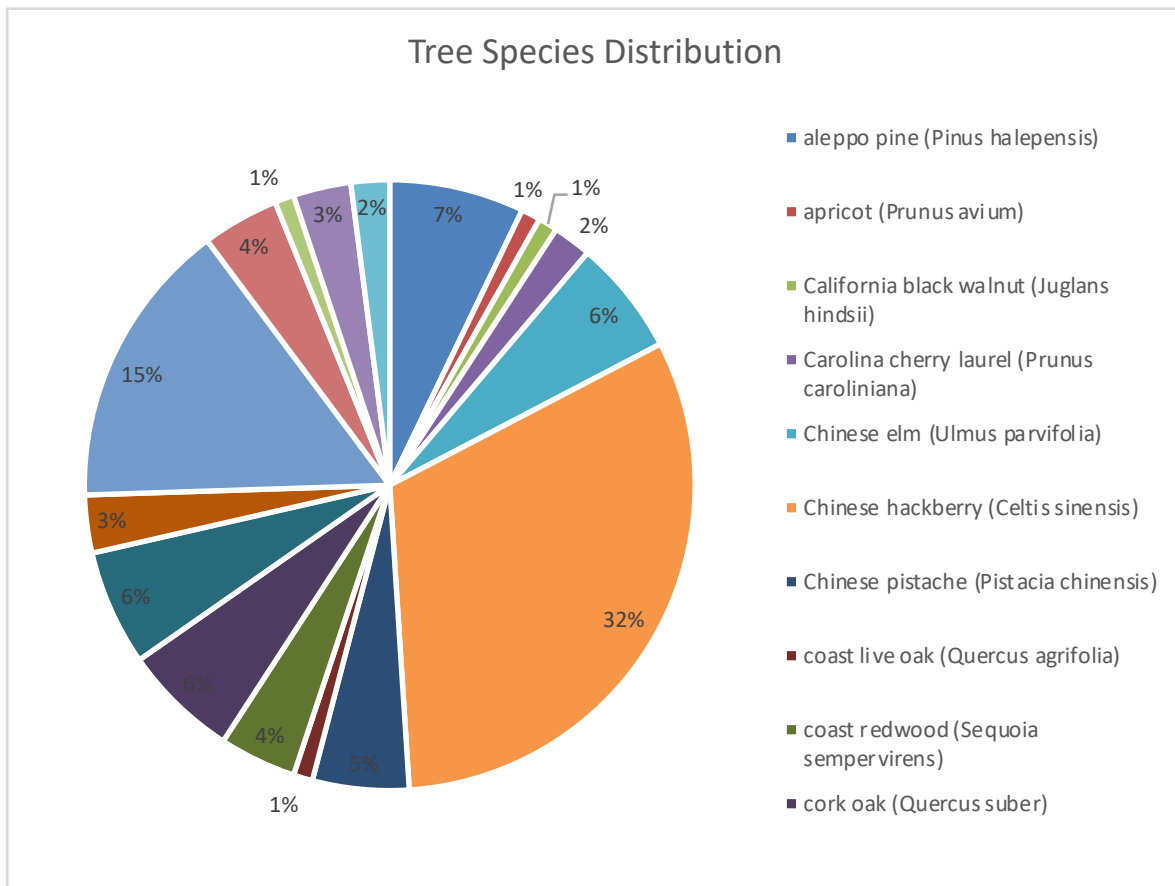
Seventeen protected tree species were represented on site. Chinese hackberry and fruitless mulberry were the most populous, representing 31 and 15 percent of the total population, respectively. Aleppo pine, cork oak and crepe myrtle represented 7, 6 and 6 percent of the total population, respectively. No other species represented more than 5% of the population (Figure 1).

Figure 1. Tree species distribution of protected on-site trees.

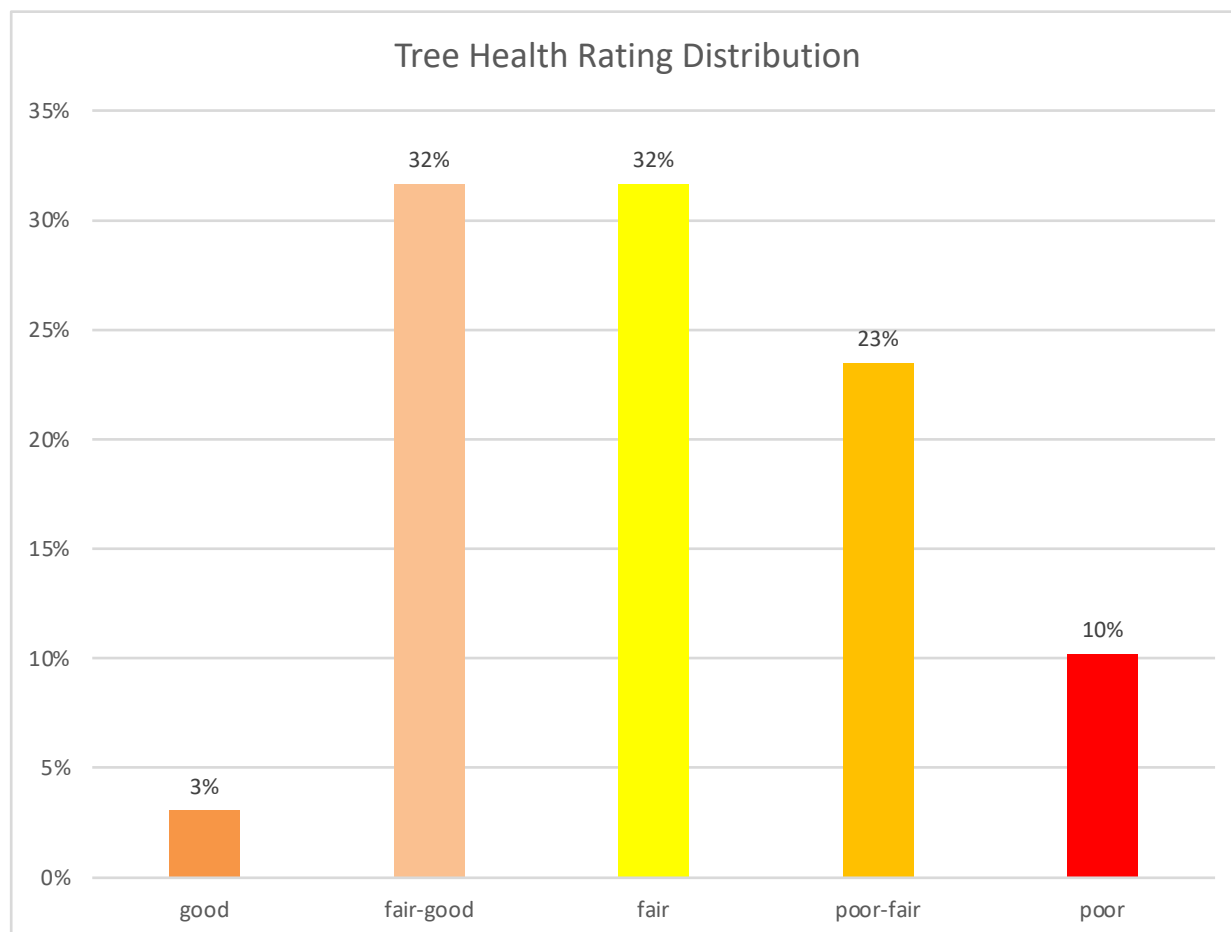
Thirty-five percent or 34 of the trees had no significant health concerns (rated fair-good or good). Thirty-three percent or 33 of the trees were in poor-fair or poor health while the remaining thirty-two percent or 31 trees were in fair health (Figure 2). Many of the trees, especially those in the parking lot planters, were exhibiting symptoms of drought stress (foliar yellowing, burn, drop, twig and branch dieback). No irrigation was apparent in the planters. Irrigation is critical to the maintenance of all but the most drought tolerant trees in the Central Valley, especially those in planters.

Figure 2. Health ratings of on-site trees.

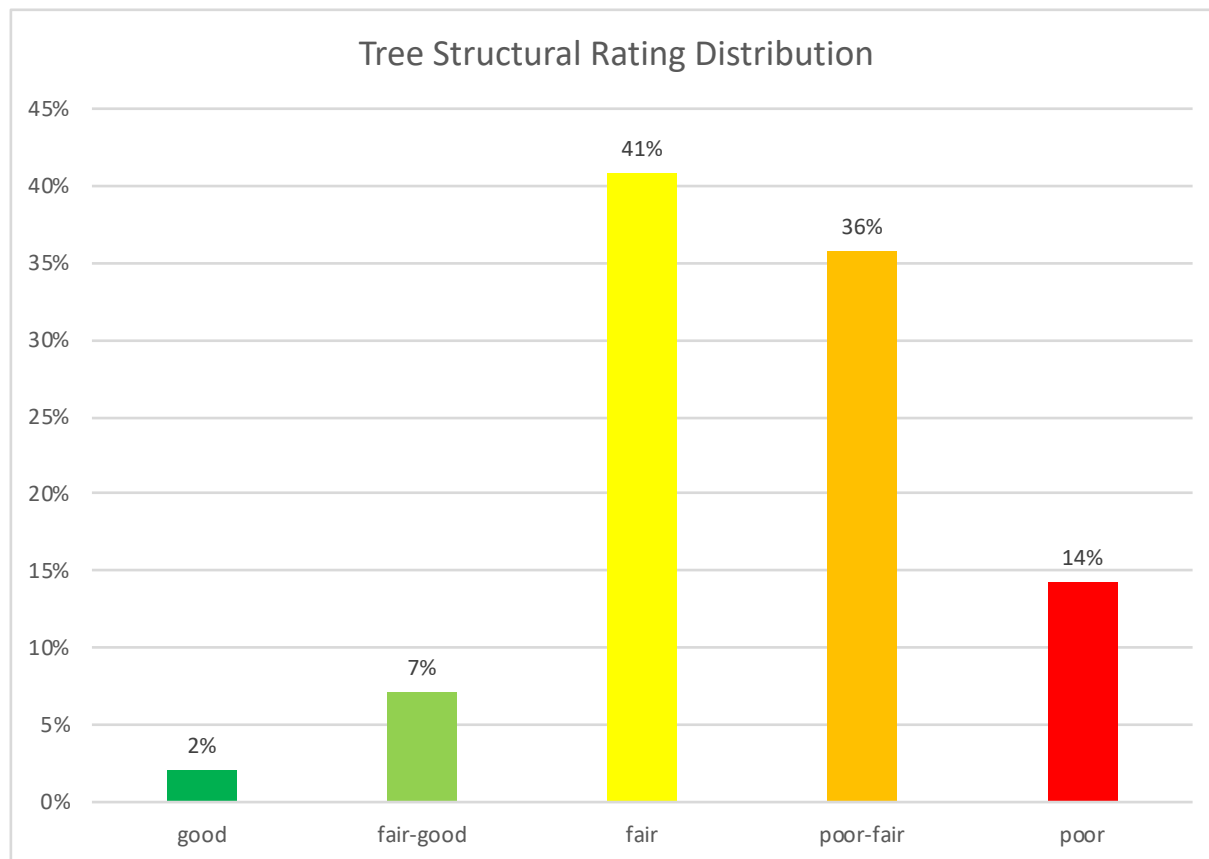
Nine percent or 9 of the trees had no significant structural concerns (ratings of fair-good or good), while 50% or 49 trees were in poor or poor-fair structural condition (Figure 3). Many of the trees (most of the fruitless mulberries) had previously been topped which was detrimental to their structure. Aside from the topping, it appeared that the on-site trees had only been pruned to raise their canopies and not to improve their structure.

Figure 3. Structural ratings of on-site trees.
