**TREE EVALUATION, APPRAISAL,  
DEVELOPMENT IMPACT ASSESSMENT AND  
PRESERVATION GUIDELINES  
TRACKSIDE CENTER, DAVIS**

**Prepared for  
CUNNINGHAM ENGINEERING CORPORATION  
Davis, California**

**January 26, 2017**

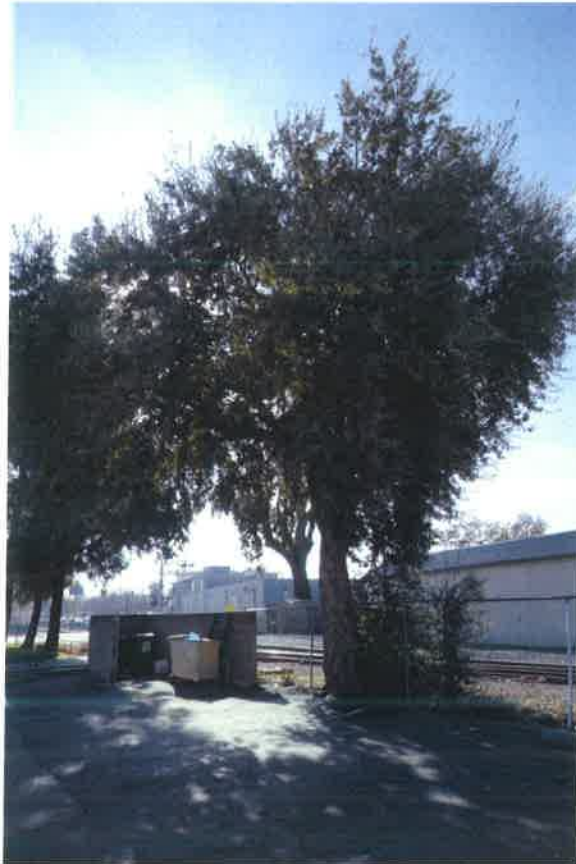
**Figure 1. Looking southwestward at cork oak #79.**

<b>Tree #</b>	<b>Species</b>	<b>Dia. (in.)</b>	<b>Max Dripline (ft.)</b>	<b>TPZ (ft.)</b>	<b>Comments</b>	<b>Health Rating</b>	<b>Structural rating</b>	<b>Condition Rating</b>	<b>Recommendations</b>
79	cork oak	27	29	27	trunk has grown over chain link fence; codominant trunks with included bark; primary limbs with excessive end weight; asphalt to trunk; likely a volunteer	good	fair	75%	supress south trunk using reduction cuts over several prunings.
80	Canary Island pine	18	21	18	primary limbs with excessive end weight	fair-good	fair	84%	use reduction cuts to remove 25% foliage of primary limbs with > 1/3 trunk dia.
81	Canary Island pine	15	19	15		fair-good	good	91%	
82	Canary Island pine	24	22	24	unbalanced crown; primary limbs with excessive end weight	fair-good	fair	84%	use reduction cuts to remove 25% foliage of primary limbs with > 1/3 trunk dia.
83	sweet gum	22	27	22	girdling roots; lifting walk and curb significantly; walk ground down; primary limbs with excessive end weight; headed limbs; codominant trunks	fair-good	fair	72%	remove tree due to severe hardscape displacement and impact to tree of repair of walk.

Tree #	Species	Max Dripline (ft.)	TPZ (ft.)	Infrastructure within TPZ	Development Impact Rating	Possible Design Modifications/Construction Methods	Impact Rating Following Modification
79	cork oak	29	27	Concrete plaza 10' northeast, east and southeast of trunk; stormwater planter swale under tree; retaining wall 10' north and south of trunk; seat wall 23' east and 25' south of trunk; storm drain 25' north and northeast of trunk.	Severe	Avoid all grading and soil disturbance (and retaining walls and plaza) within 16' east and 20 feet north/south of trunk. Pre-cut roots at grading limits. Remove stormwater planter from within TPZ. Install irrigation within TPZ where possible. Plant drought tolerant plants and install wood chip mulch within TPZ.	Low/ Moderate
80	Canary Island pine	21	18	Retaining wall immediately west of trunk; stormwater planter swale under tree; seat wall north of trunk; fence north of trunk	Severe	Avoid all grading and soil disturbance (including retaining wall west and south of trunk, stormwater planter and storm drain) within 13' east and 15' north of trunk. Redesign site grading to place retaining wall to the east of tree. Pre-cut roots at grading limits. Install irrigation within TPZ where possible. Plant drought tolerant plants and install wood chip mulch within TPZ. Install fence with piers avoiding roots >2" diameter.	Low/ Moderate

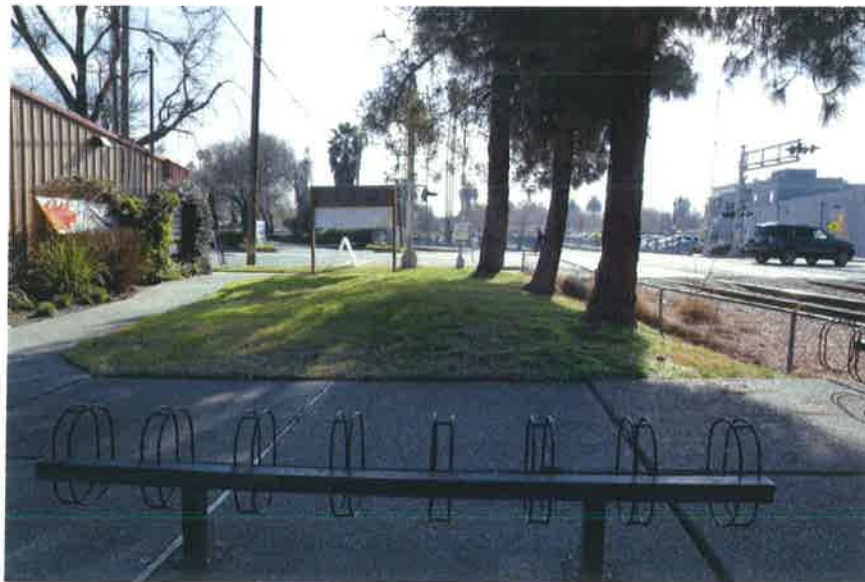
**Figure 2. Looking southward at trees 80-82 (front to back) with Third Street beyond.**

<b>Tree #</b>	<b>Species</b>	<b>Max Dripline (ft.)</b>	<b>TPZ (ft.)</b>	<b>Infrastructure within TPZ</b>	<b>Development Impact Rating</b>	<b>Possible Design Modifications/Construction Methods</b>	<b>Impact Rating Following Modification</b>
81	Canary Island pine	19	15	Retaining wall immediately west of trunk; stormwater planter swale under tree	Severe	Avoid all grading and soil disturbance (including retaining wall west and south of trunk, stormwater planter and storm drain) within 11 feet east of trunk (retaining wall could be installed at this location). Pre-cut roots at grading limits. Install irrigation within TPZ where possible. Plant drought tolerant plants and install wood chip mulch within TPZ.	Low/ Moderate
82	Canary Island pine	22	24	Retaining wall immediately west and several feet south of trunk; stormwater planter swale under tree;	Severe	Avoid all grading and soil disturbance (including retaining wall west and south of trunk, stormwater planter and storm drain) within 16 feet east of trunk (retaining wall could be installed at this location). Pre-cut roots at grading limits. Install irrigation within TPZ where possible. Plant drought tolerant plants and install wood chip mulch within TPZ.	Low/ Moderate

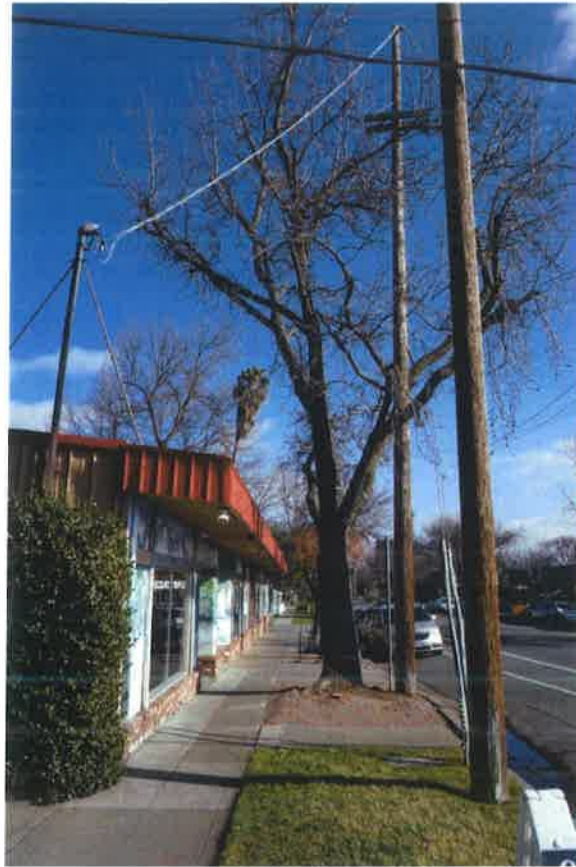
**Figure 3. Looking eastward at trees 83-85 (front to back) with Third Street on the right. Note severe displacement of hardscape adjacent to tree #83.**

84	sweet gum	9	14	9	low vigor; limbs headed	poor-fair	fair	66%	remove due to poor health and poor species suitability for street tree planting.
85	callery pear	14 @3'	22	14	low vigor; sidewalk damage; walk ground down; primary limbs with excessive end weight; limbs headed	poor-fair	fair	56%	remove due to poor health and hardscape displacement.

83	sweet gum	27	22	Remove due to severe hardscape damage	Removed		
84	sweet gum	14	9	Remove due to poor health and poor species suitability for street tree planting	Removed		
85	callery pear	22	14	Remove due to poor health and hardscape displacement	Removed

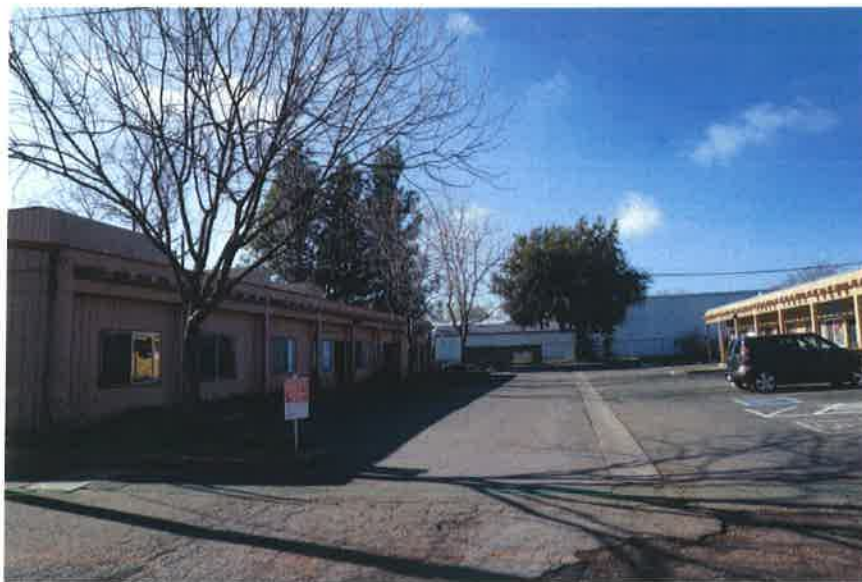
**Figure 4. Looking westward at trees 86-88 (front to back). Trees 79-82 are in the background (right to left).**

<b>Tree #</b>	<b>Species</b>	<b>Max Dripline (ft.)</b>	<b>TPZ (ft.)</b>	<b>Infrastructure within TPZ</b>	<b>Development Impact Rating</b>	<b>Possible Design Modifications/Construction Methods</b>	<b>Impact Rating Following Modification</b>
86	Chinese pistache	21	9	To be removed to accommodate development	Removed		
87	Chinese pistache	16	7	To be removed to accommodate development	Removed		
88	Chinese pistache	20	11	To be removed to accommodate development	Removed		
A	elm	40	48	Alley re-built just west of trunk.	TBD	Demolish existing road under arborist supervision preserving any roots >2" which are found. Abandon utilities in place if roots found in vicinity. Construct road avoiding damage to these roots using a modified road section if necessary.	Low

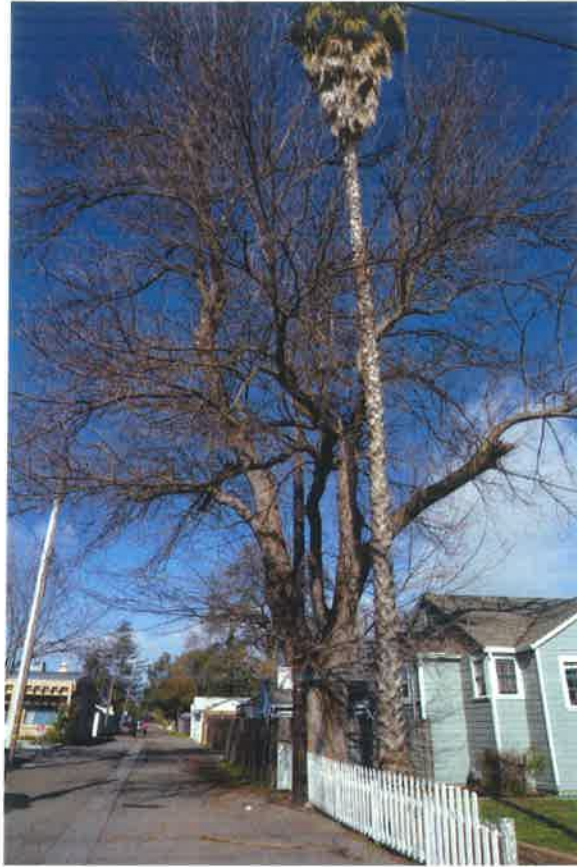
**Figure 4. Looking northward at tree A, with alley to the left.**

Tree #	Species	Dia. (in.)	Max Dripline (ft.)	TPZ (ft.)	Comments	Health Rating	Structural rating	Condition Rating	Recommendations
A	elm	48 est	40	48	codominant trunks; trunk decay; primary limbs with excessive end weight; limb breaks; limbs with decay	fair-good	poor	n/a	aerial inspection. map decay. crown reduction. crown clean. use reduction cuts to remove 25% foliage of primary limbs with > 1/3 trunk dia.
86	Chinese pistache	9	21	9	codominant trunks with included bark; multiple trunks	fair-good	fair	63%	select leader, drop crotch competing trunks or primary limbs.
87	Chinese pistache	7	16	7	multiple trunks; low vigor	fair	fair	66%	select leader, drop crotch competing trunks or primary limbs.
88	Chinese pistache	11	20	11	codominant trunks; multiple trunks	fair-good	fair	69%	select leader, drop crotch competing trunks or primary limbs.
