Existing Conditions

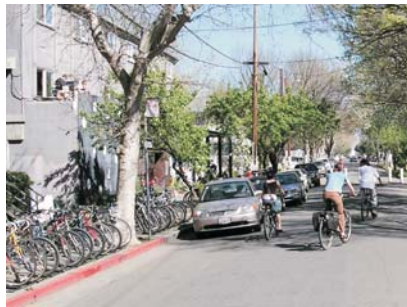
Plenty of bike parking - well used
Lots of bikes use the street
Limited car access makes bicyclists safe

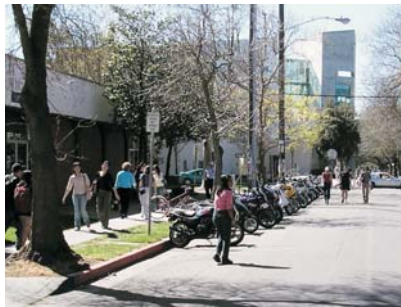
Pedestrians walk in the street because of narrow sidewalks.
Motorcycle parking an obstruction and eyesore.

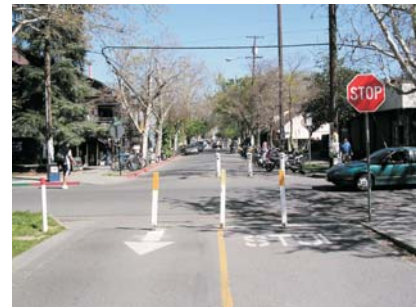
Ugly bollards, lighting, furnishings
Overhead wires are ugly and lead to badly headed street trees.

- Formalize multiple-use street
- Eliminate curb
 - Install unique paving
- Improve tree health and overhead aesthetics
- Underground utility lines
 - Replace badly headed and unhealthy trees.
- Improve sidewalk environment
- Increase area for furnishings by reducing width of driving lane.
 - Replace furnishings and add pedestrian-level streetlights.
 - Use consistent paving, planting and furnishings palette.
 - Encourage sidewalk seating.
 - Accommodate parking and loading zones as necessary.
