To: Michael Bisch
From: John M. Lichter, M.S.
ASCA Registered Consulting Arborist #375, ISA Certified Master Arborist #863,
ISA Qualified Tree Risk Assessor
Date: February 29, 2016
Re: Tree Preservation, City of Davis Greenbelt Trees, Hyatt House Project

The Hyatt House project, located at 2750 Cowell Boulevard in Davis is to be built north of the City's greenbelt. Twenty-one City-owned trees are located on the greenbelt adjacent to the northern boundary of the project. Due to their proximity to the project, the trees were included in an Arborist report concerning the property that I previously prepared (entitled Tree Evaluation, Appraisal and General Preservation Guidelines, Hyatt House Project, Davis, California), dated December 28, 2015.

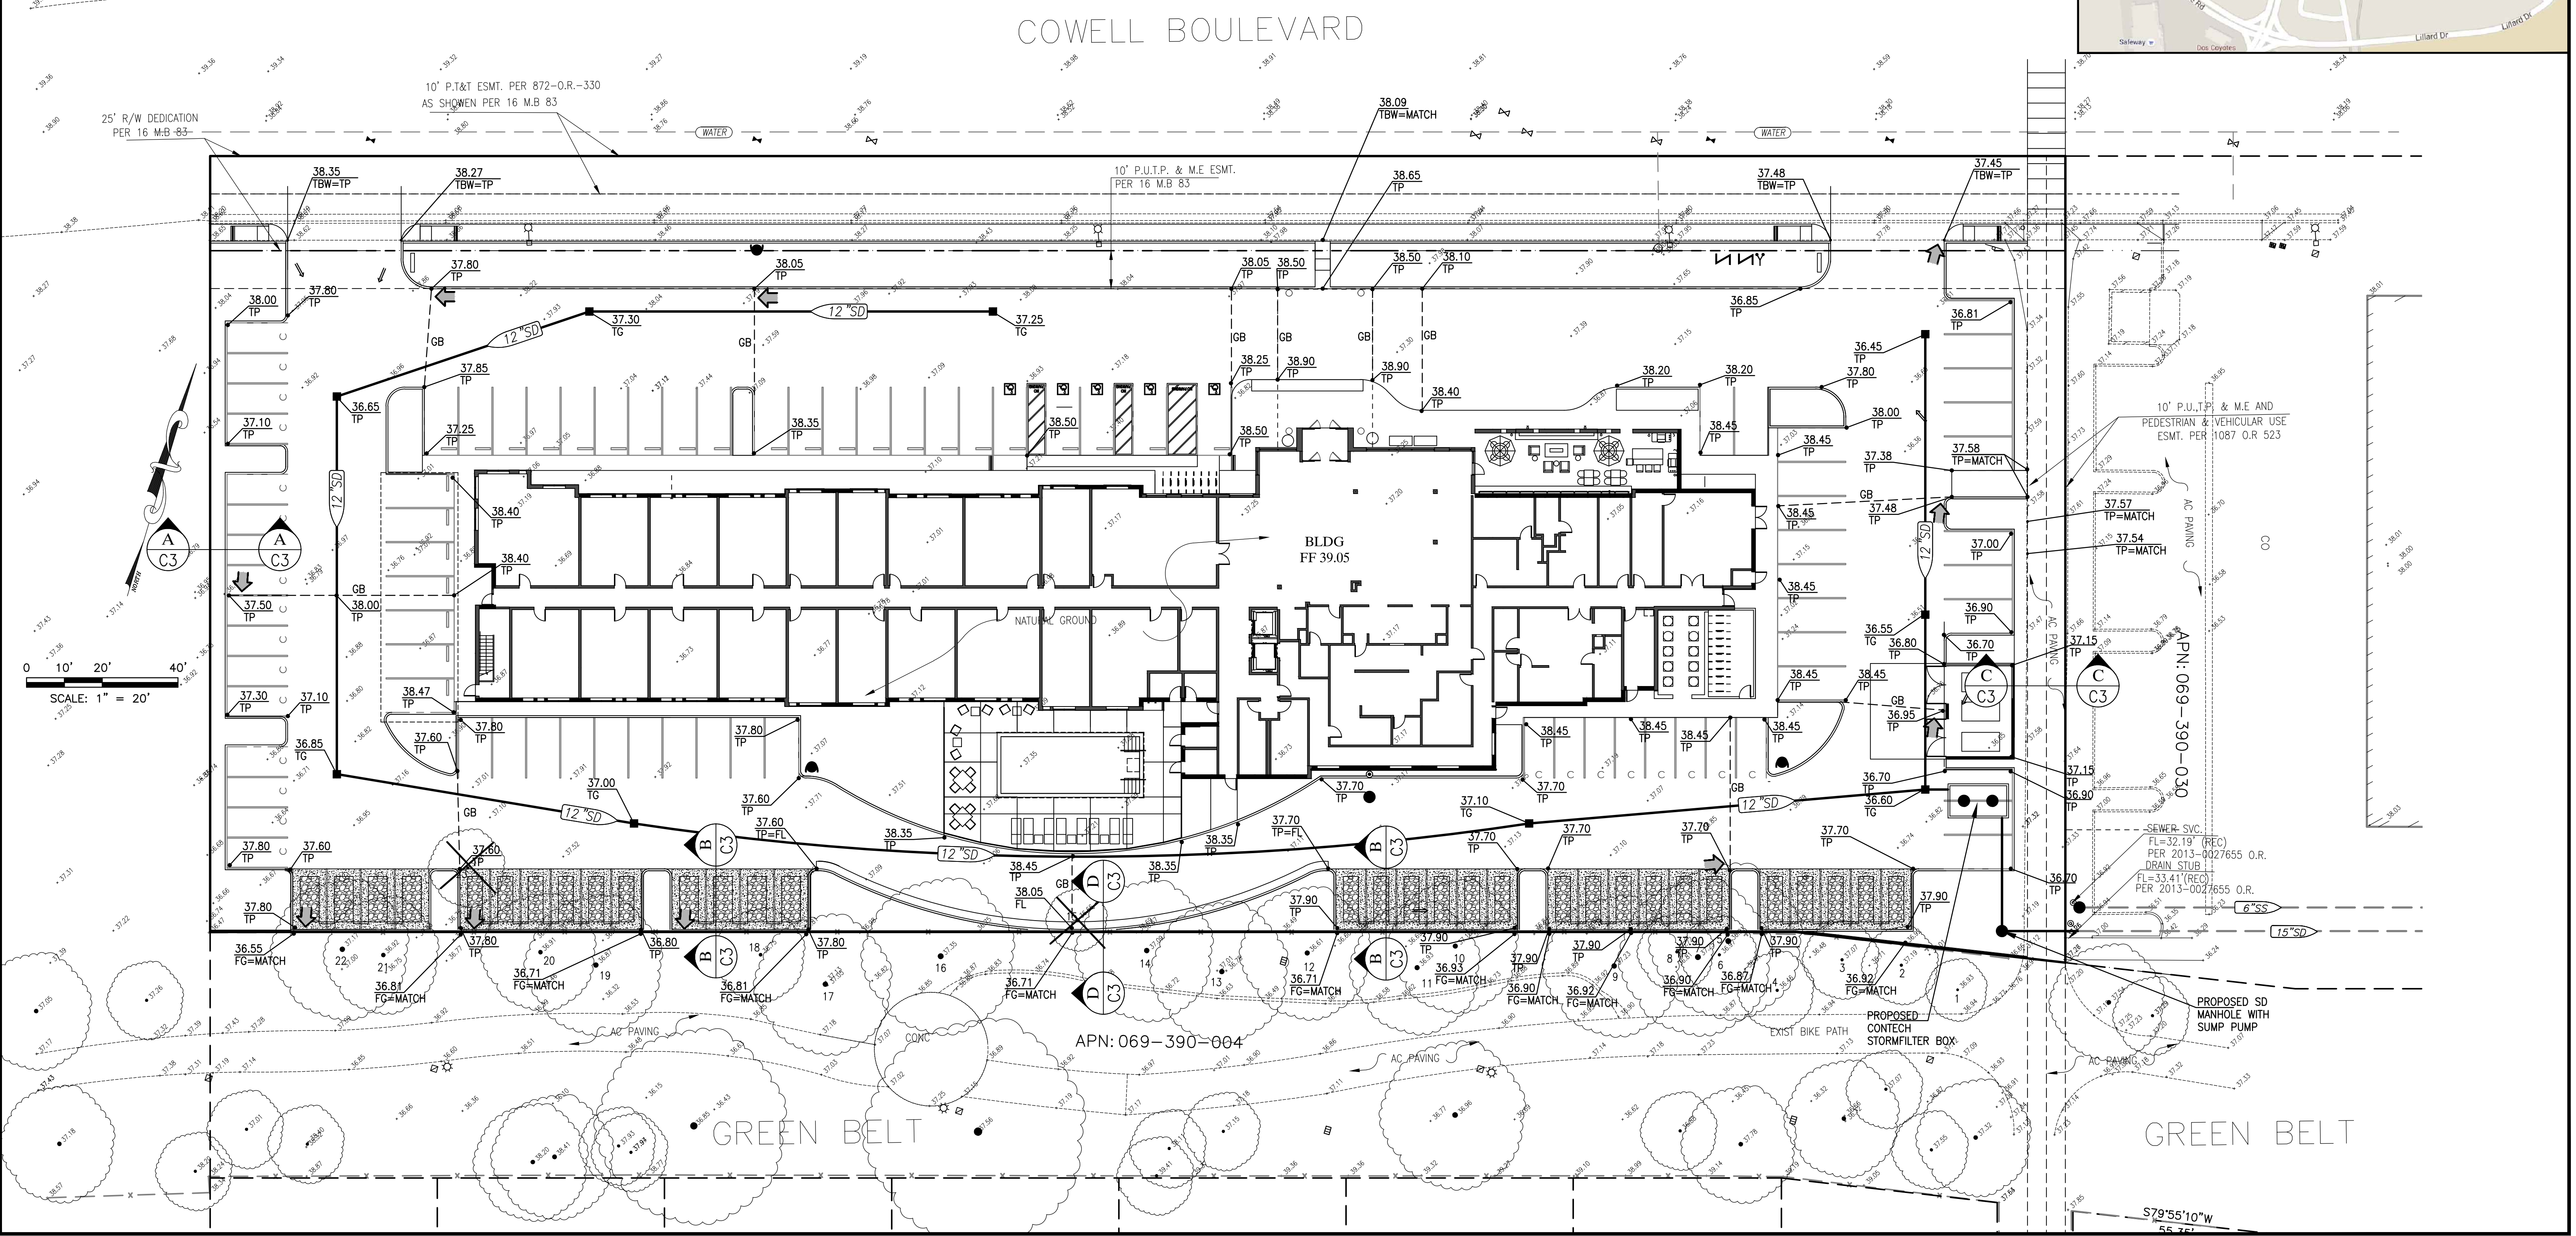
PRELIMINARY GRADING AND DRAINAGE PLAN
2750 COWELL BOULEVARD
HYATT HOUSE
CITY OF DAVIS
APN: 069-0390-031
CALIFORNIA

The fire lane is sufficiently far from the subject trees to pose no significant impact with the exception of trees #12, 14 and 16 (see attached grading plan). The distance between the fire lane and the trees is approximately 5, 4 and 6 feet, respectively. The design team has indicated that the total extent of excavation and soil disturbance (scarification) will be limited to 12 inches to install the fire lane.

A 15-inch deep hand excavation adjacent to trees #12 and 14 one foot from the northern edge of the proposed fire lane within 12 feet of the trunks revealed no roots larger than 0.5 inches. Within twelve feet of the trunk of tree #16, one foot from the northern edge of the fire lane, I tile-probed (with a sharpened steel rod) to a depth of greater than 15 inches. In one location, we found two 0.75" diameter roots.

Given the above, I rated the level of development impact to these trees as low/moderate.

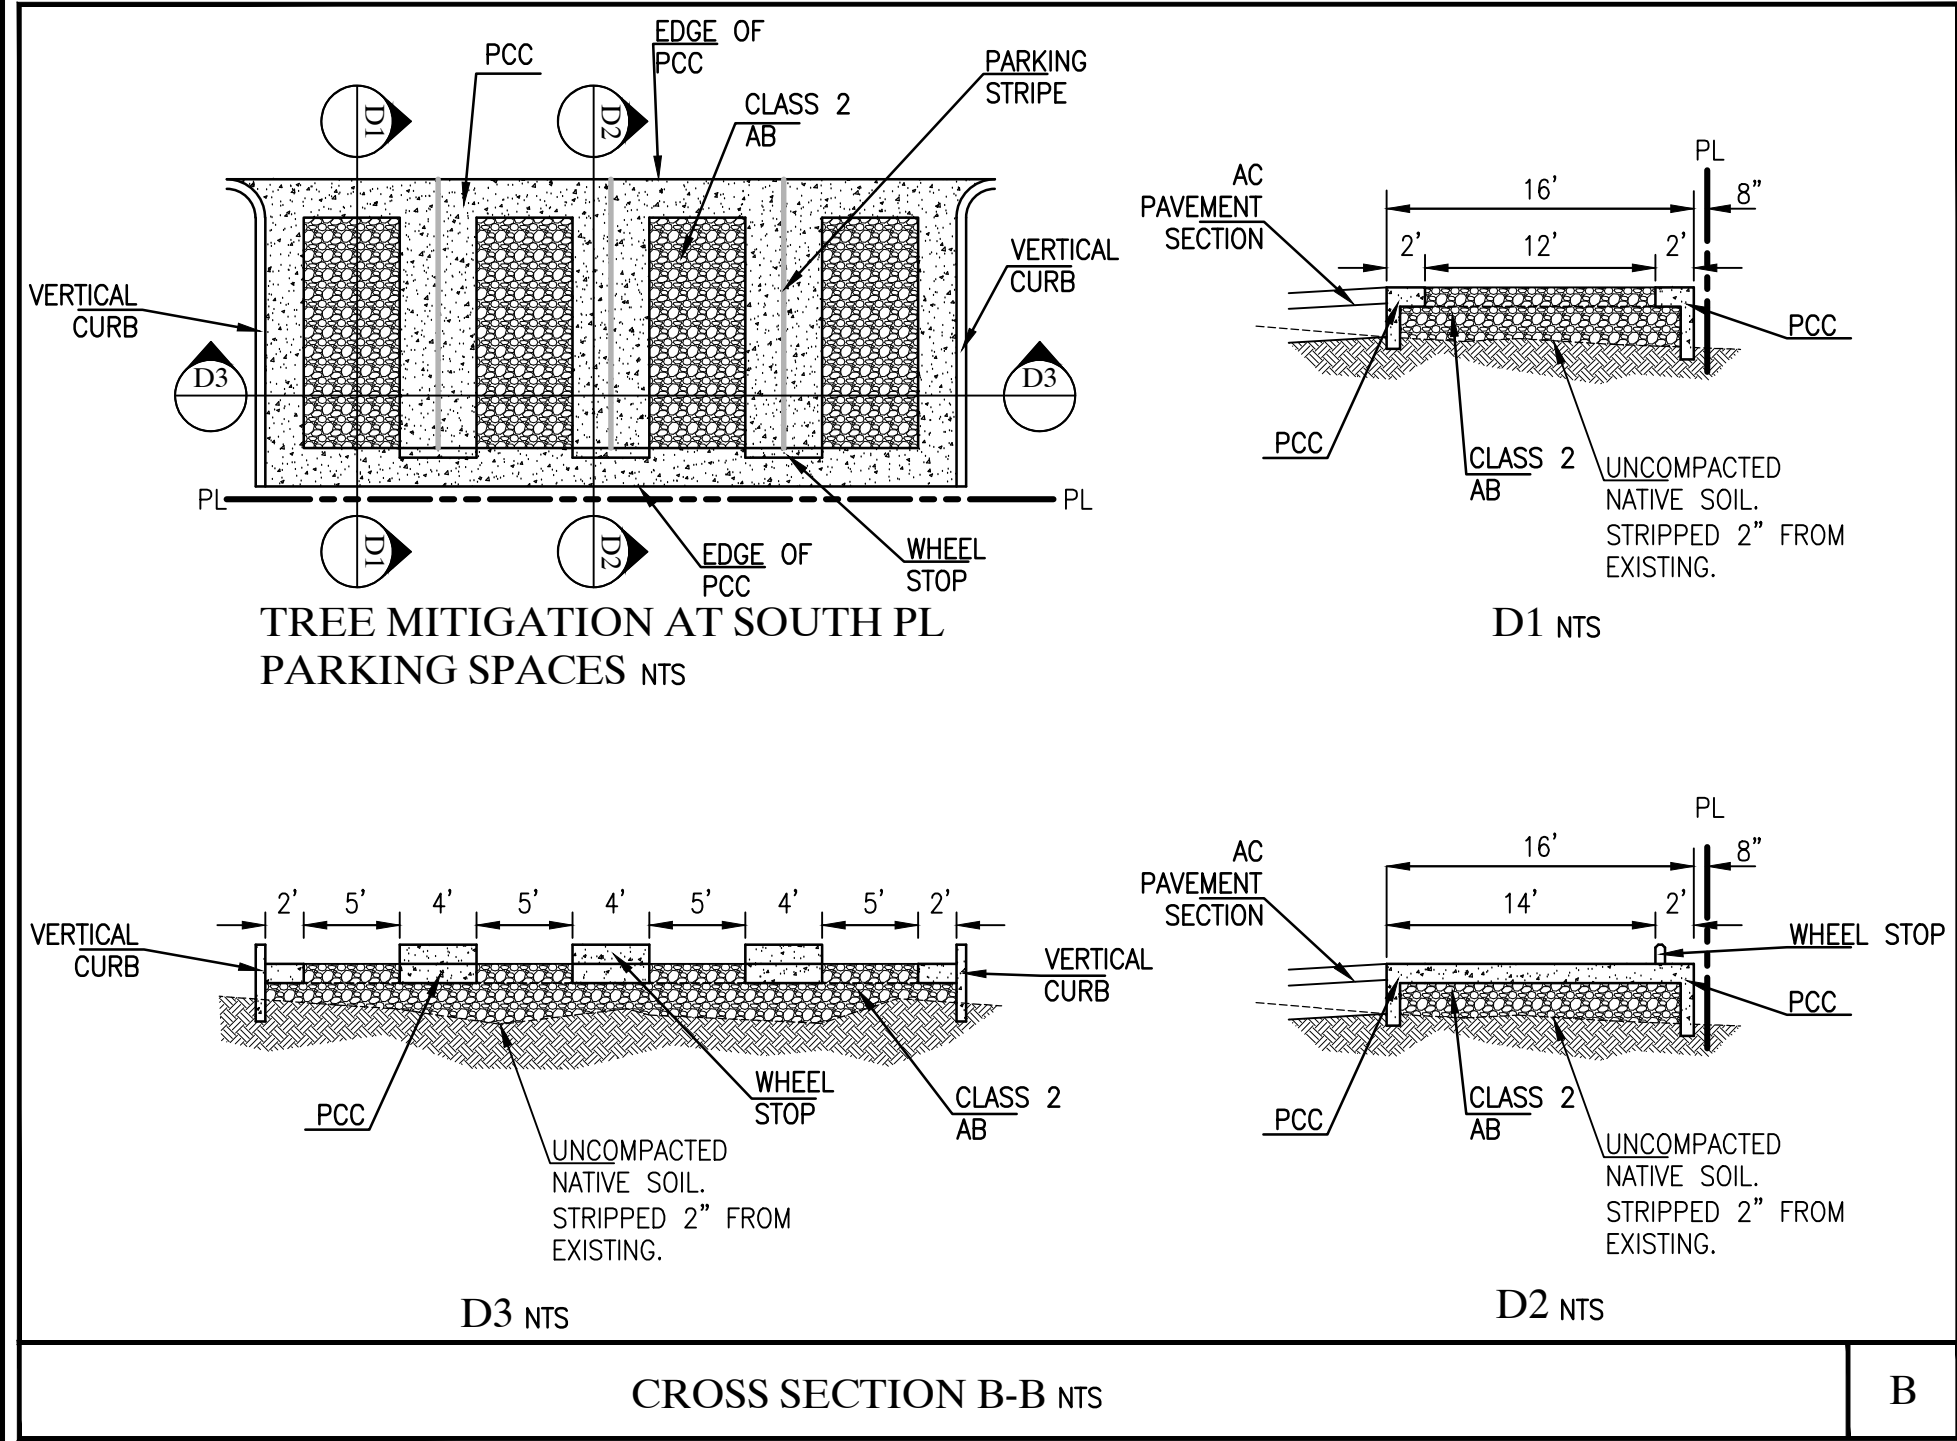
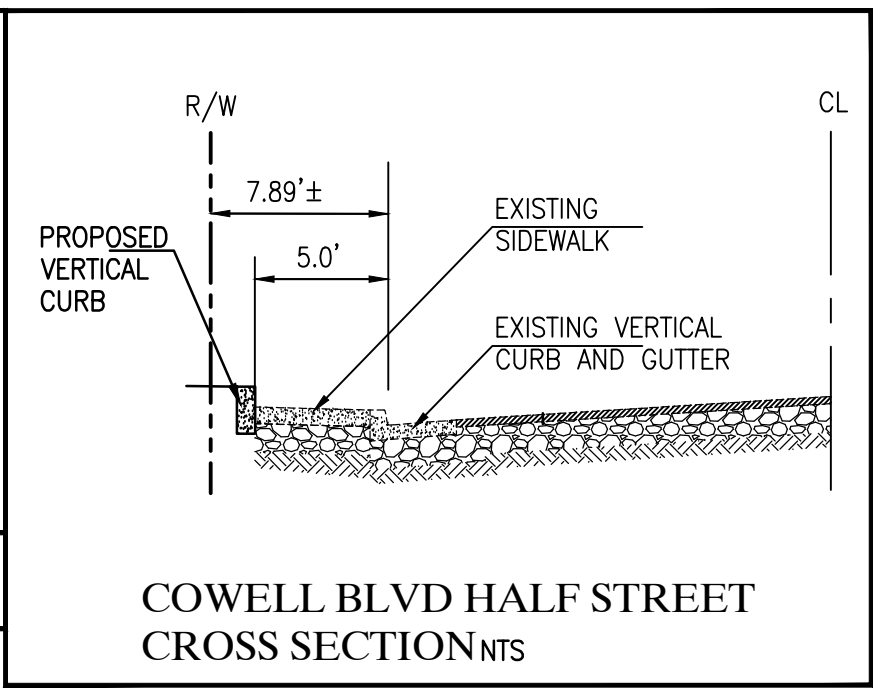
DETAILS SHEET
2750 COWELL BOULEVARD
 HYATT HOUSE
 CITY OF DAVIS
 APN: 069-0390-031
 CALIFORNIA

During this meeting, we discussed a "tree friendly" parking detail installed on grade utilizing gravel and concrete strips, which the design team prepared for my review (Preliminary Grading and Drainage Plan and Detail Sheet, 2/26/16, attached). I indicated that I wanted to excavate to determine root locations adjacent to a portion of the fire lane to determine potential impacts to the roots of a few of the nearby trees. In addition, I was asked to evaluate pruning necessary to provide vehicle clearance for the fire lane and parking. The

The proposed parking, which is located adjacent to the remaining greenbelt trees, involves installing gravel surrounded by poured concrete strips. The gravel is to be installed on uncompacted native soil (2" of soil stripped) with no scarification. The intent of this design is to avoid root injury and provide adequate soil moisture and structure to allow continued root growth.

- Revise parking lot detail to utilize drain rock rather than AB in between concrete strips.
- Specify on plans to excavate for curb installation with water or air under ISA Certified Arborist supervision. If roots greater than or equal to 2 inches in diameter are encountered, bridge curb over roots allowing space for roots to expand in girth.
