**PHASE I ENVIRONMENTAL
SITE ASSESSMENT, APN 070-324-002, 909-919 THIRD
STREET, DAVIS, YOLO COUNTY, CA 95616.**

PHASE I ENVIRONMENTAL SITE ASSESSMENT

Property: APN 070-324-002, 901-919 Third Street, Davis, Yolo County, CA 95616.
Section 15, Township 8 North, Range 2 East, Davis USGS Quadrangle.
38.5455 North Latitude, -121.7379 West Longitude.

Site Use: Multiple tenant retail/commercial buildings

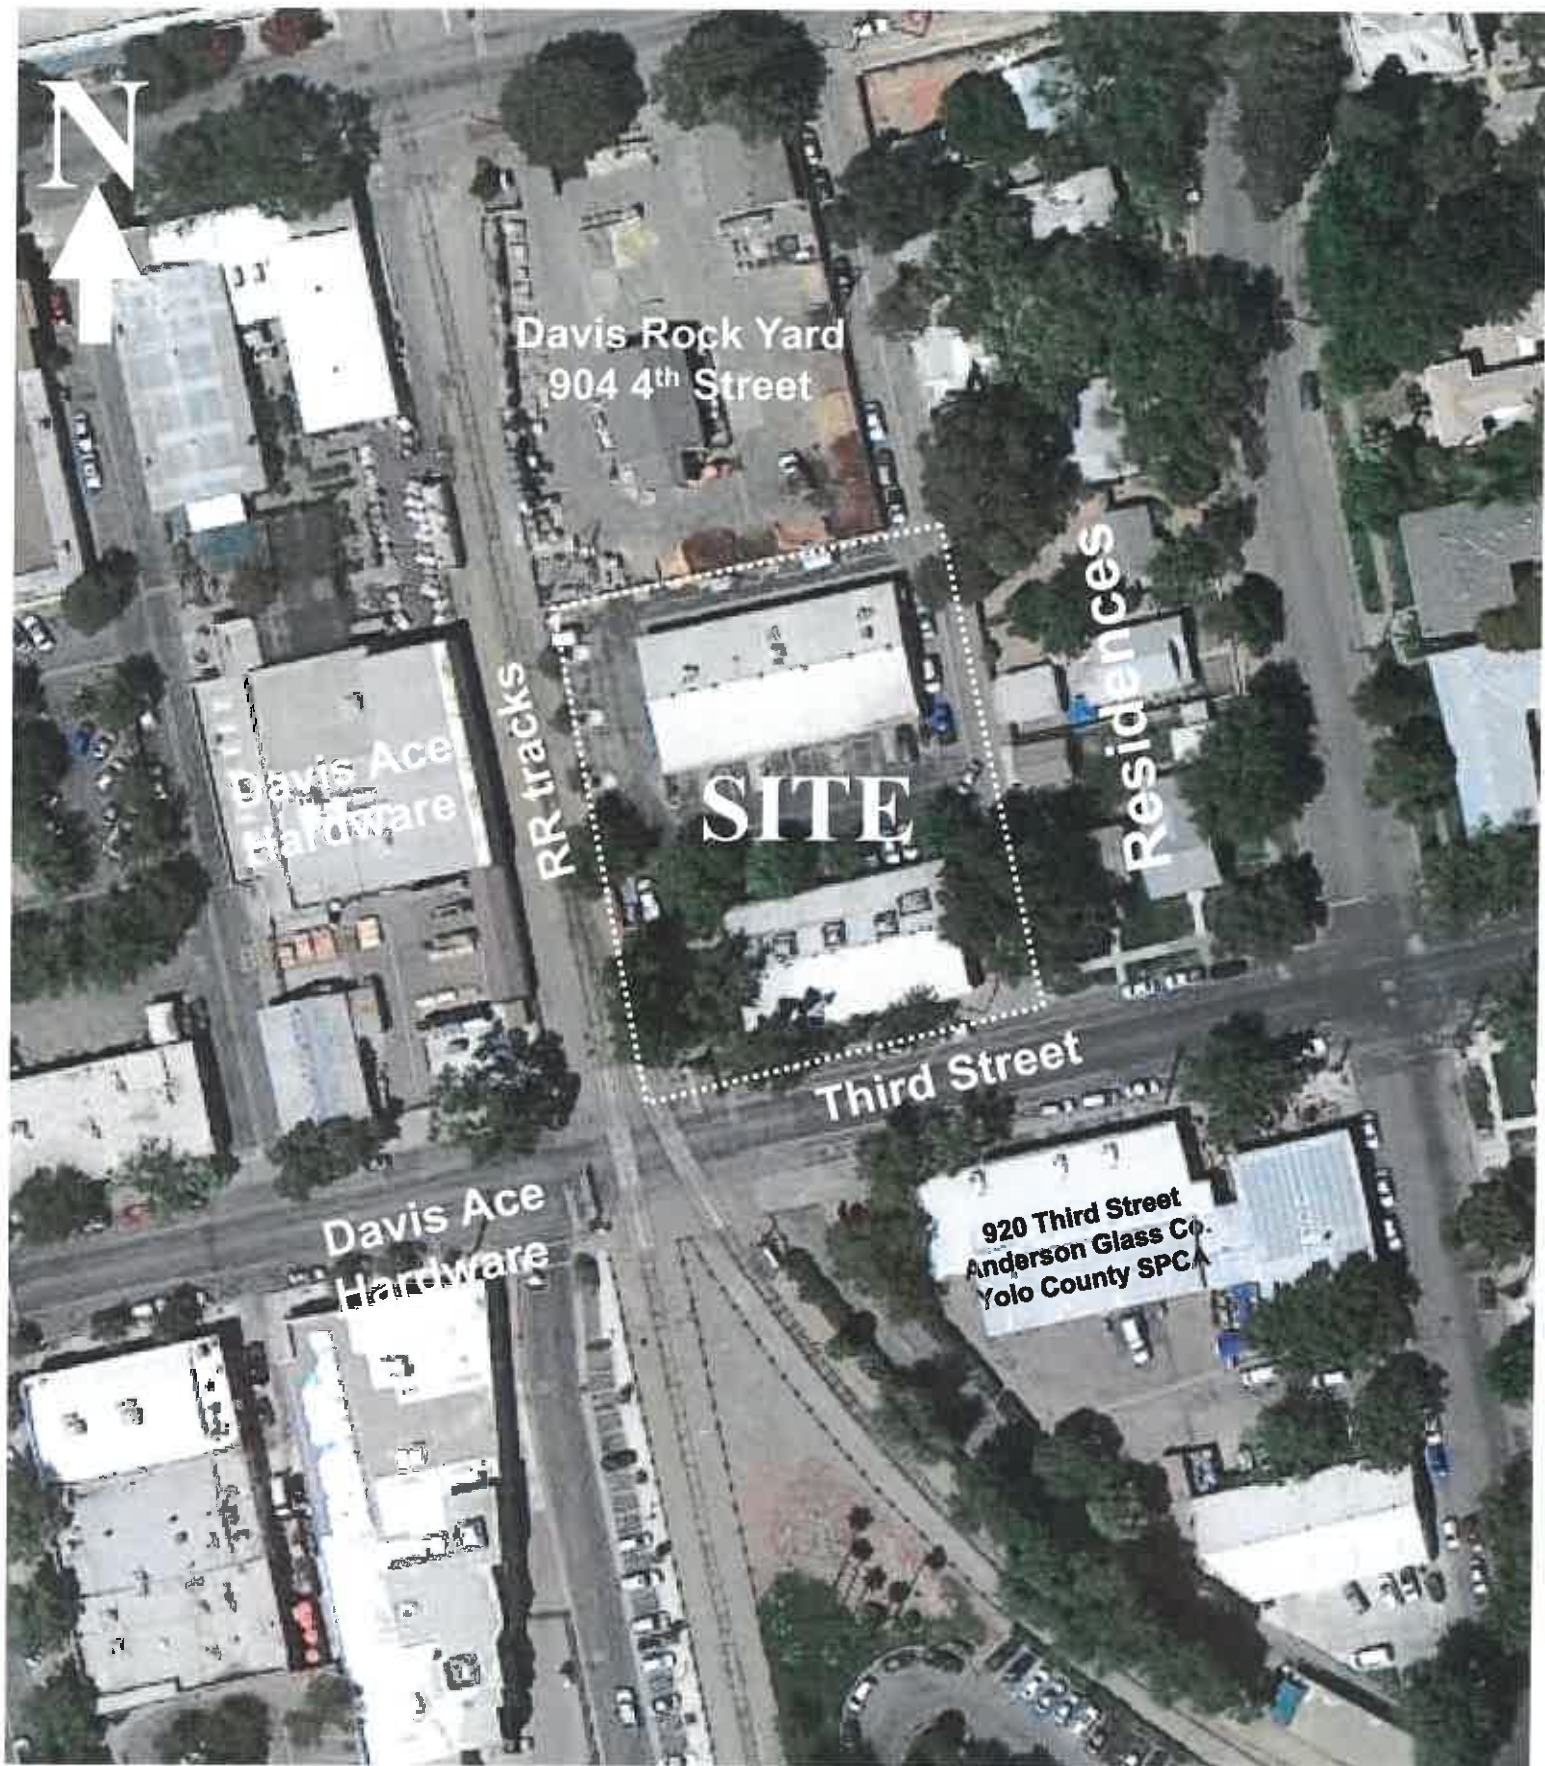
Figure 2

Site Location Map: 901-919 Third Street, Davis, Yolo County, CA 95616. Site is shown surrounded by residences, a rock yard, Davis Ace Hardware, a glass company, offices, and railroad tracks.

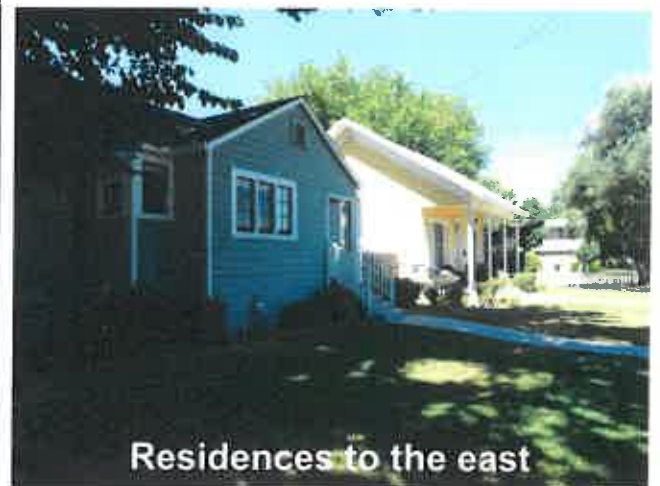
Residences to the east

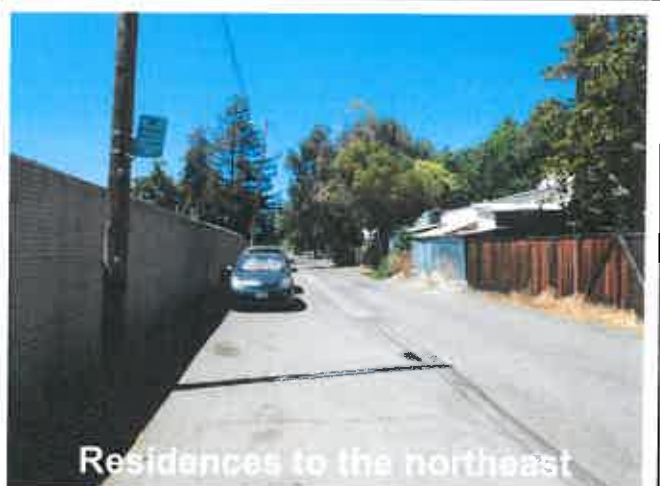
Residences to the northeast

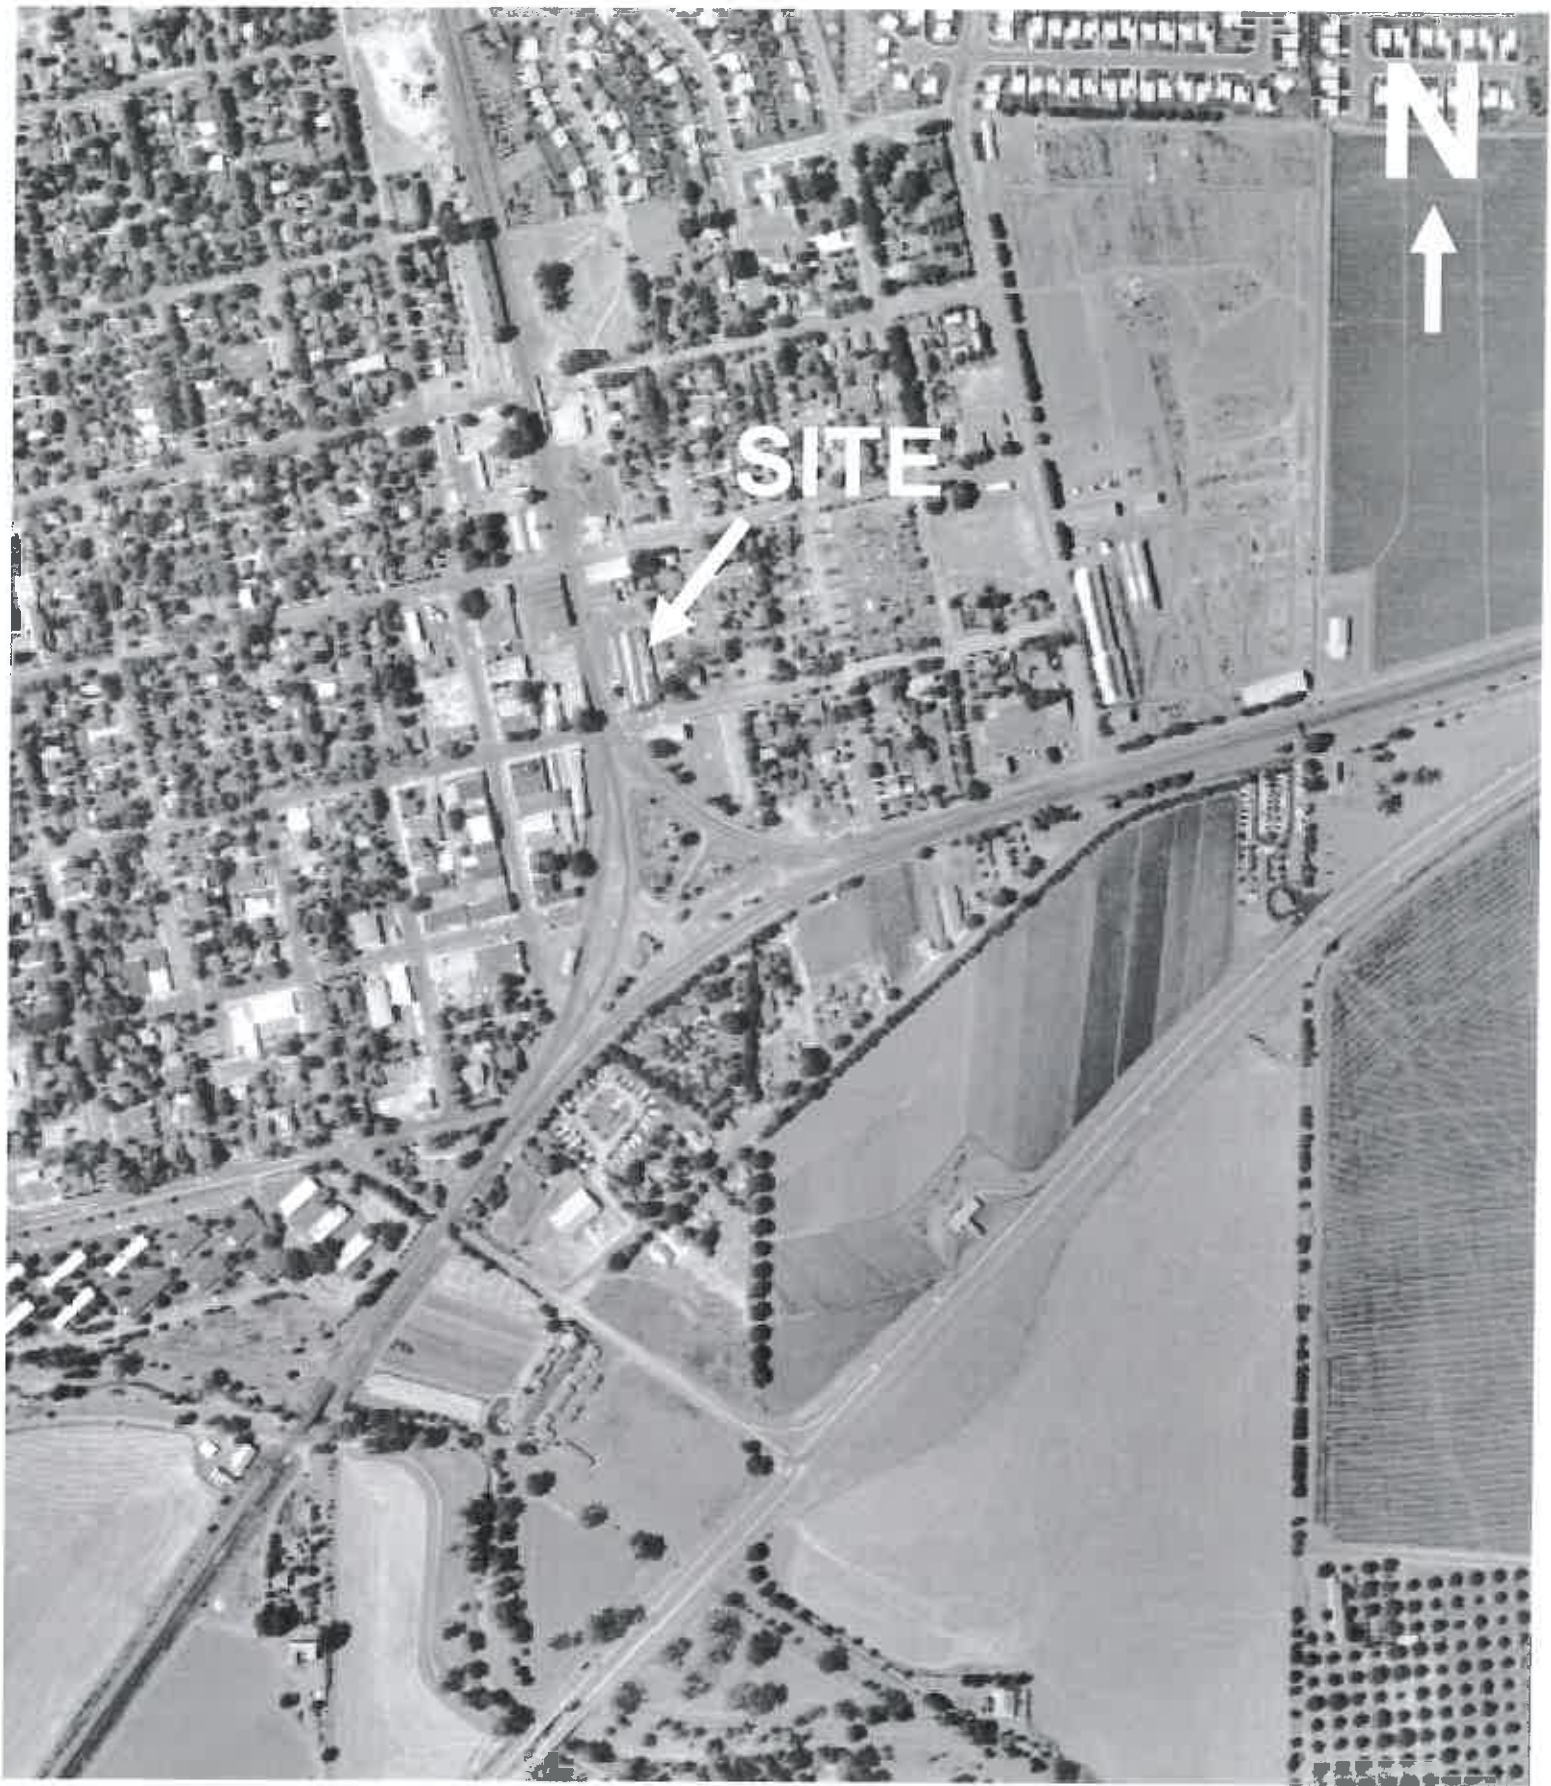
Aerial Photo, 1957: APN 070-324-002, 901-919 Third Street, Davis, CA 95616. Photo shows site containing a rectangular warehouse.

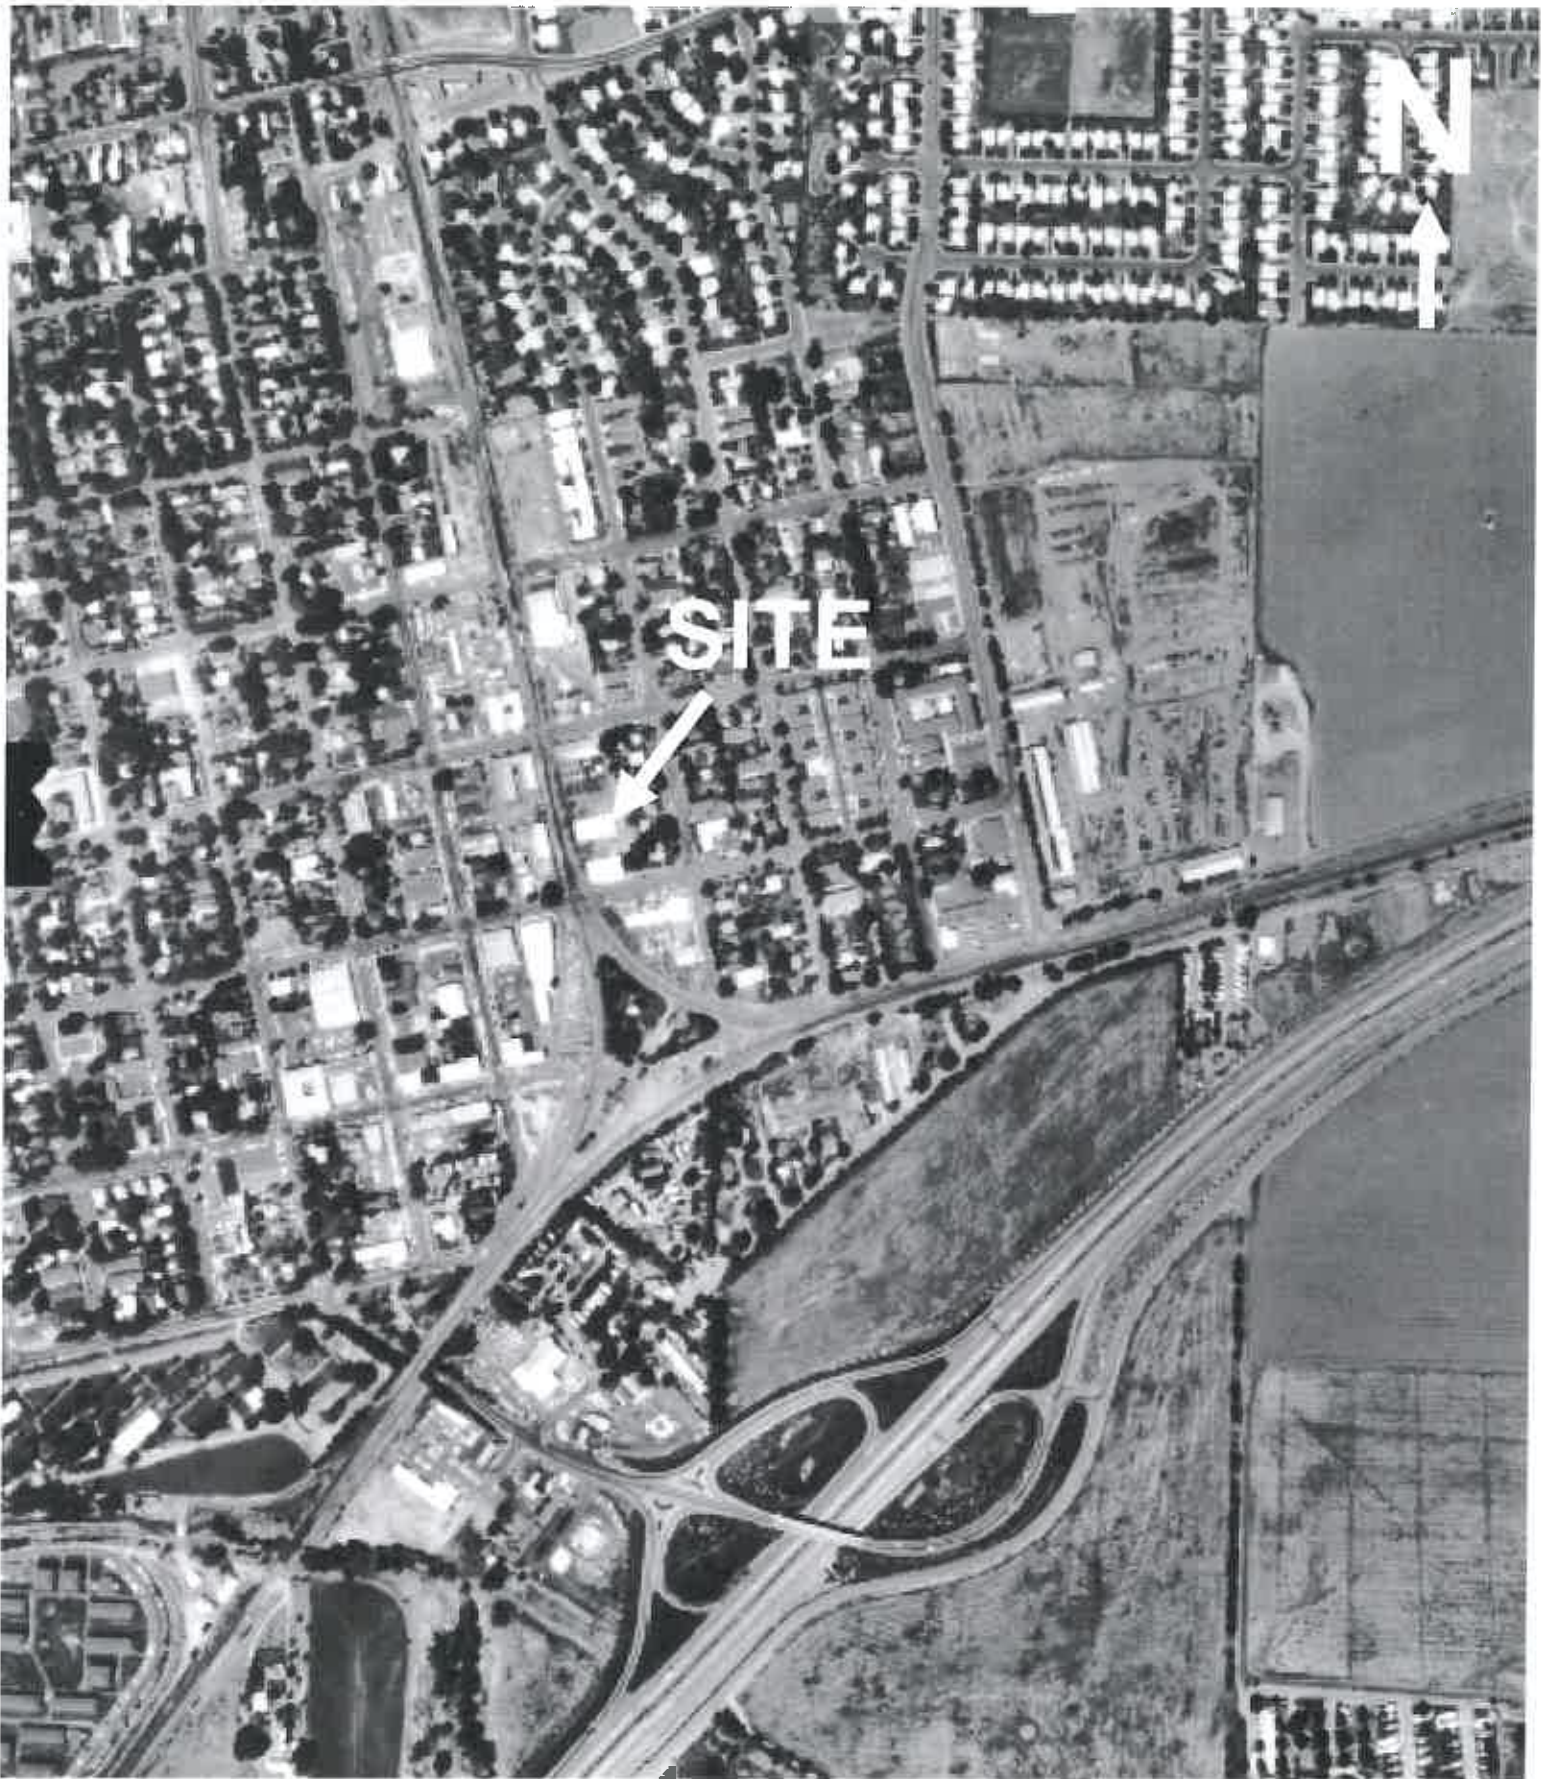
Aerial Photo, 1965: APN 070-324-002, 901-919 Third Street, Davis, CA 95616. Photo shows site containing two retail/commercial buildings.

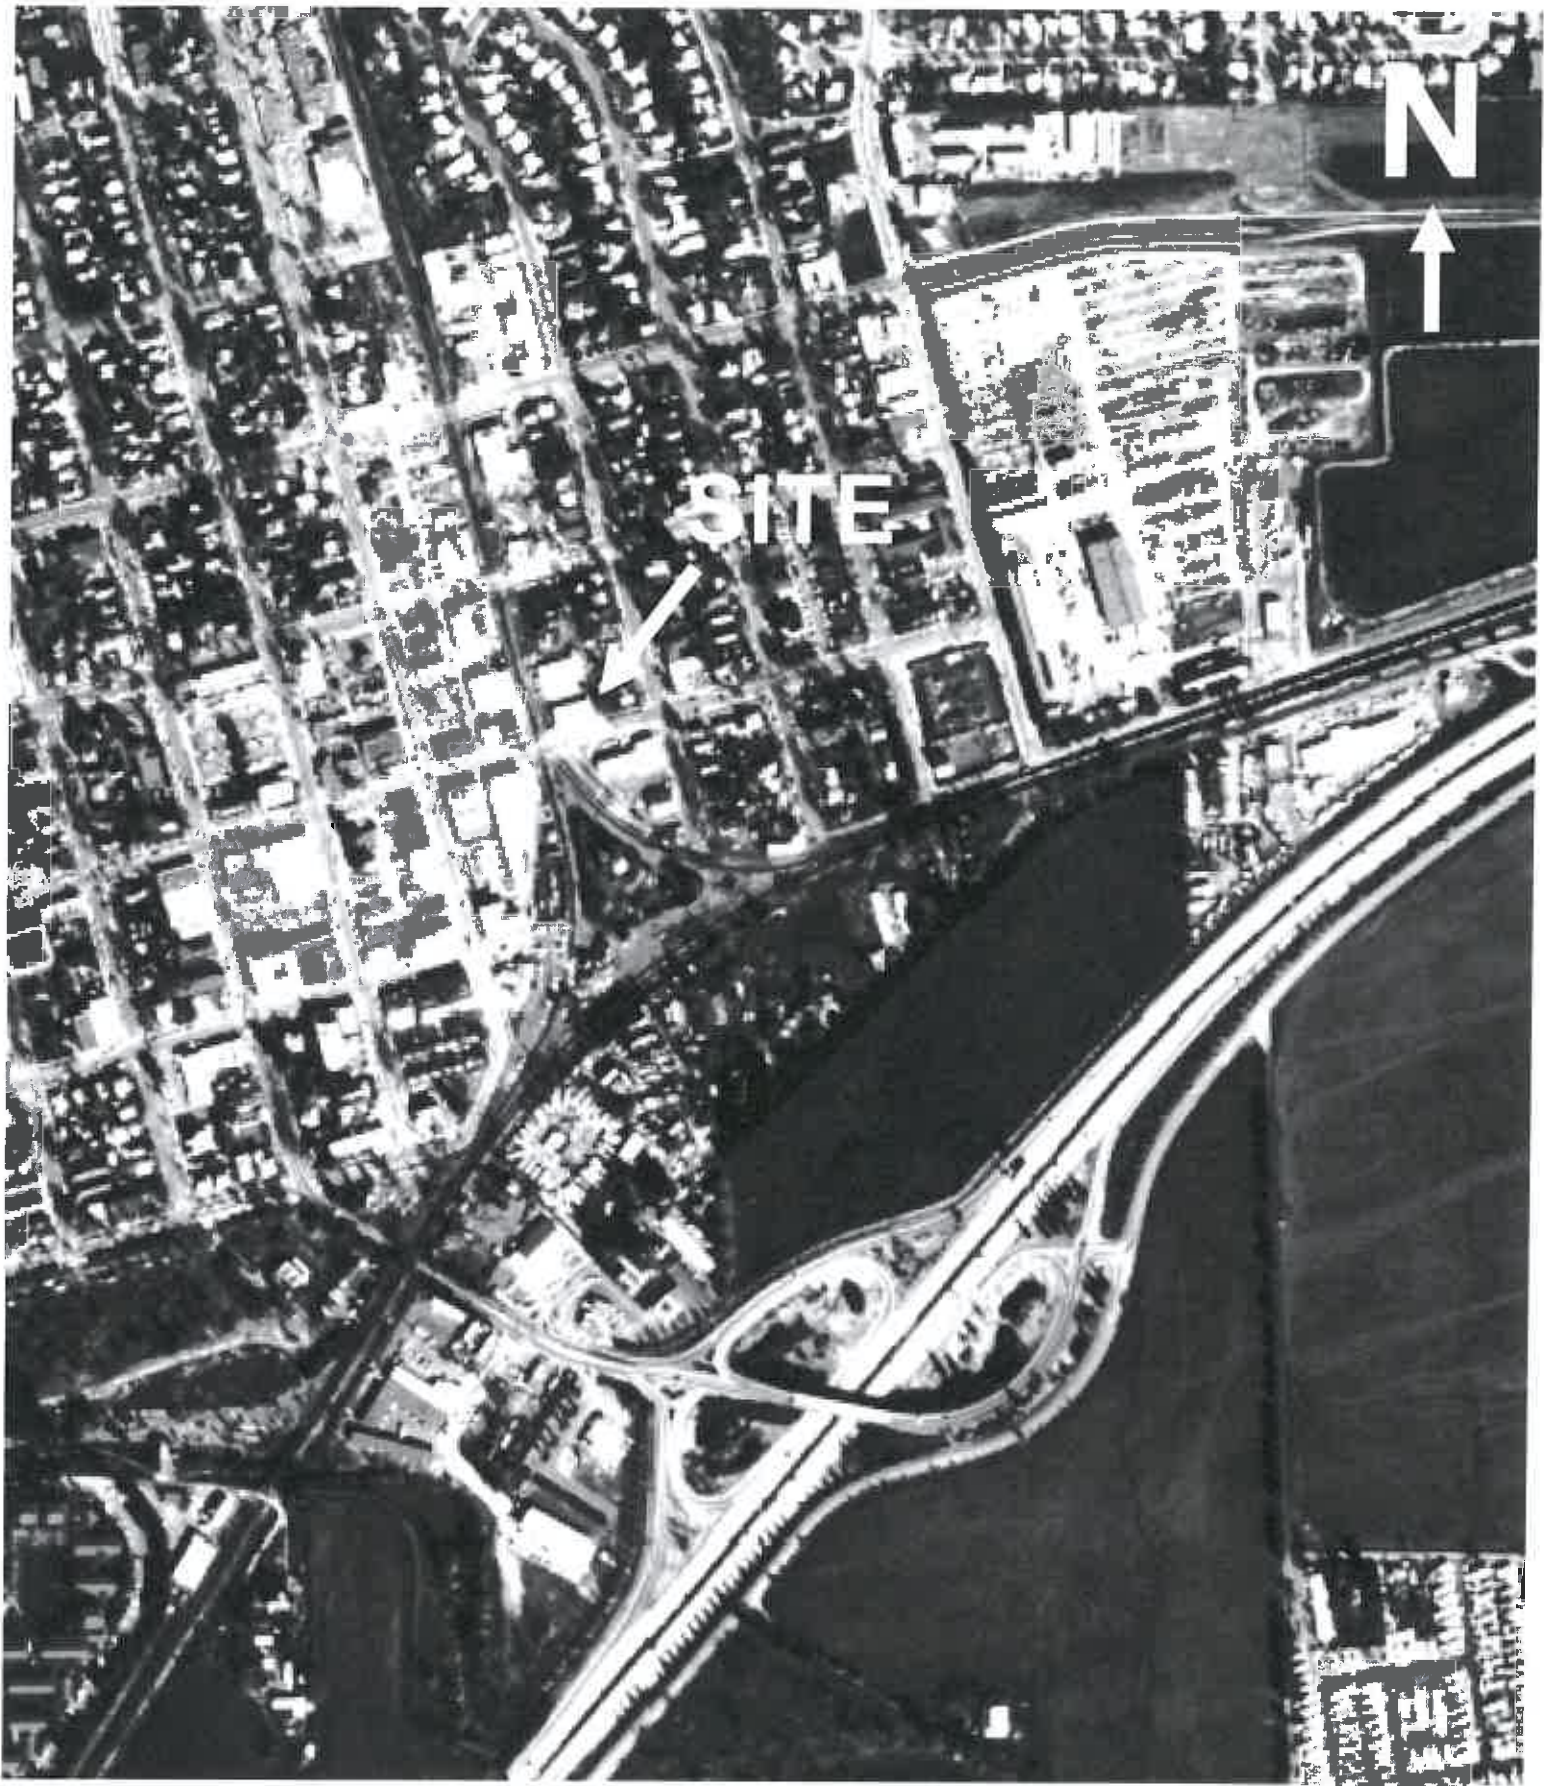
Aerial Photo, 1970: APN 070-324-002, 901-919 Third Street, Davis, CA 95616. Photo shows site containing two retail/commercial buildings.

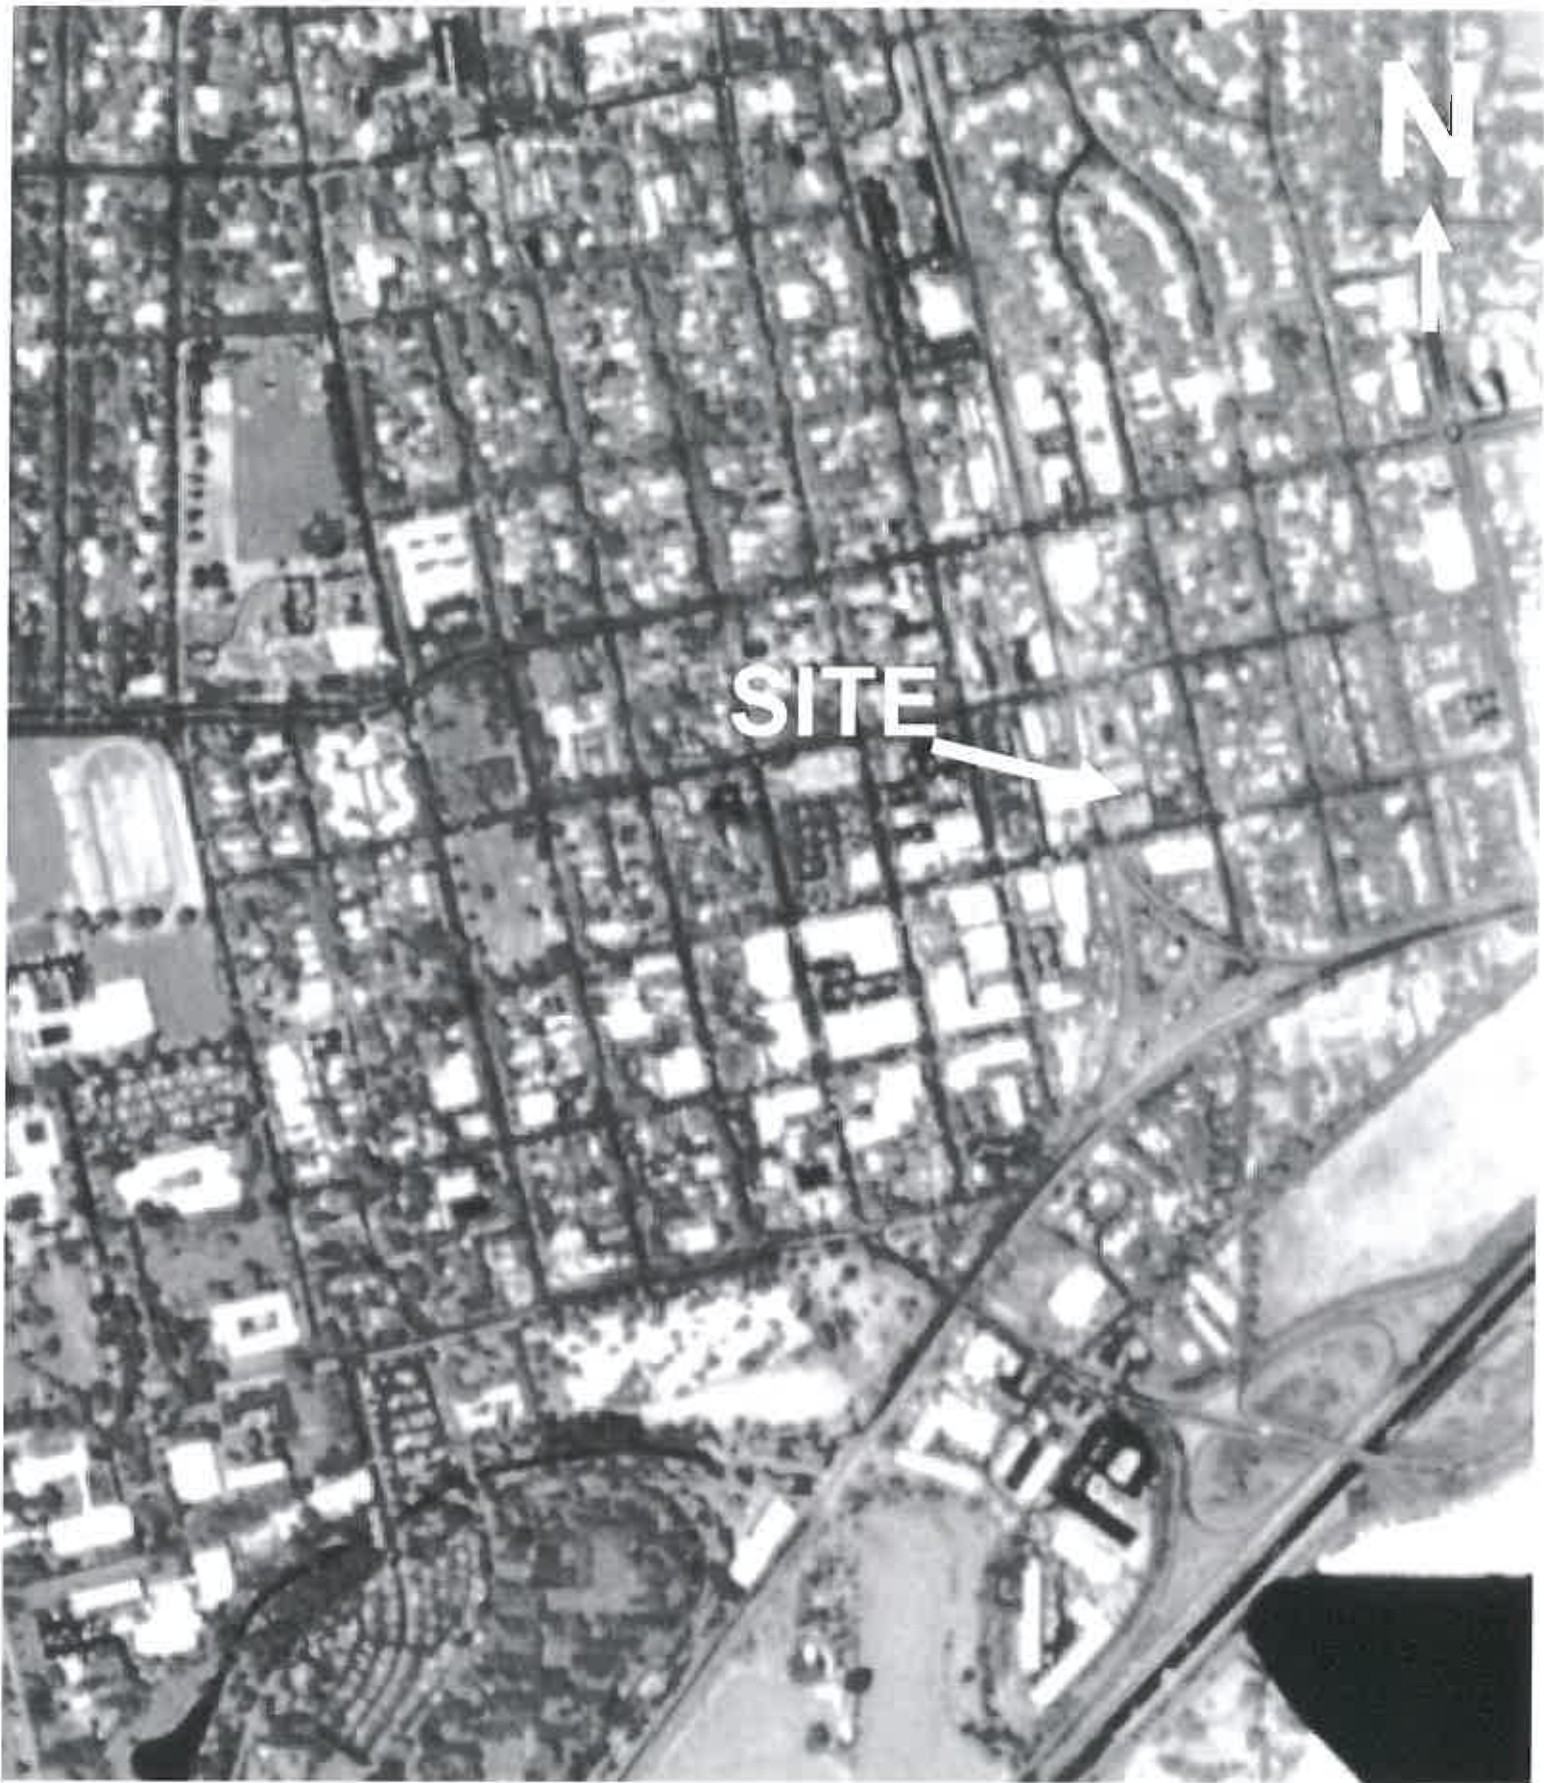
Aerial Photo, 1973: APN 070-324-002, 901-919 Third Street, Davis, CA 95616. Photo shows site containing two retail/commercial buildings.

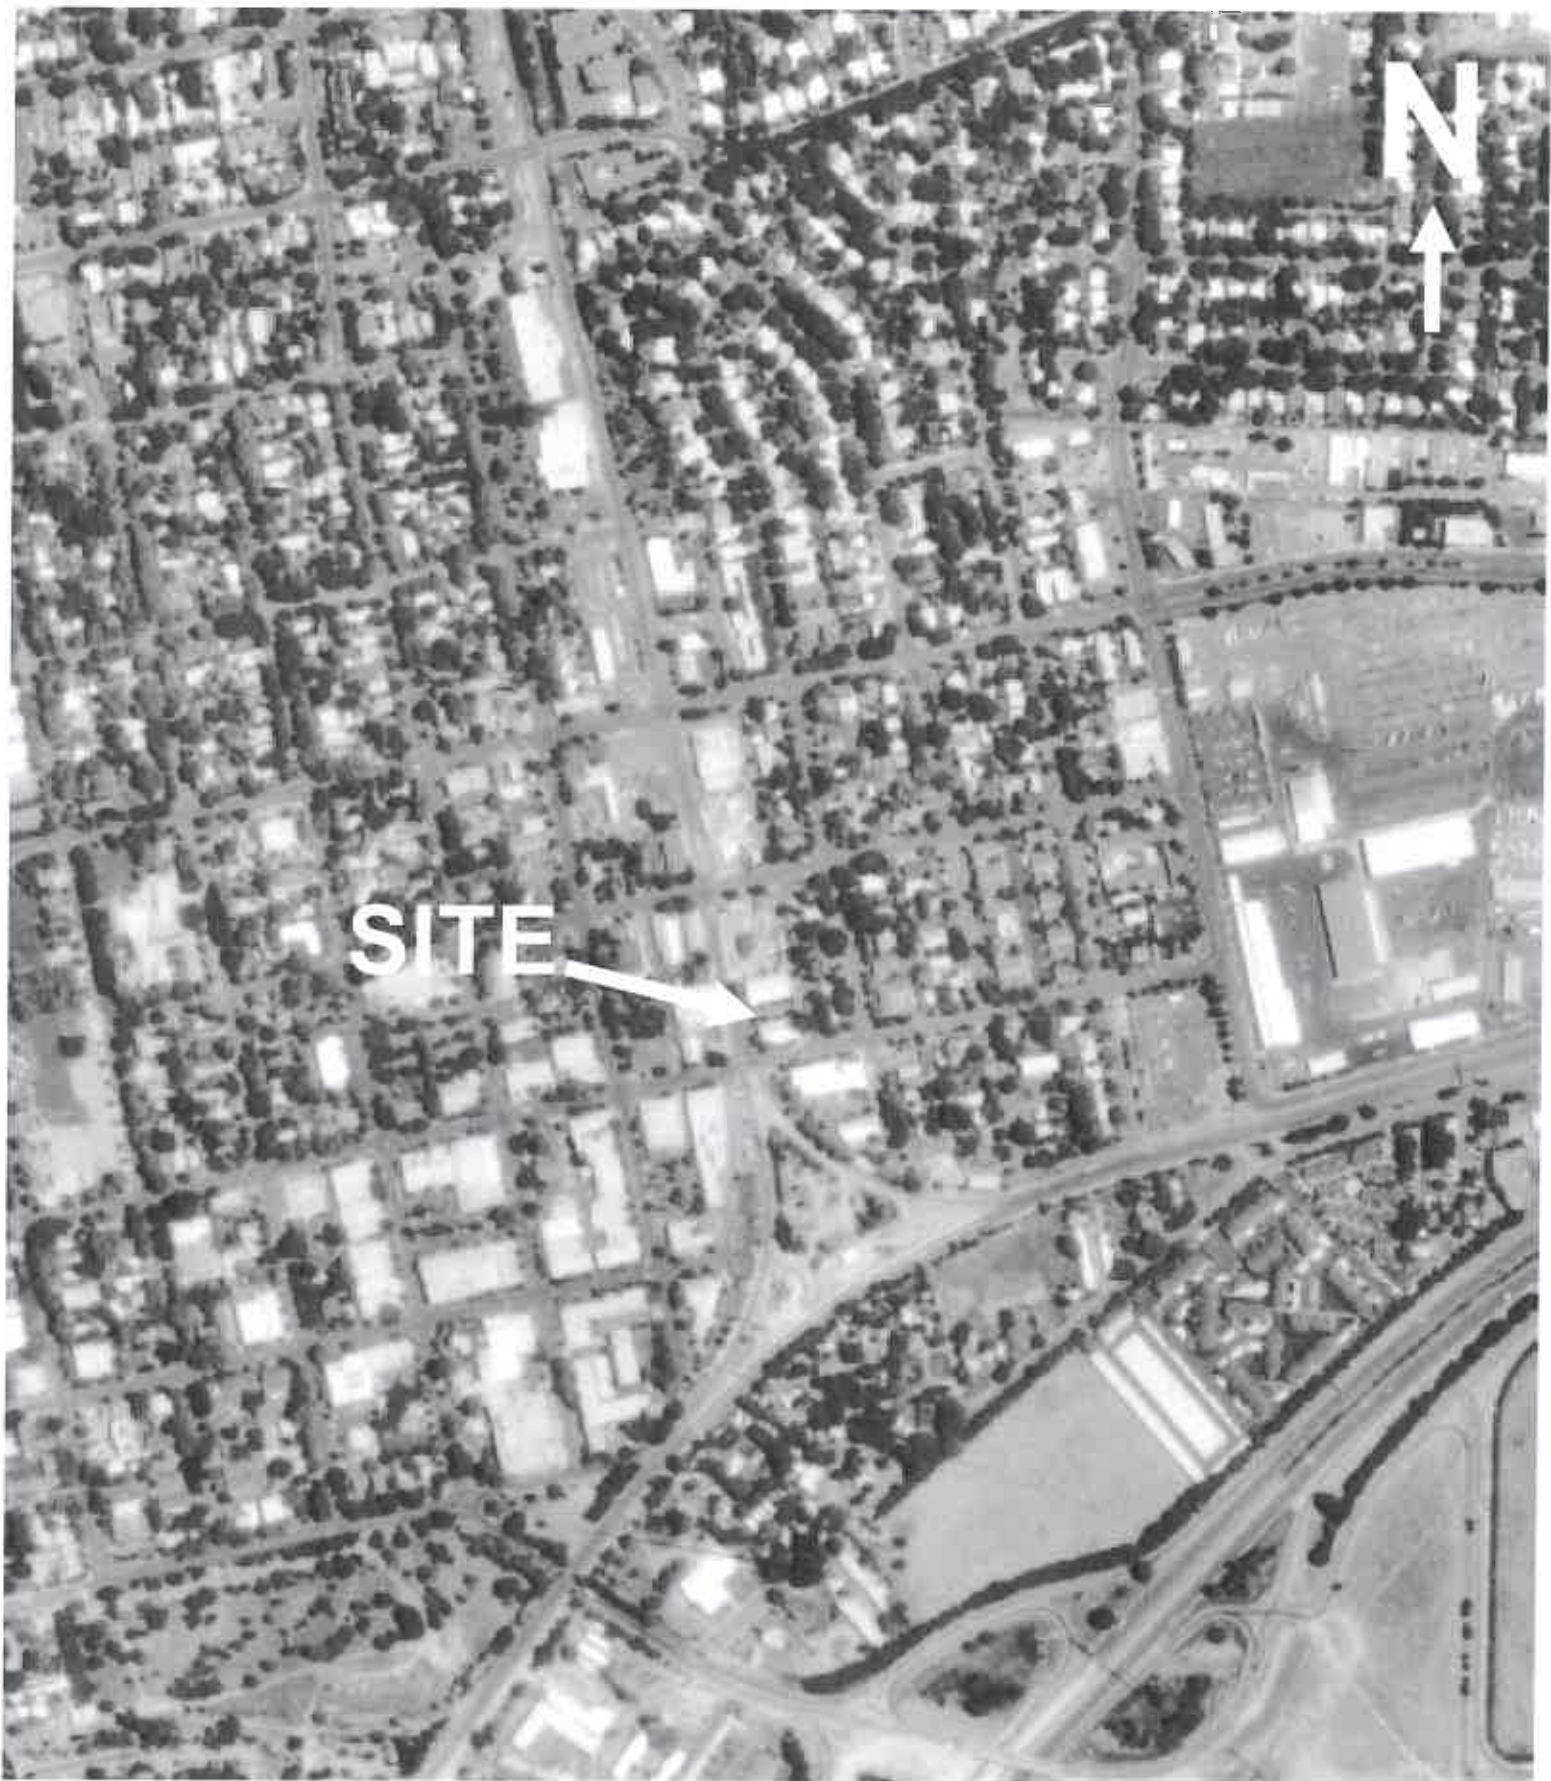
Aerial Photo, 1984: APN 070-324-002, 901-919 Third Street, Davis, CA 95616. Photo shows site containing two retail/commercial buildings.

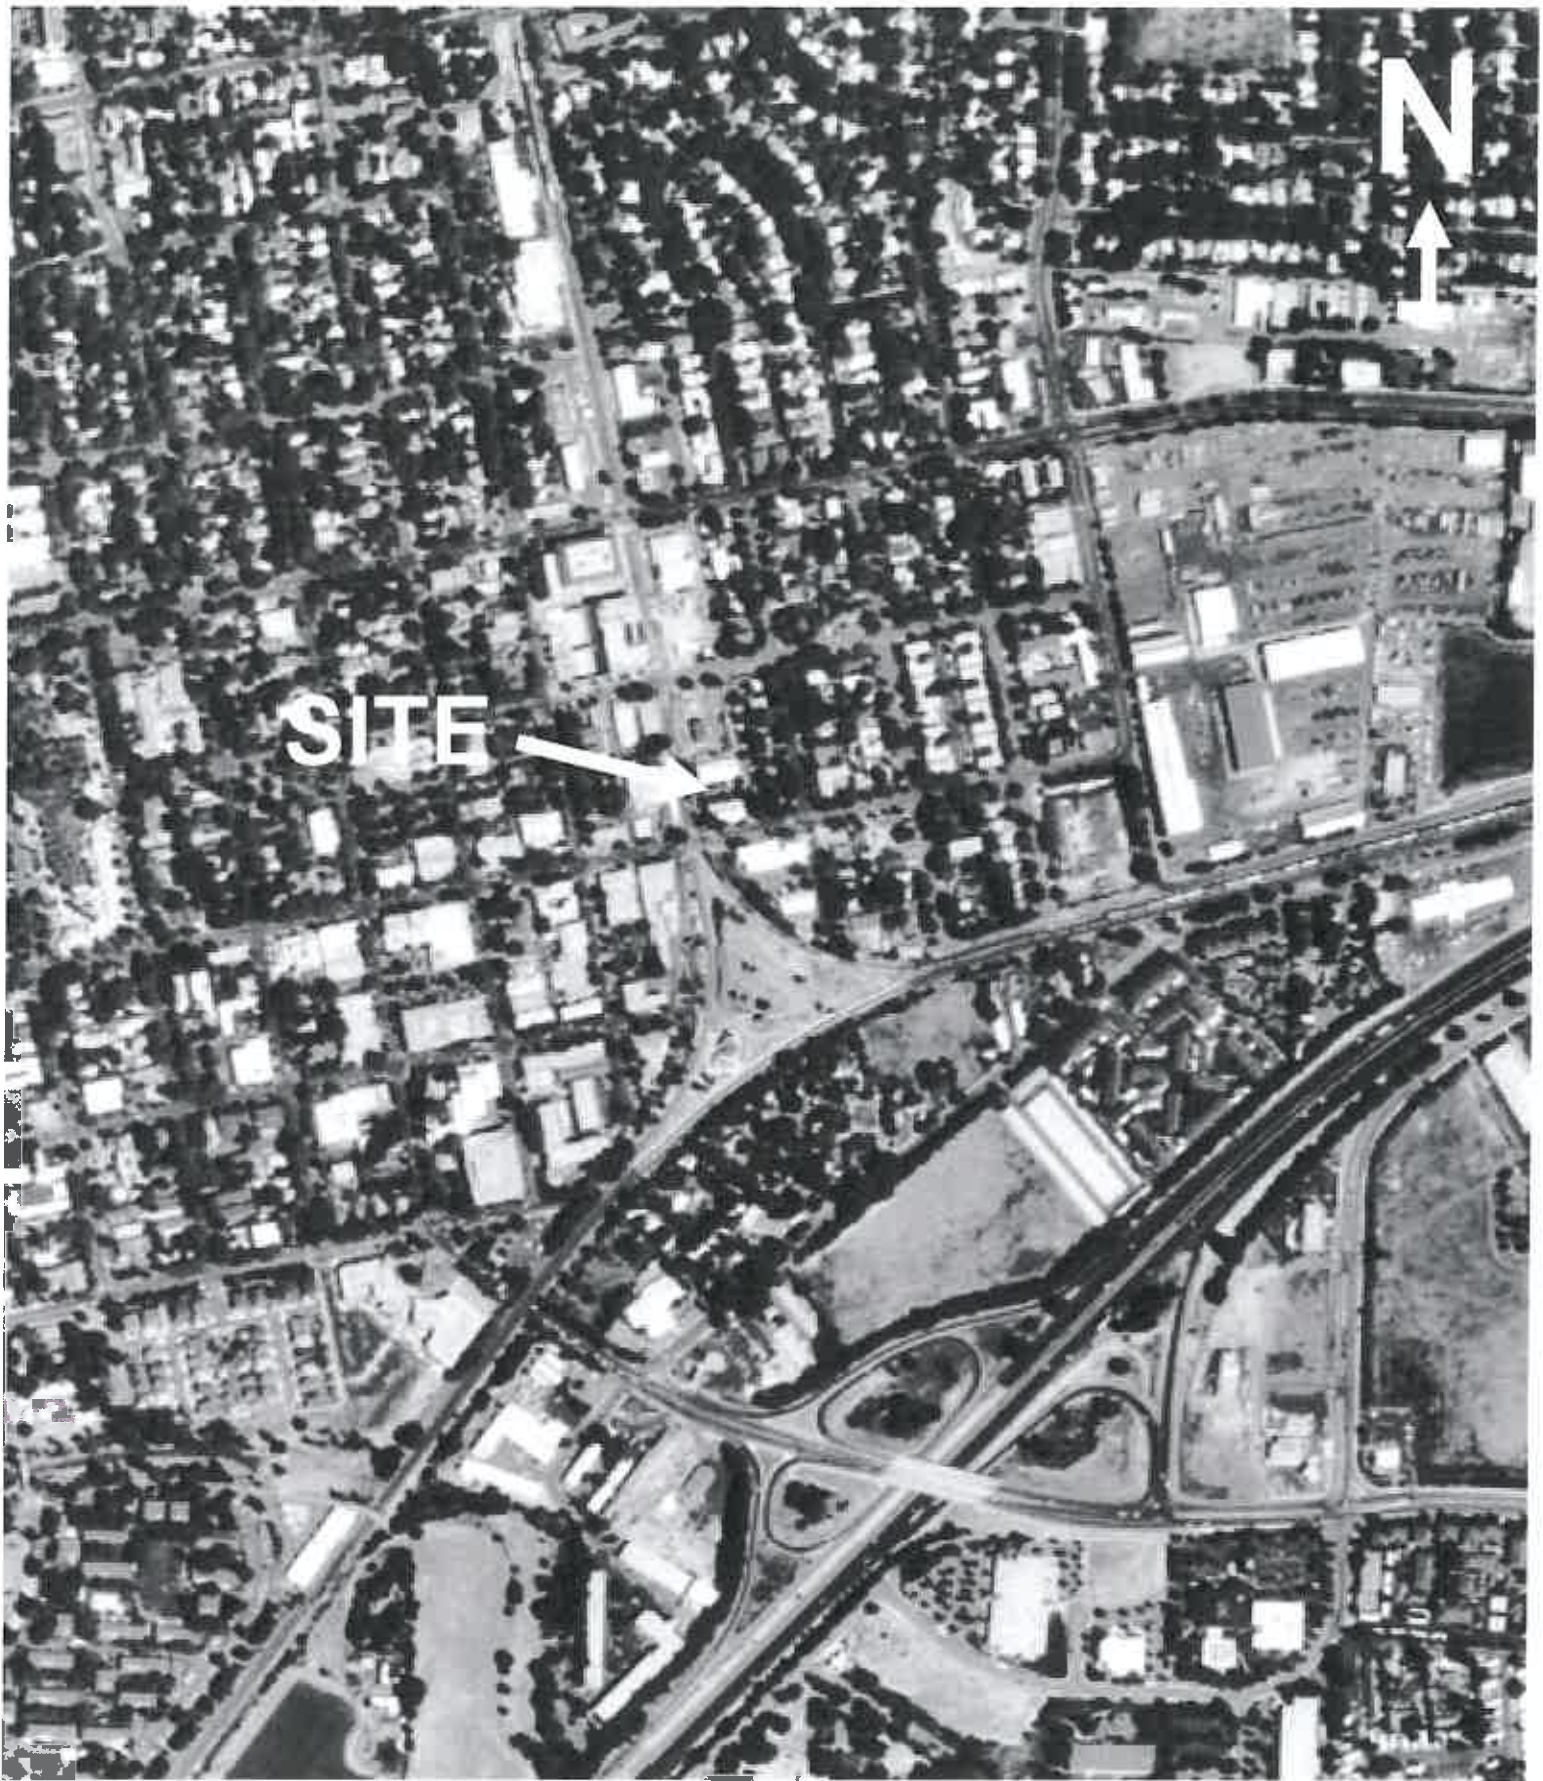
Aerial Photo, 1993: APN 070-324-002, 901-919 Third Street, Davis, CA 95616. Photo shows site containing two retail/commercial buildings.

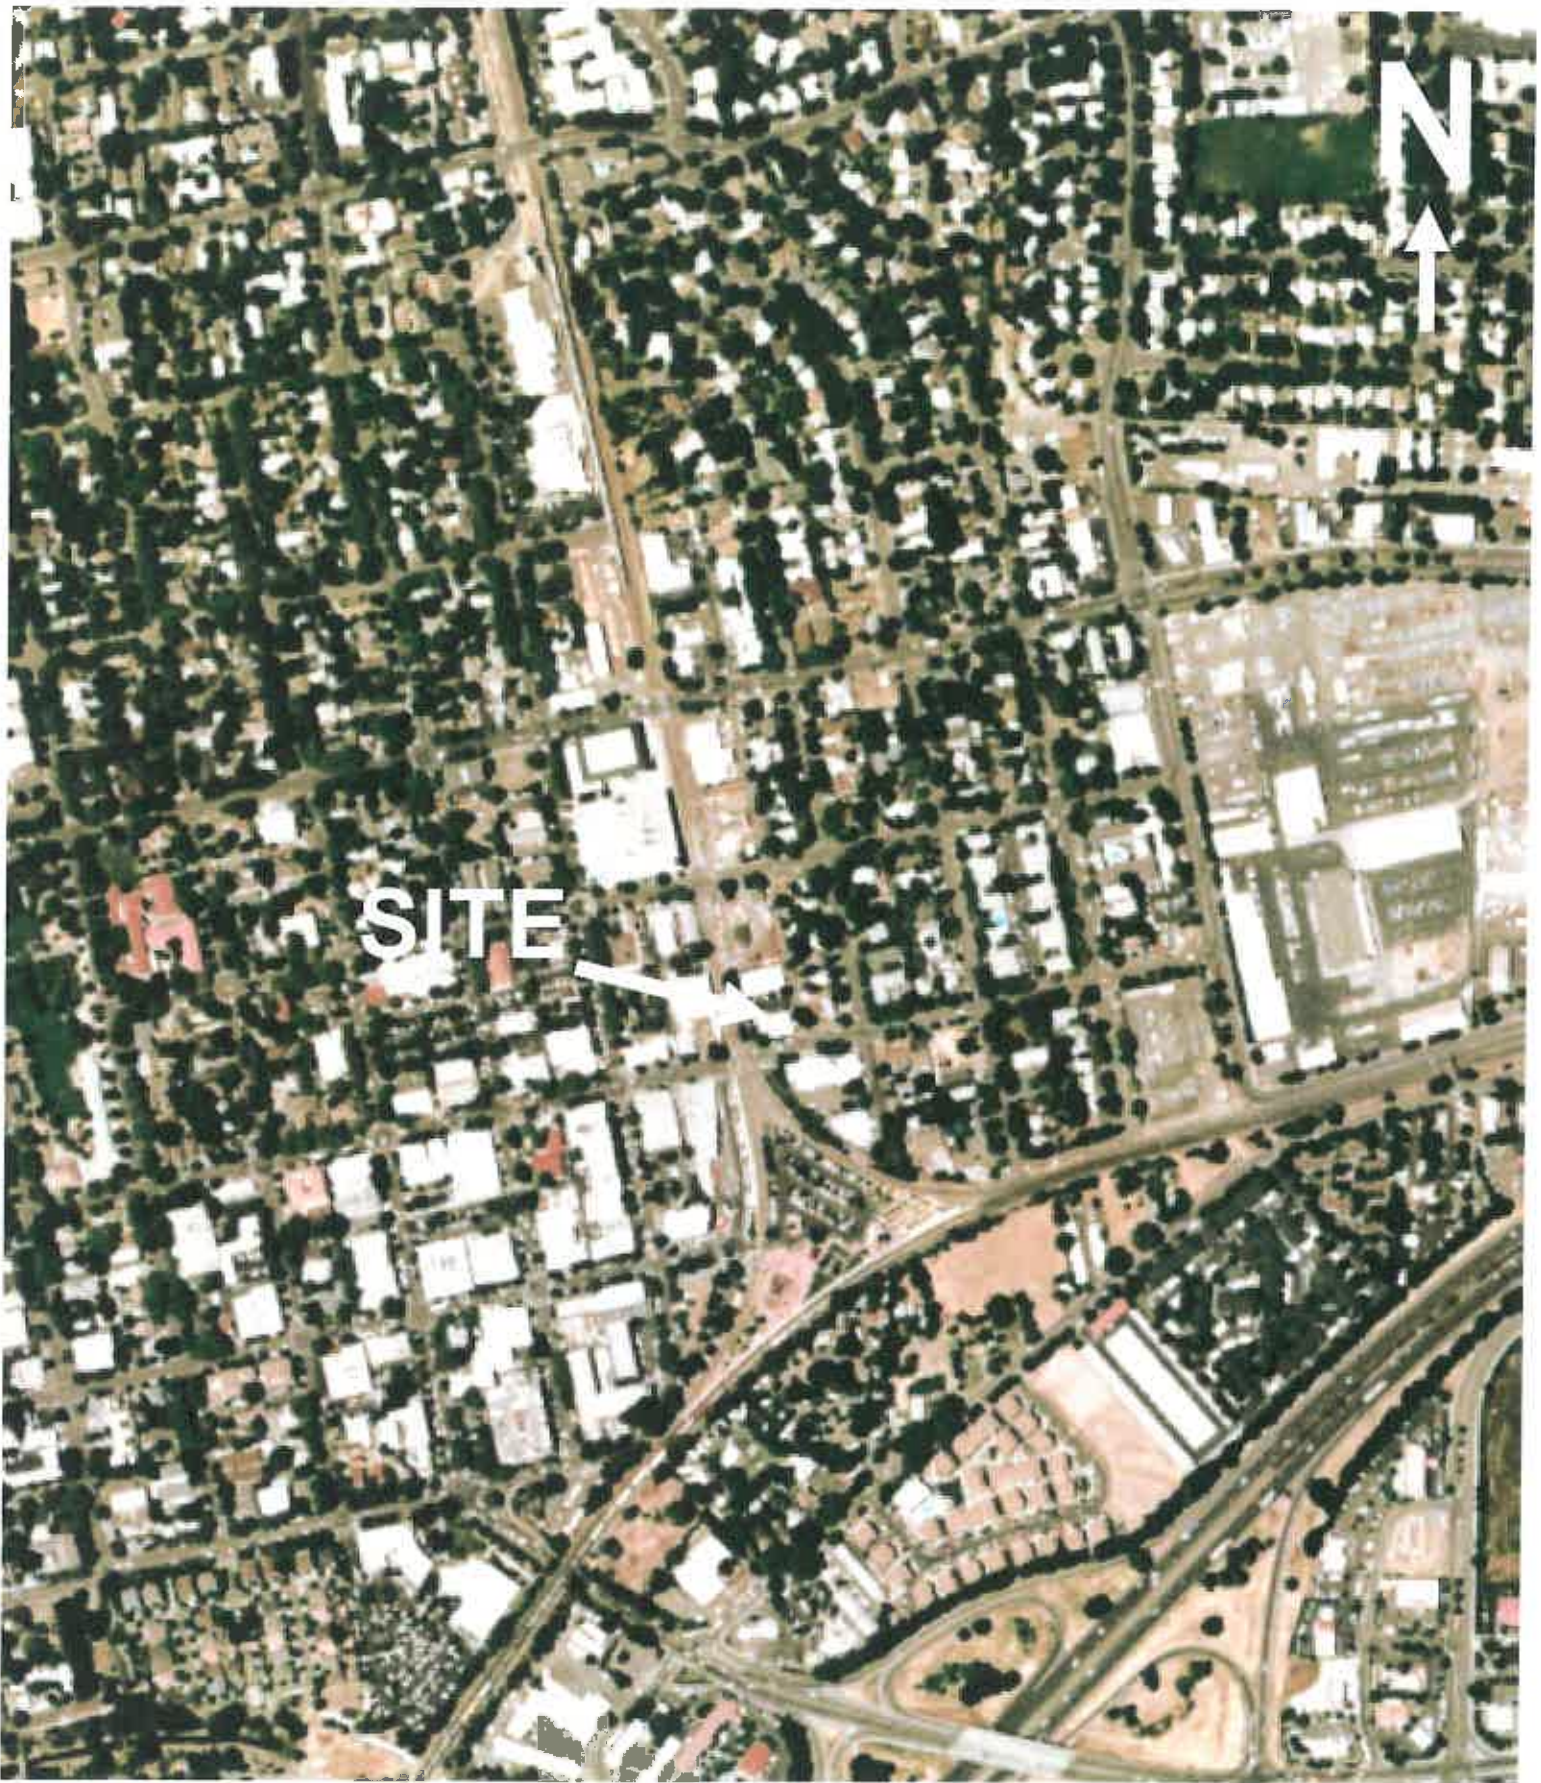
Aerial Photo, 1998: APN 070-324-002, 901-919 Third Street, Davis, CA 95616. Photo shows site containing two retail/commercial buildings.
