**PHASE I ENVIRONMENTAL
SITE ASSESSMENT, APN 070-324-002, 909-919 THIRD
STREET, DAVIS, YOLO COUNTY, CA 95616.**

PHASE I ENVIRONMENTAL SITE ASSESSMENT

Property: APN 070-324-002, 901-919 Third Street, Davis, Yolo County, CA 95616.
Section 15, Township 8 North, Range 2 East, Davis USGS Quadrangle.
38.5455 North Latitude, -121.7379 West Longitude.

Site Use: Multiple tenant retail/commercial buildings

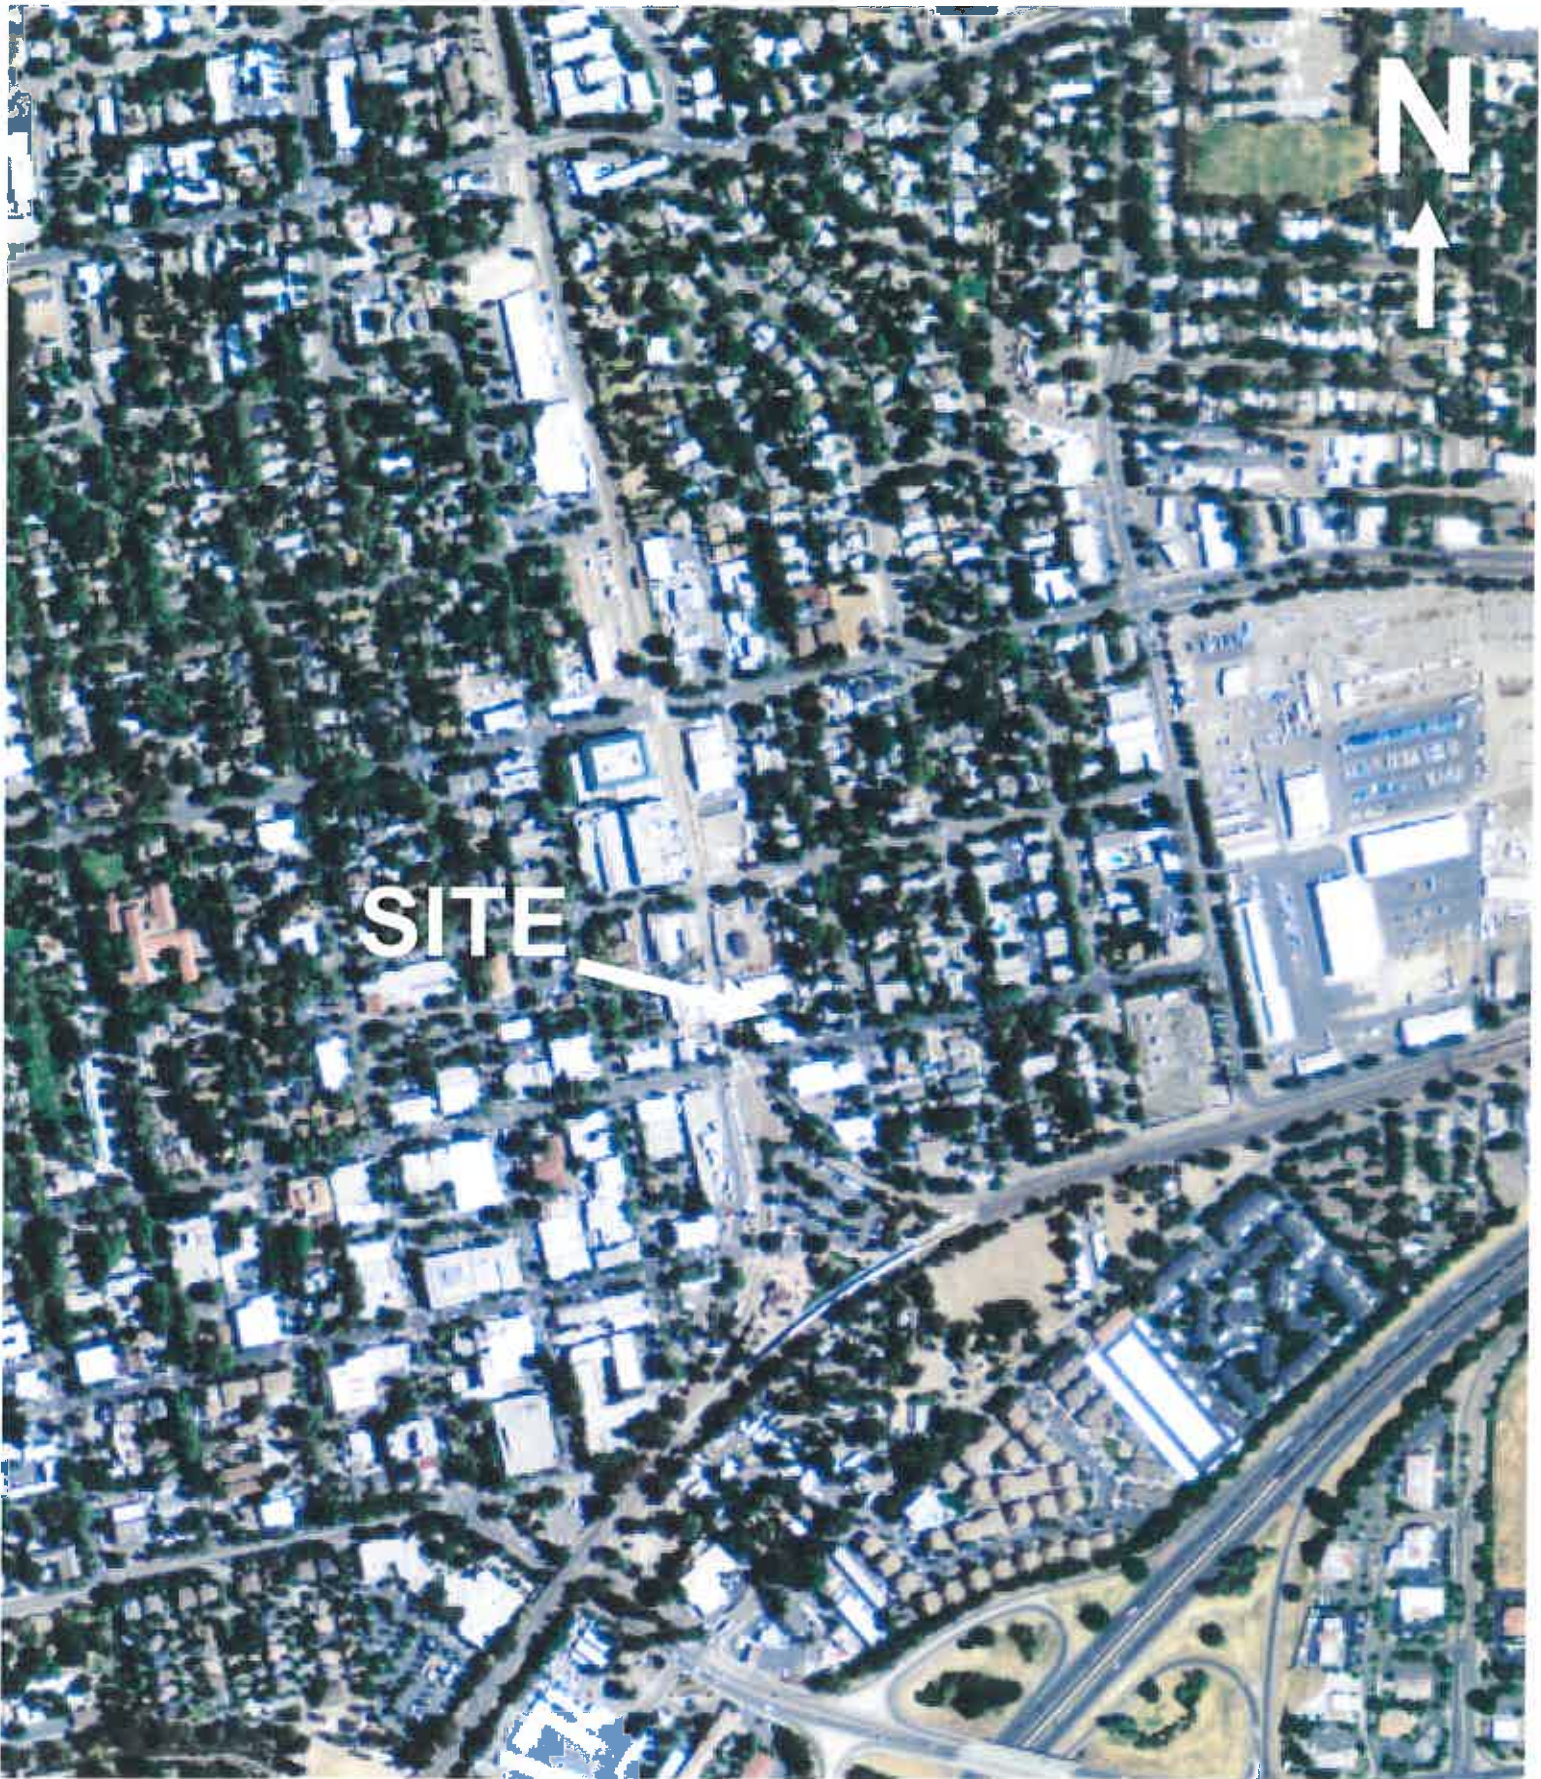
Aerial Photo, 2006: APN 070-324-002, 901-919 Third Street, Davis, CA 95616. Photo shows site containing two retail/commercial buildings.
