Final Report

Utility Cut Impact Assessment and Fee Development

Davis, CA

November 2022

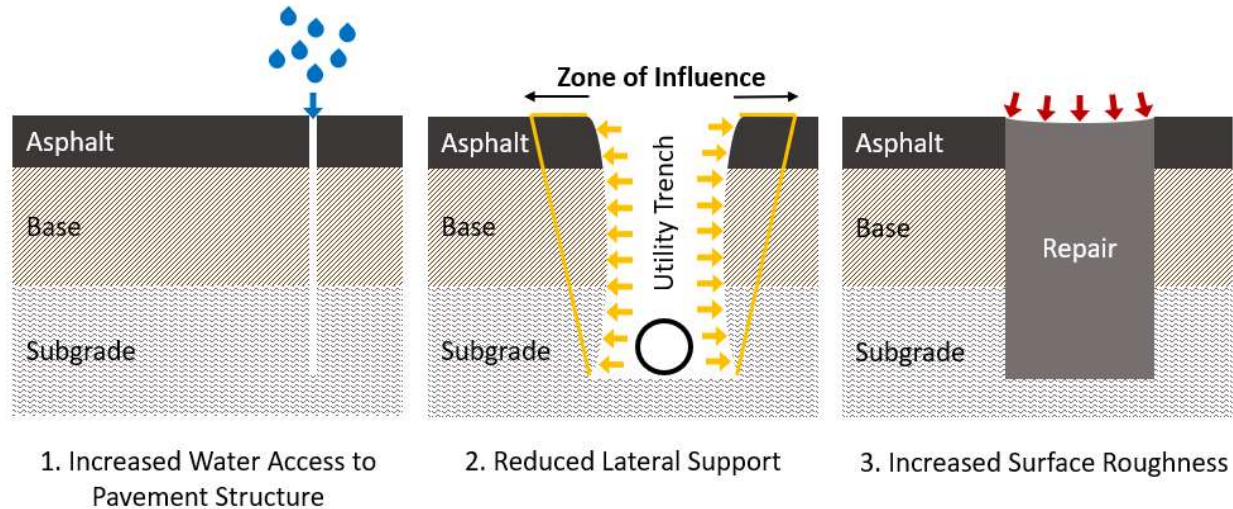
Figure 1. Utility Cut Damage Mechanisms

Underground utility work can damage pavements in three general ways, as illustrated in Figure 1. First, cutting a pavement structure creates an entry point for water, which can damage the underlying pavement layers. Second, removing pavement layers creates a plane of weakness where the pavement structure may

not be adequately supported laterally – particularly during underground utility maintenance, but also after restoration. This lack of lateral support can cause the trench sidewalls to bulge into the trench and weaken the material under the existing pavement. This weakened area is known as the zone of influence. Third, repairing the pavement can introduce roughness if the quality of the repair does not closely match the adjacent pavement structure. Rough pavements can cause vehicles to bounce, which creates greater loads on the pavement and leads to more rapid deterioration (Tarakji 1995, Wilde et al. 2002).

These damage mechanisms can reduce the condition and structural capacity of a pavement, which reduces the pavement life within and adjacent to the utility cut (Stevens et al. 2010). Multiple utility cuts on the same street or within a small area can magnify this impact (San Francisco Department of Public Works 1998, Tarakji 1995).

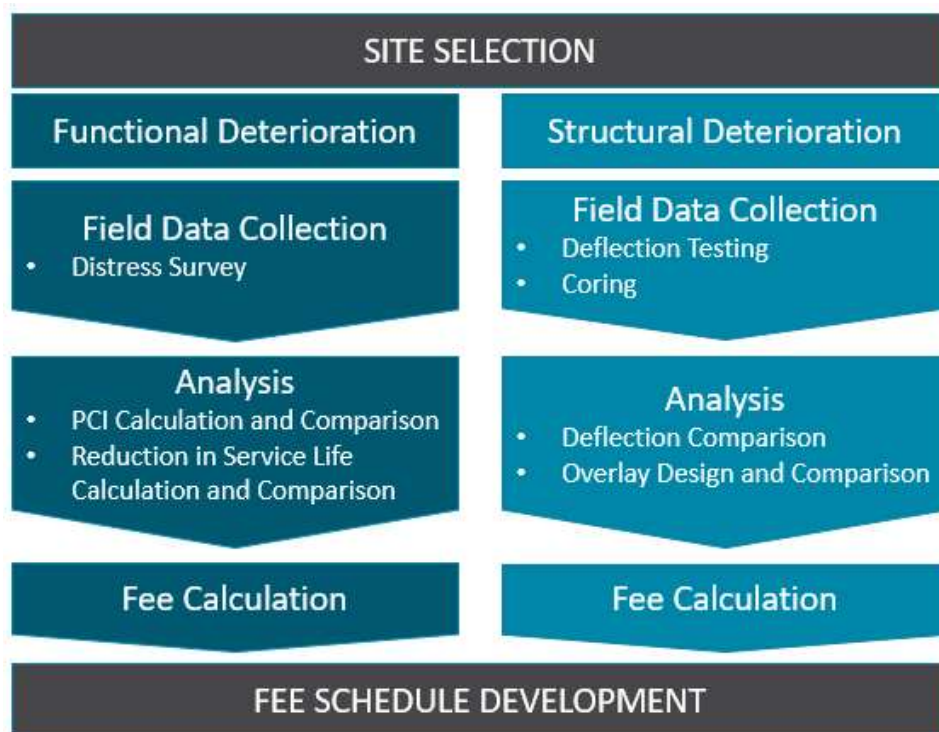
Figure 2. Study Methodology

Since utility cuts can cause damage to pavements both structurally and functionally, both types of evaluations are crucial in developing a fee to compensate for appropriate damages. Therefore, for this study parallel quantification and analysis of both structural and functional deterioration were used to identify in-situ damage and inform the development of an appropriate utility cut fee schedule. The flowchart shown in Figure 2 outlines the study methodology.

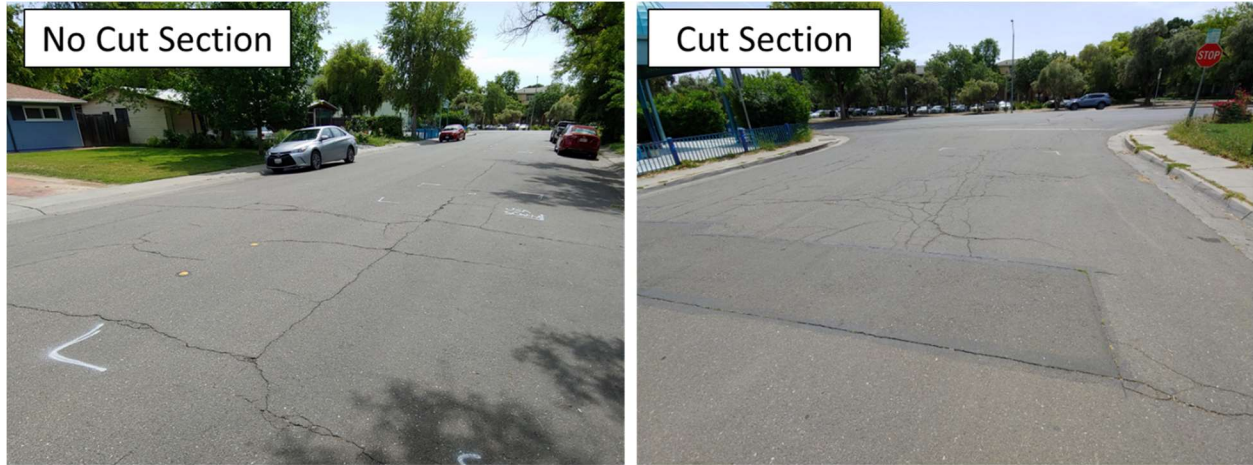
Figure 3. Example Test Site

Functional and structural field data were collected at 24 test sites throughout the City. As shown in Figure 3, each test site included a section with a utility cut and an adjacent section without a cut (hereinafter referred to as a “no-cut” section). The cut and no-cut test sections were typically 100 feet long and one or more lanes wide and were located as close to each other as reasonably possible, considering other cut locations and traffic-control needs.

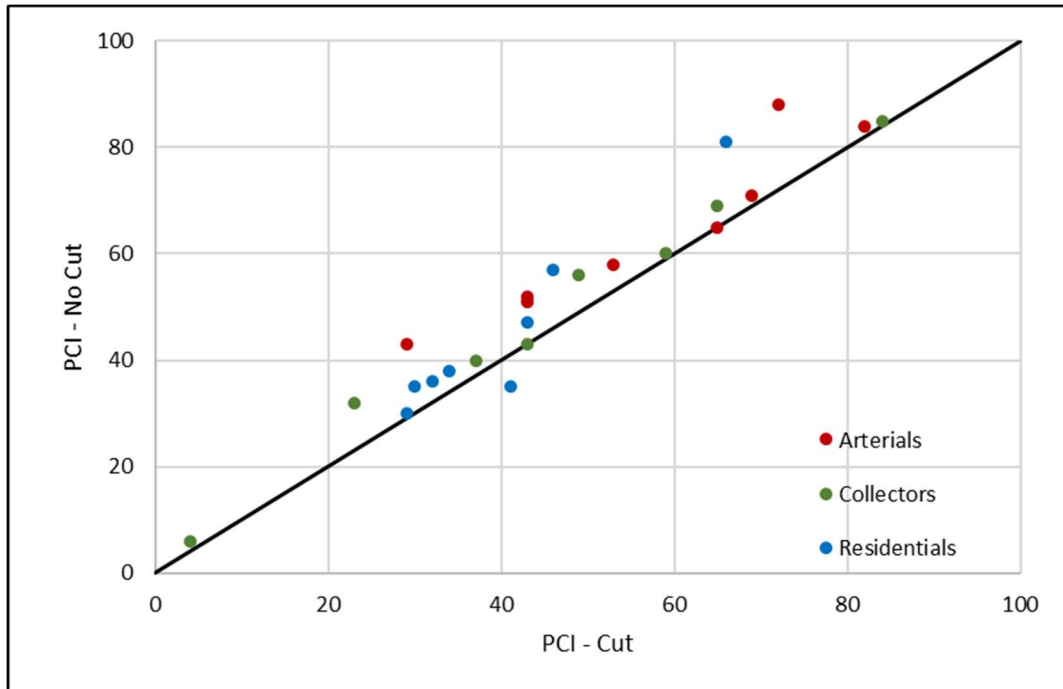
Figure 4. Comparison of No-Cut and Cut PCIs

Table 1 lists the calculated no-cut and cut PCIs for all test sites. At 88 percent of the test sites the cut PCI was lower than the no-cut PCI, thus indicating the presence of functional deterioration due to cuts. This trend is illustrated in Figure 4, which shows the cut PCI compared to the no-cut PCI with a diagonal line illustrating a one-to-one relationship. Data points that fall above the line indicate locations with functional damage. Two locations showed no change in PCI due to the cut and one location exhibited functional improvement.

On average, the PCI of the no-cut sections was 52.6, while the average PCI of the cut sections was 47.5. This average drop of 5.1 PCI points is primarily due to the presence of the cut but is also contributed to by additional longitudinal and transverse cracking near the cut. Figure 5 shows propagating longitudinal and transverse cracking near the patch on John Jones Road.

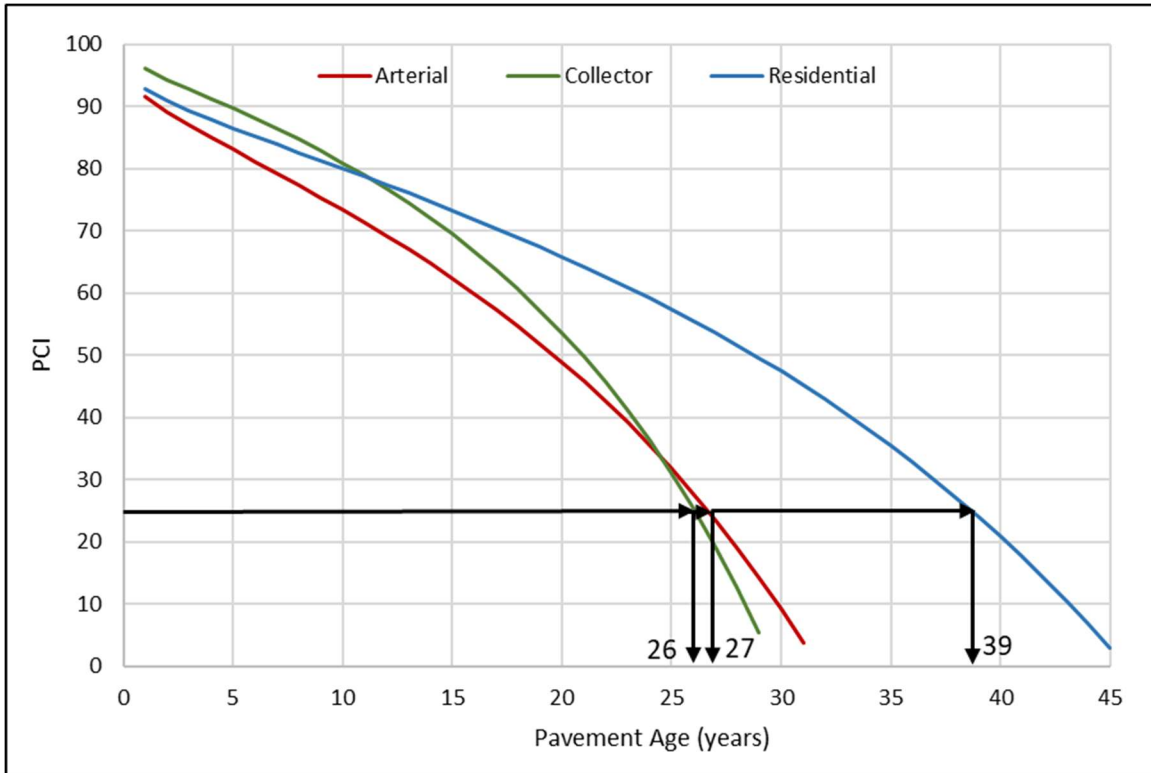
Figure 6. Pavement Deterioration Curves for Streets in Anaheim

A reduction in PCI corresponds to a reduction in remaining service life (RSL) of a pavement. A pavement's RSL is the number of years until it falls into failed condition (i.e., a pavement's RSL reaches zero when the PCI drops below 25). Based on the asphalt concrete (AC) family deterioration curves in StreetSaver® (a pavement management decision-support tool used by the City), shown in Figure 6, arterials have a total service life of approximately 27 years, collectors have a total service life of 26 years, and residential streets have a total service life of 39 years.

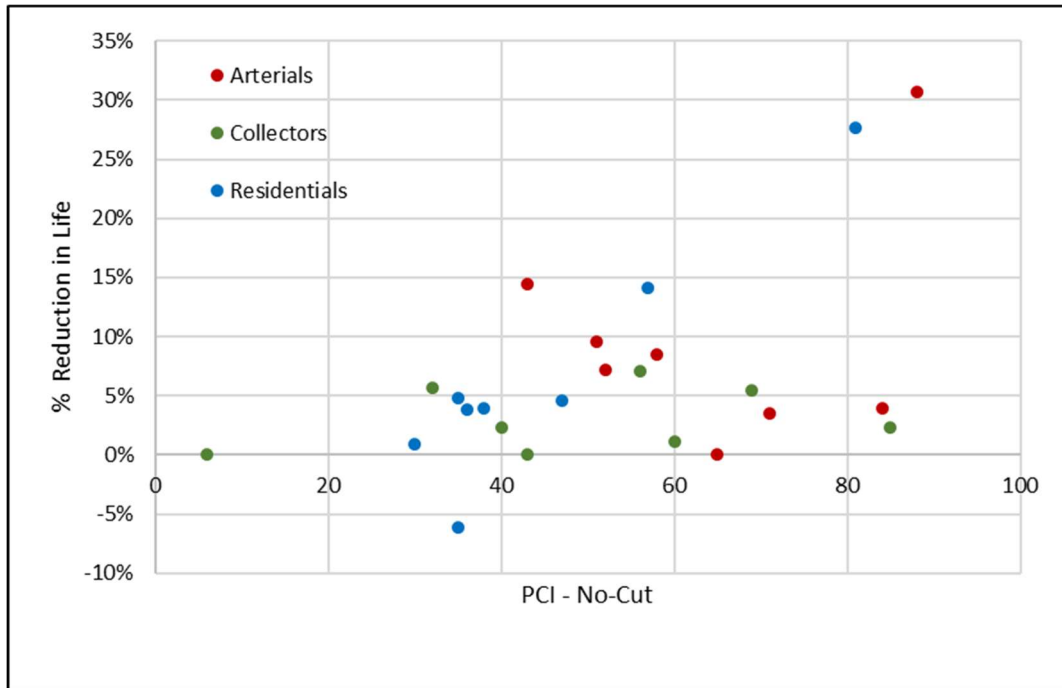
Figure 7. Pavement Deterioration Curves for Streets in Anaheim

For each test site, the percent reduction in service life due to utility cuts was estimated using the StreetSaver® family deterioration curves. For example, South Campus Way, a residential street with no cuts had a PCI of 57, which corresponds to an effective pavement age of 25 years. In contrast, the paired section that had been cut had a PCI of 46, which corresponds to an effective pavement age of 31.5 years. Consequently, the service life of the pavement was reduced by approximately 5.5 years by cutting the pavement. This corresponds to a reduction in service life of 14.1 percent (5.5 years/39 years). This calculation was performed for all test sites and the resulting percent reductions in life were plotted relative to the PCIs of the no-cut sections (See Figure 7). The percent reduction in service life ranges from -6 to 31 percent and has an average value of 6 percent. The single location with a negative percent reduction in life indicates that life was added to the

pavement (PCI increased). This test location was a residential street with a low PCI resulting from fatigue and longitudinal and transverse cracking some of which was likely repaired when the trench was placed thus causing a slight increase in PCI.

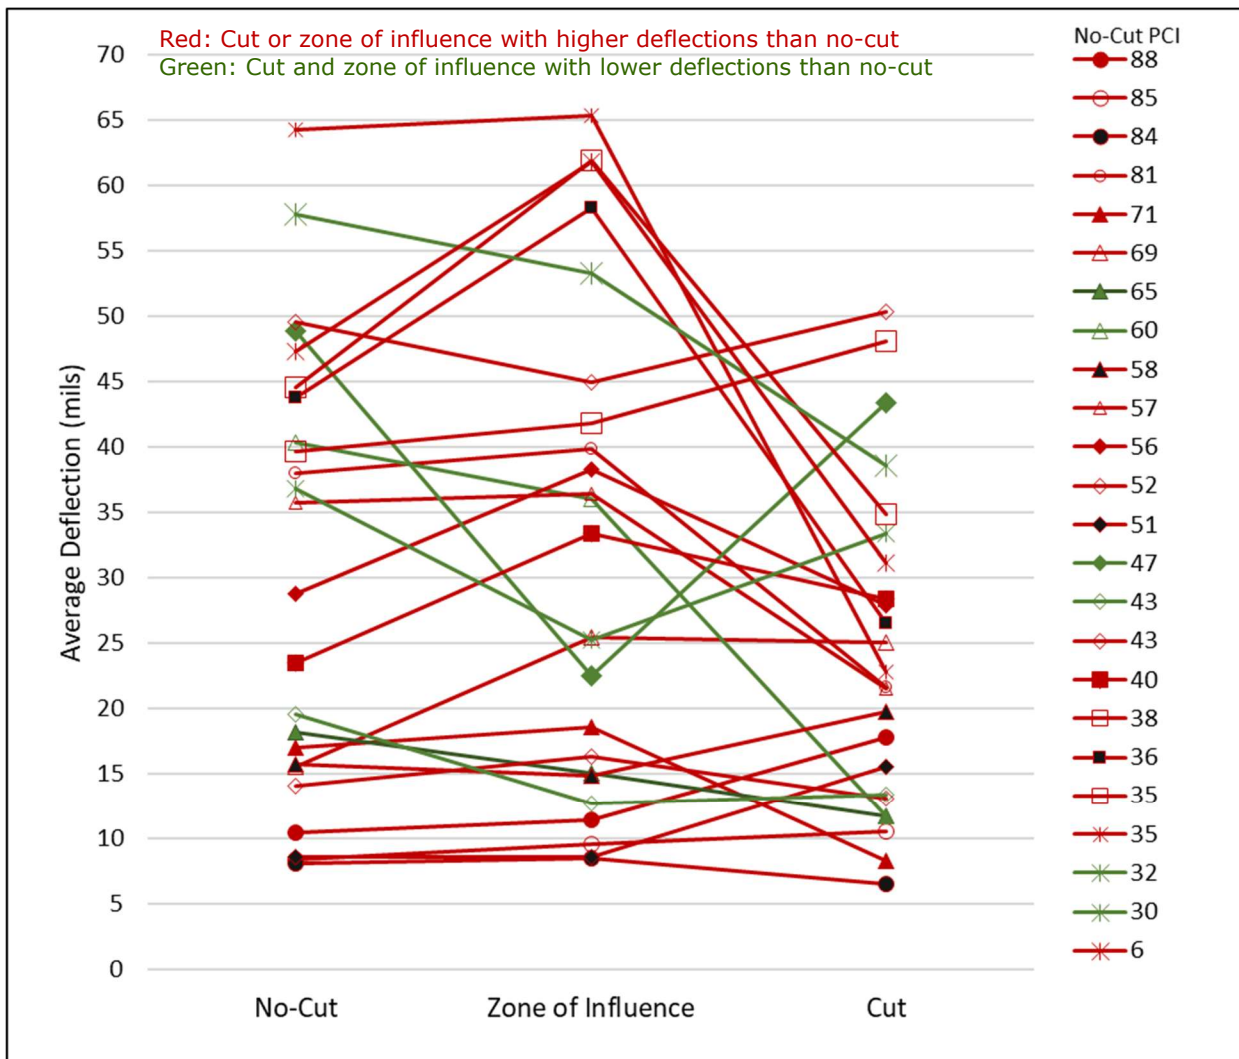
Figure 9. Deflection Trends Organized by No-Cut PCI

Figure 9 shows the average measured deflections for each test site organized by the PCI of the site’s no-cut section. Sections exhibiting damage due to cuts are represented by red lines. Green lines represent sections where the deflections in the cut and zone of influence were lower than the deflections in the no-cut section, meaning the repair and restoration were performing well at the time of testing.

Based on the deflection data, 75 percent of test sites showed structural damage in the cut or zone of influence (red lines in Figure 9) while the remaining 25 percent showed a structural improvement in both the cut and zone of influence compared to the no-cut section (green lines in Figure 9). Sixty-three percent of test sites exhibited damage 2 feet from the edge of the patch, thus indicating that the zone of influence typically extends past the current restoration standard repair area.

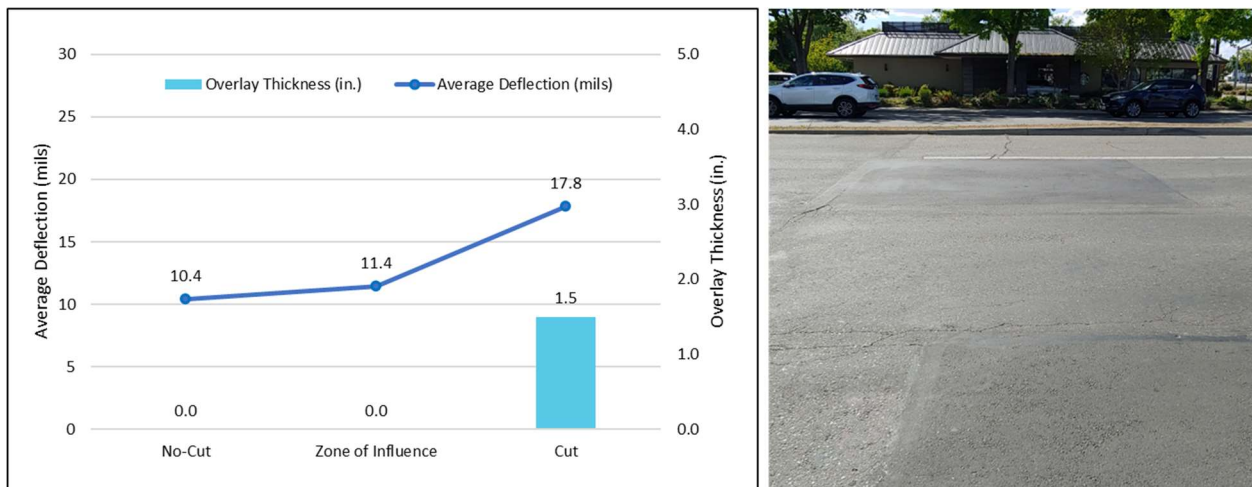
Figure 10. Deflection and Required Overlay Thickness for Mace Blvd

Two examples of sections exhibiting damage due to utility cuts are provided. Note that if a cut damages a pavement structure, then the cut and/or zone of influence will require a thicker overlay than the no-cut section. Figure 10 shows the results for Mace Blvd, where the cut and zone of influence do not yet need an overlay. In contrast, the cut section requires a 1.5-inch overlay.

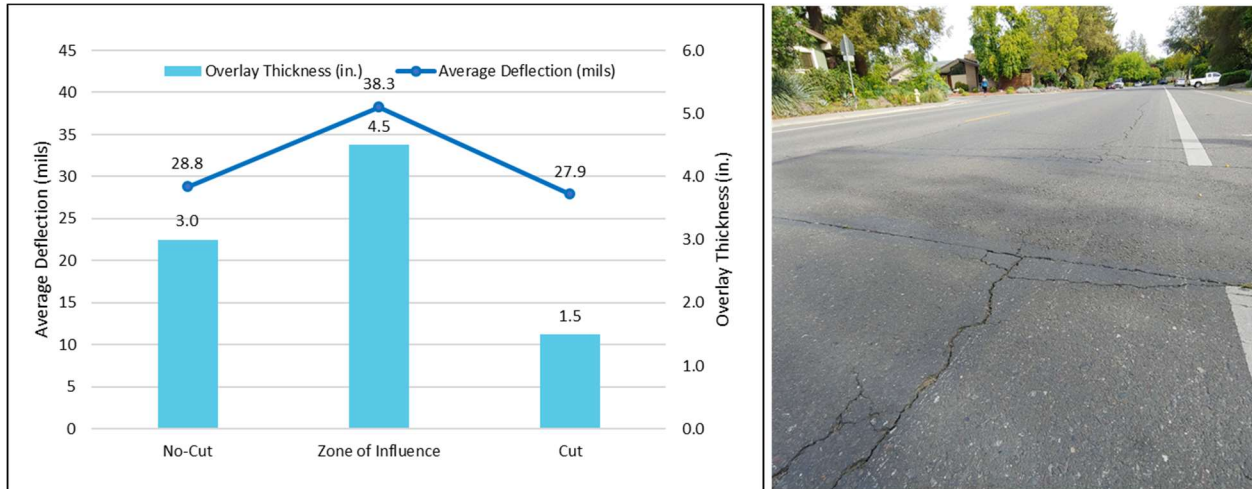
Figure 11. Deflection and Required Overlay Thickness for Sycamore Lane

Figure 11 shows the results for Sycamore Lane, where the no-cut section needs an overlay of 3.0 inches, the zone of influence needs an overlay of 4.5 inches, and the cut needs an overlay of 1.5 inches to satisfy structural capacity for a TI of 9.5. For this test site, the zone of influence exhibited the most structural damage and therefore required the thickest overlay.

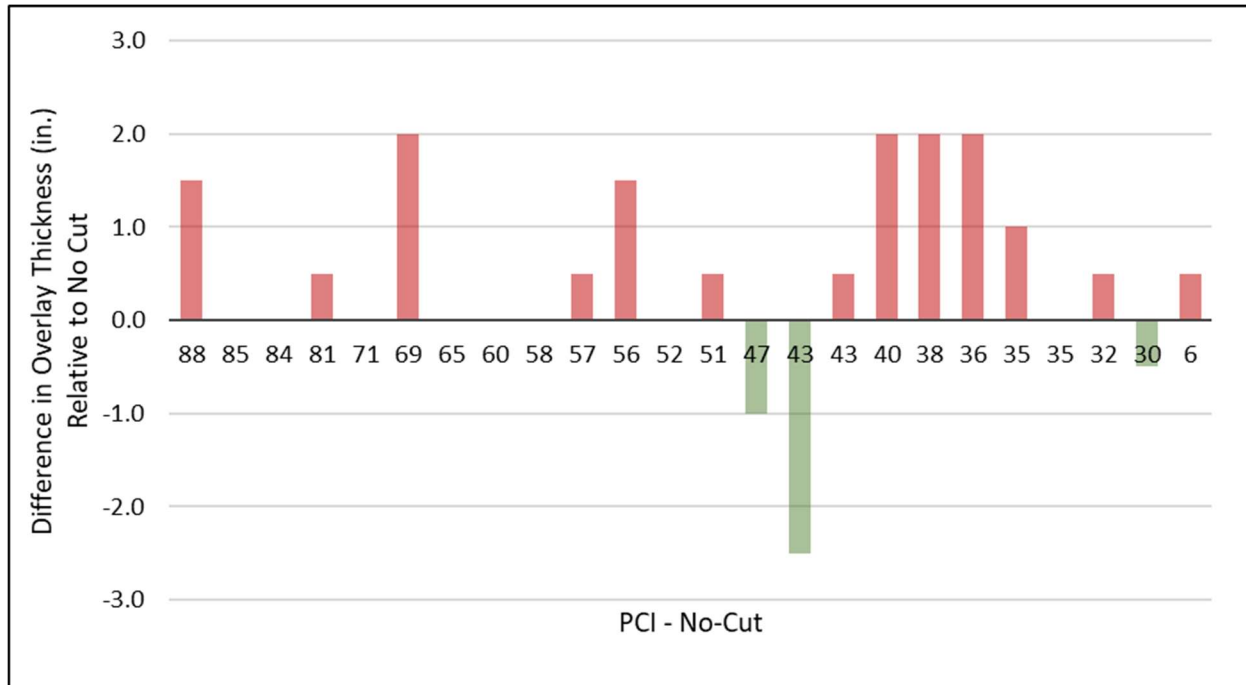
Figure 12. Differences in Overlay Thickness

Figure 12 summarizes the differences in overlay thickness between the no-cut section and the maximum value of either the cut or zone of influence for all test sites. The data are organized by the PCI of the no-cut section.

- Red bars indicate test sections that required a thicker overlay to compensate for a loss in structural capacity at the cut or zone of influence compared to the no-cut section.
- Green bars indicate that the repaired cut was performing better than the no-cut section.
- PCI values shown without bars indicate that, for that test site, the same overlay thickness, or no overlay at all, was required at all three of the measurement locations.

It was observed that 54 percent of the sites would need an average of 1.5 inches of additional overlay in the cut or zone of influence to compensate for the loss in structural capacity due to utility cuts.

- Fifty-four percent of test sites needed an average additional overlay thickness of 1.5 inches in the cut or zone of influence to compensate for structural damage.
