CENTRAL DAVIS HISTORIC CONSERVATION DISTRICT

CITY OF DAVIS

HISTORICAL RESOURCES SURVEY

AUGUST 2003

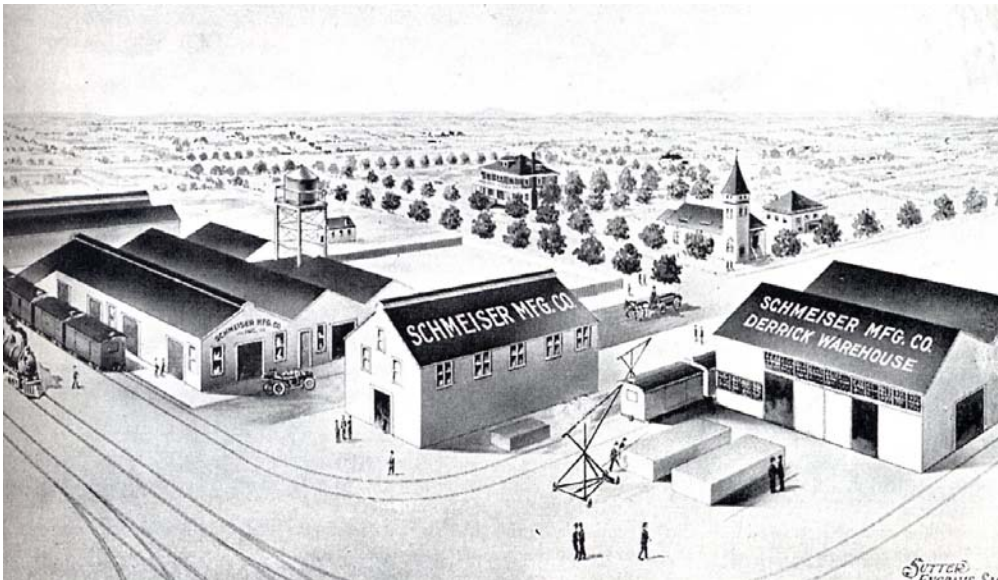
Figure 6: This highly idealized drawing of the Schmeiser Manufacturing Plant, one of Davis' most important non-University related businesses c. 1915. The recently constructed Schmeiser home is seen in the background. The drawing illustrates the close proximity of Old East manufacture and residential.

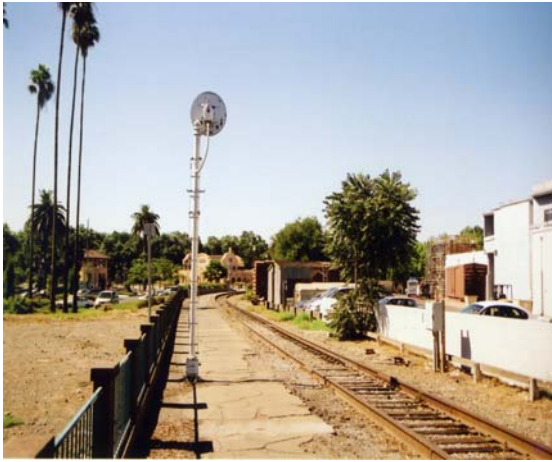
Figure 7
The railroad corridor and alley that separate the downtown and the Old East area.

The first two blocks east of the tracks were bisected by a wide alley. This functioned to separate the industrial operations near the tracks from the rest of the neighborhood. The only residential uses within the industrial corridor were two buildings noted on the Sanborn Maps in the 1880s as "Chinese Dwellings." From the alley east, the area was entirely

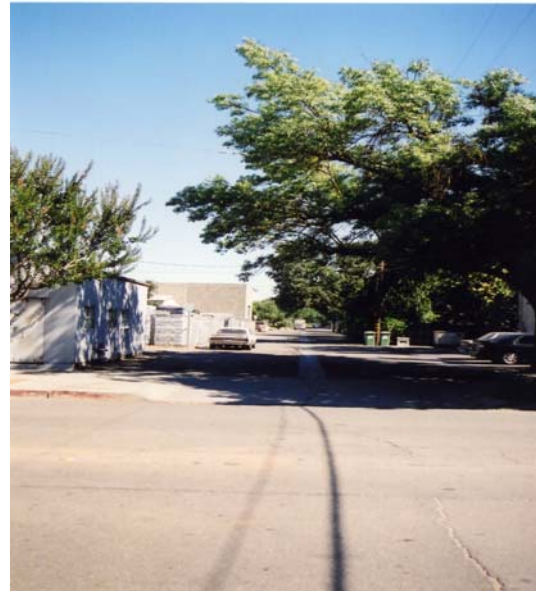
Figure 8

A multitude of small outbuildings and fourteen barns still dotted the landscape during the 1920s. Tank houses and windmills were not uncommon and long, commercial poultry houses were found along K Street. A 1920 aerial shows large open fields, particularly toward K which then fade into the adjacent fields outside the city limits.

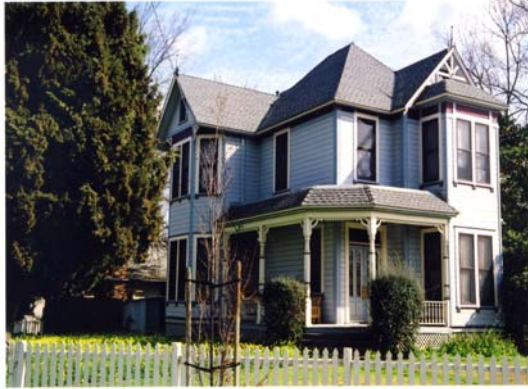
Figure 10 a

These figures illustrate the range of Victorian house types and styles that are represented in Old East, from high style East Lake (10a. Tufts House 434 J Street); to the vernacular and modified vernacular of the Williams-Drummond house (10b. 320 I Street) and Montgomery house (10c. 923 3rd Street) and (10d. 231 K Street).

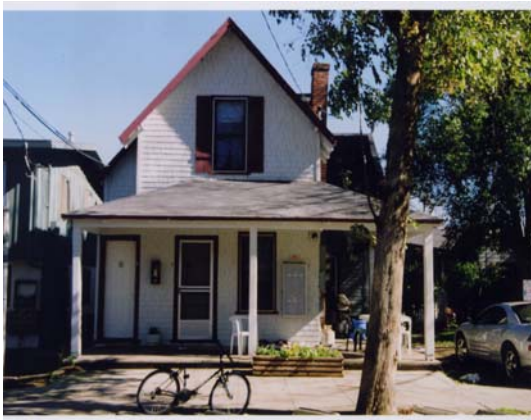
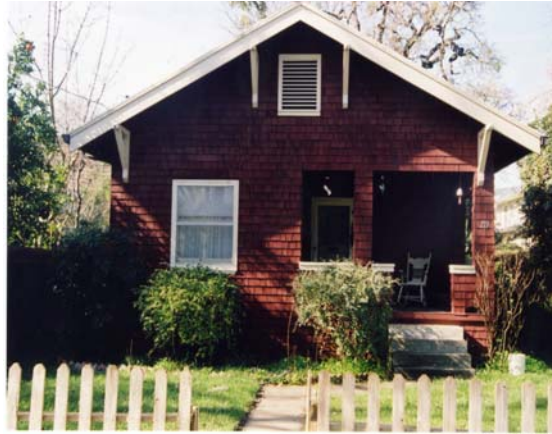
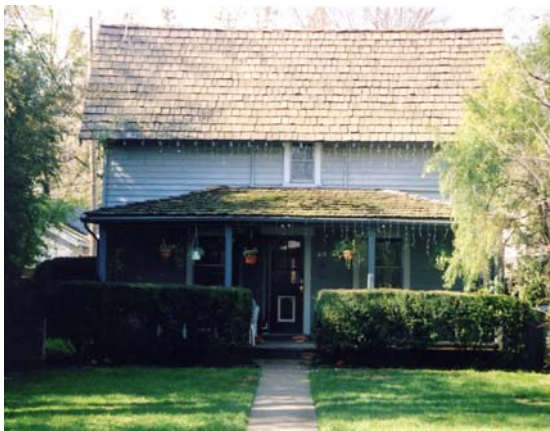
Figure 11: All of these buildings were constructed on University Avenue specifically to serve as student rentals. Their construction dates, from left to right, are 1912, 1914, and 1923.

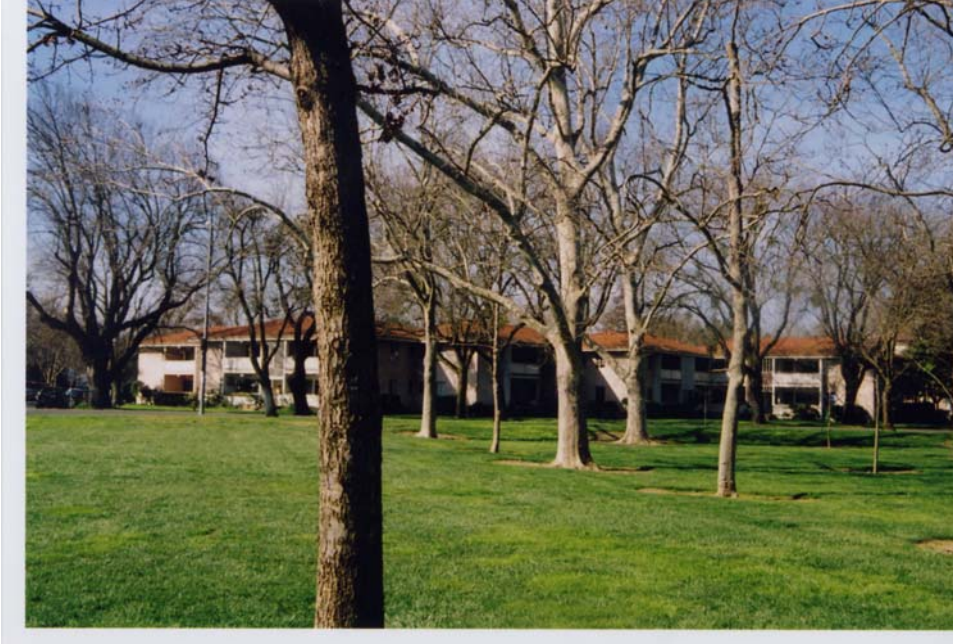
Figure 12: The first large apartment complex constructed in the University area.

In addition, it should be noted that the Davis Townhouse Apartments are the first major multi unit complex within the Downtown Historic Conservation District and it is significant as an indicator of the growth and influence of University on the town in the late 50's. It is also important as an excellent example of the "garden apartment" idea – to provide multiple unit housing in an inviting and park-like environment.

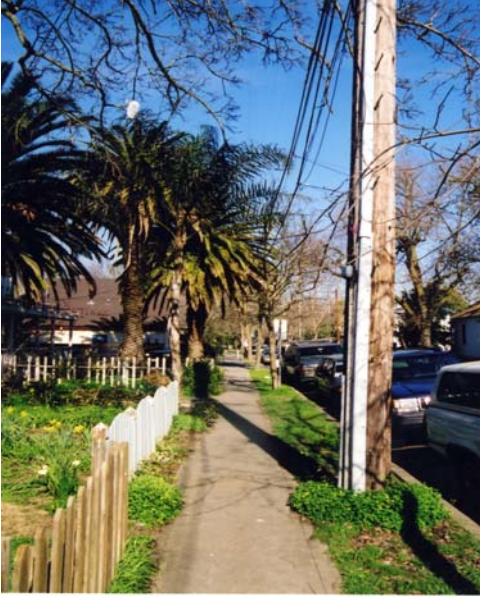
By contrast the streets in the University area are generally narrower than in the rest of the city. They are not always laid on a straight axis; rather they jog slightly to the right or left at the end of blocks. This is particularly true of University Avenue which bisects the center of the neighborhood. Several, although not all, blocks are divided by narrow alleys that run along the back of the lots. These block-long, narrow, unpaved or partially paved, corridors add to the sense of the area being traversed by an informal network of pathways and lanes. These corridors are multi-functional, not only providing service areas for the residents, but also giving auto and pedestrian access to rear apartments and cottages, and creating (unintentionally) alternative routes through the car, bicycle and foot congestion created by proximity to the campus. These alleys also vary in ambiance, some are dirt and grass tracks behind yards, while others, such as the alleyway that connects 1st and 2nd through Rice Lane, have come to function like, and physically resemble, streets.

Figure 13: University Area Streetscape
Looking north from the 300 block of
University Avenue

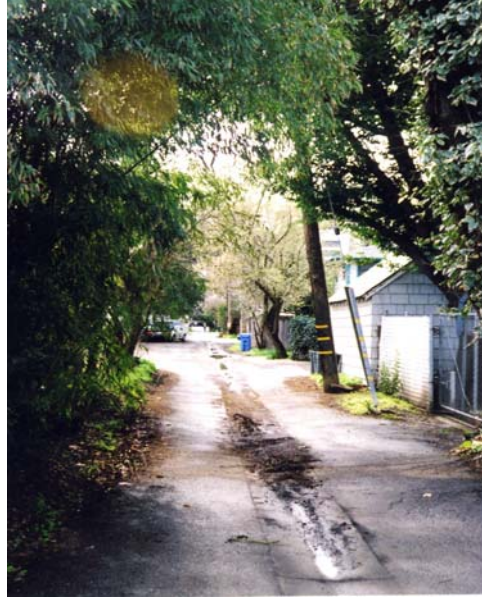
Figure 14: One of several alleys that
run through the University area.

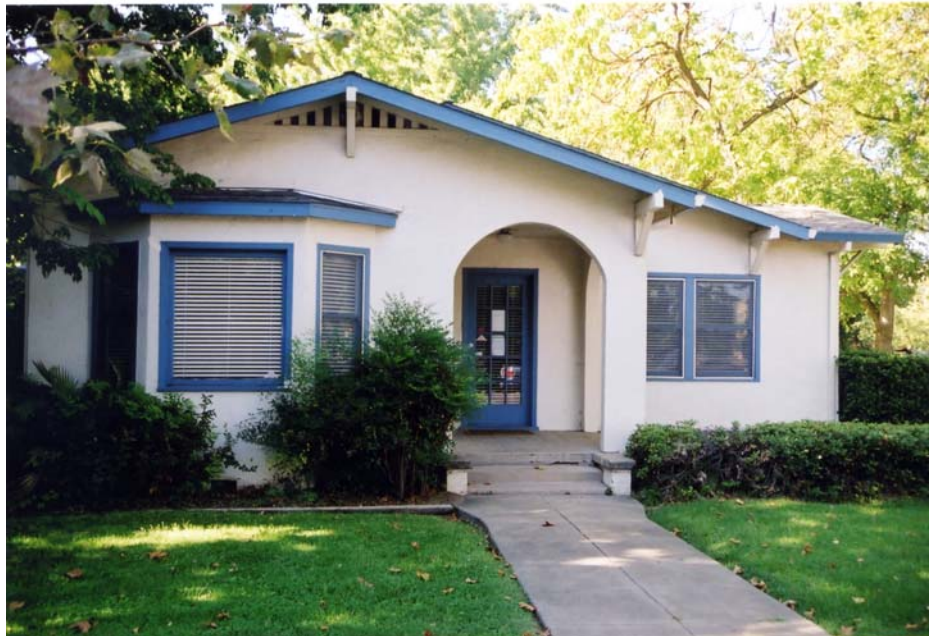
This L-plan, stucco clad bungalow has a low cross gable roof with wide overhangs supported on knee brace brackets. The projecting front wing has a cut-in porch which is sheltered under the primary roof. Access to the porch is via two arched openings, one on the south and the other on the east side of the porch. This arched, double entry is more common in Period Revival buildings from which this treatment was probably adapted. A bay projects from the front façade with a fixed, probably replacement window in the center and one-over-one double hung windows on the sides. Other fenestration consists of paired and single one-over-one double hung windows. The entry door is multi light. The house is a good example of a late bungalow and retains its integrity of design, materials, workmanship, setting and association despite its reuse as an office. The building appears to contribute to the historic character of the Downtown/ Commercial area of the Conservation District.

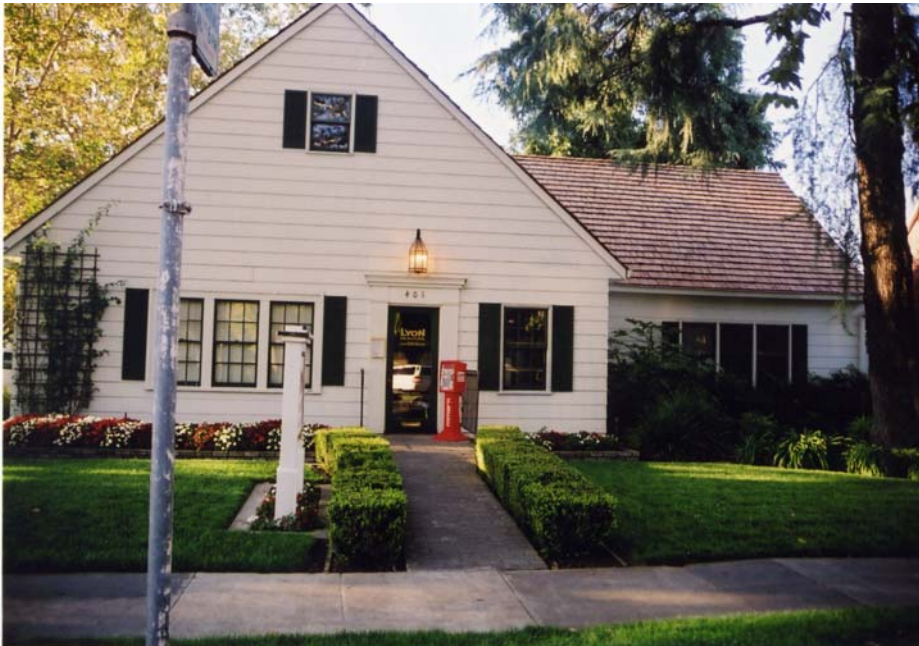
This building originally served as a combination medical office and home for Dr. Walter Bates. T-shape in plan, it is composed of two large two-story intersecting wings surmounted by steeply pitched cross gable roofs. Eaves and gables are clipped. The clapboard clad building is an asymmetrical interpretation of the Colonial Revival Style. The front projecting gabled wing has an entry door which is emphasized by engaged columns and a classical pediment. The original door was multi-light, but has been replaced by a metal and glass commercial building door. Six-over-six double hung windows are arranged in a ribbon across the west side of the front façade. Other fenestration consists of multi-light double hung windows arranged singly and in ribbons. A brick chimney pierces the west slope of the roof, as does a gable roofed attic vent dormer. The building appears much today as it did in a 1940 photograph included in Lofland and Haig's *Images of America*. It retains its integrity of design, materials, workmanship, setting and association. The building appears to contribute to the historic character of the Downtown/ Commercial area of the Conservation District.

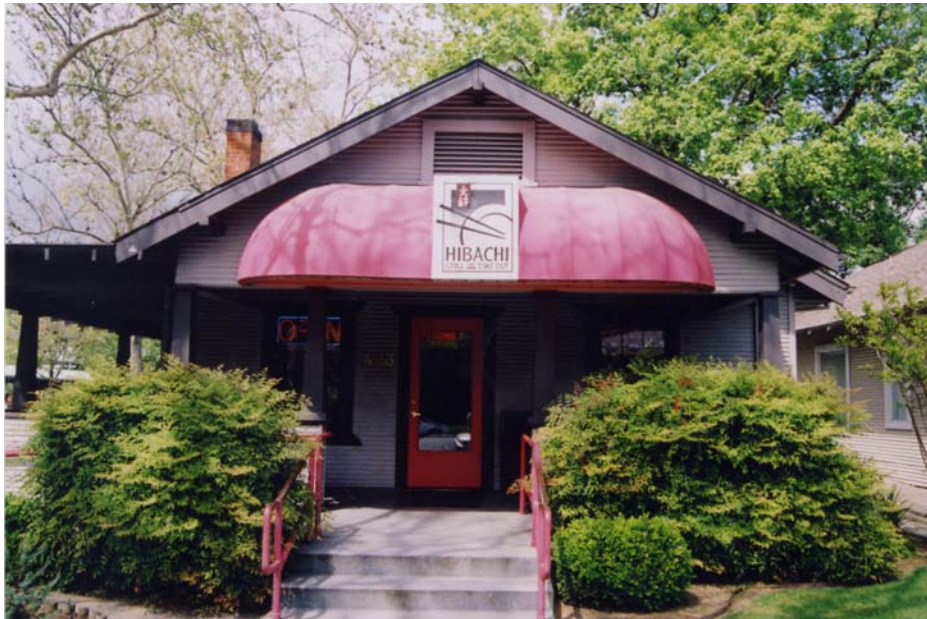
*P3a. Description: Rectangular in plan, the building is surmounted by a moderately pitched, gable roof that projects to cover the porch. Gable and eaves exhibit wide overhangs, with the front porch gable supported on projecting purlins. A louvered, rectangular attic vent punctuates the gable end. Fenestration consists of one-over-one double hung windows arranged symmetrically on either side of the central entry door which is glazed. A brick chimney is found on the west façade. The original porch columns and rail have been removed. A side porch serves as an outdoor eating area for the restaurant that occupies the property. It has been fashioned with exposed rafters and battered columns in an attempt to integrate it with the original residence. Cladding is narrow novelty siding. The building integrity of design, materials, and workmanship have been compromised by alterations to the front porch area and the side porch addition. Also, a large awning across the front gable end distracts from the bungalow appearance, but is removable. The building is one of three very similar bungalows which are sited next door to each other at the western end of this block of 3rd Street. It retains its essential form and details and is clearly recognizable as a bungalow style residence building. The removal of the side porch and awning would restore integrity. However, at the present time it does not appear to contribute to the historic character of the Downtown/ Commercial area of the Conservation District.

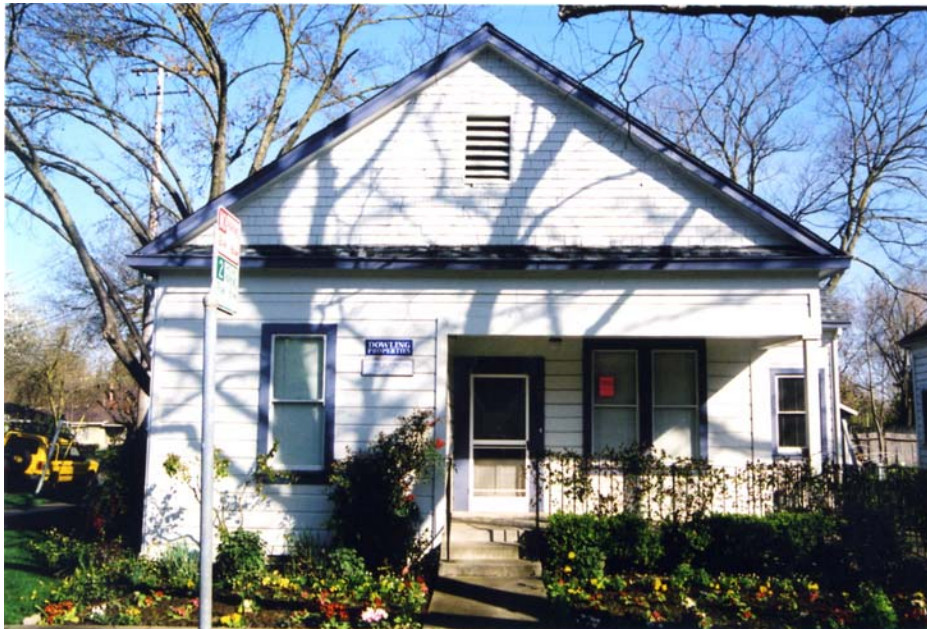
This Craftsman Bungalow/ Vernacular house was identified in previous historical resource surveys. It is associated with the Grieve family, early residents of Davis. With the exception of the replaced porch rails, the building retains integrity of design, materials, workmanship, location, setting and association. It was recognized in the 1996 and 1980 surveys. It appears to contribute to the historic character of the Downtown/ Commercial area of the Conservation District.

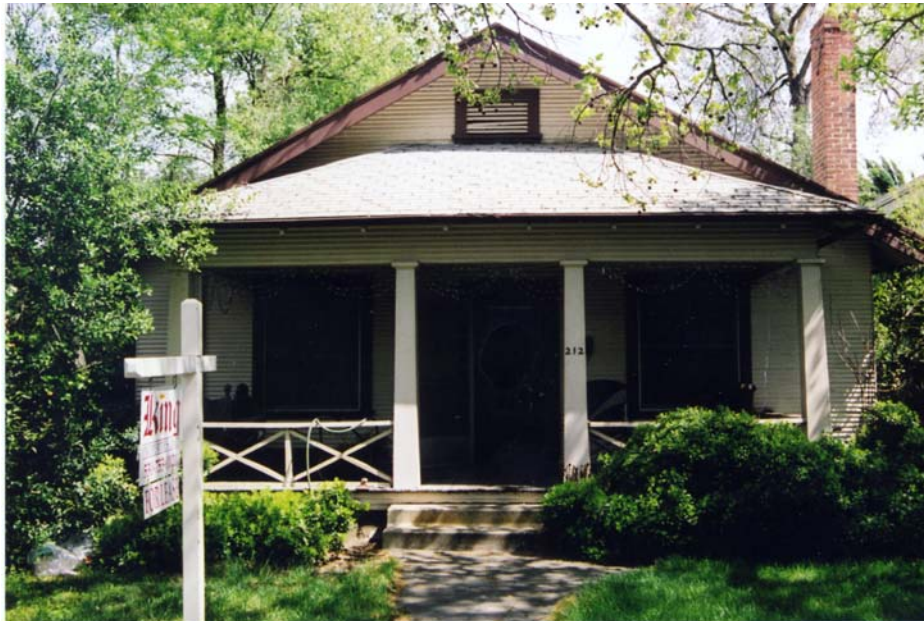
*This small, front gable bungalow was identified in the 1996 survey. A symmetrically arranged façade exhibits a central entry, flanked by single, double hung windows. A spanning front porch is covered by a projecting hip roof supported on full-length battered wooden columns. An open, decoratively designed rail encloses the porch. A tall brick chimney is found on the south façade. Cladding is narrow novelty siding. The house is a good example of its style type. It retains its integrity of design, materials, workmanship, setting and association. The building contributes to the historic character of the Downtown/ Commercial area of the Conservation District.

- *P3b. Resource Attributes: HP2
*P4. Resources Present: Building Structure Object Site District Element of District
P5b. Description of Photo:
View east *
P6. Date Constructed/Age:
c1920 83 years old estimated
 Prehistoric Historic
 Both

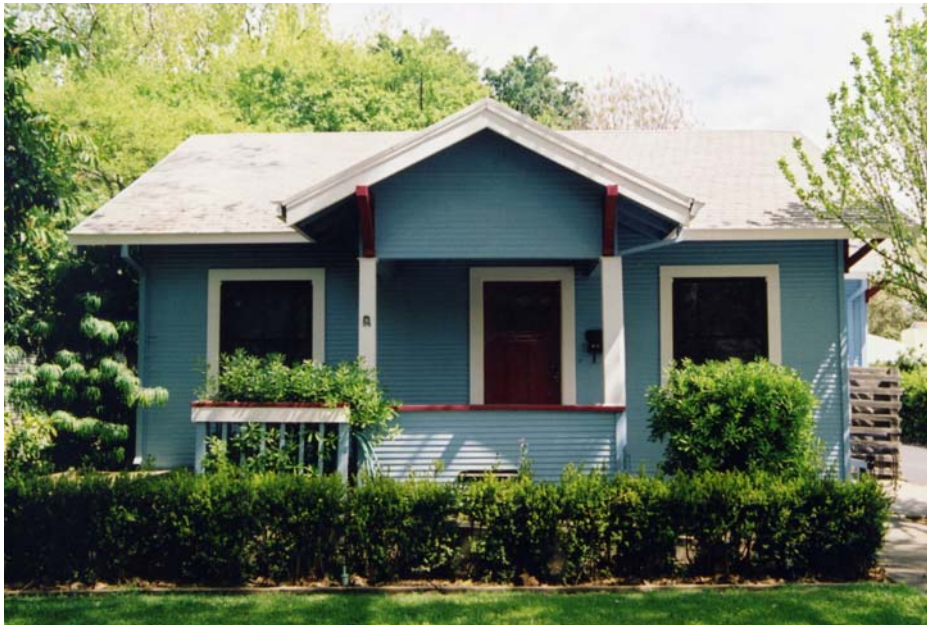
This simple bungalow is rectangular in plan with a moderately pitched side gable roof. Gable ends are supported on knee brace brackets. A small gable projects from the front façade to cover the centered porch. The gable exhibits knee brace bracketing with the gable end supported on square posts that are set on the closed front rail. Entry to the porch is located on the south side. Six-over-six double hung windows flank the entry door. The house is clad with narrow novelty siding. The design of the house is one that is found in other locations in the downtown and Old North area. The building retains integrity of design, materials, workmanship, setting, location and association. The building appears to contribute to the historic character of the Downtown/ Commercial area of the Conservation District.

- *P3b. Resource Attributes: HP2
*P4. Resources Present: Building Structure Object Site District Element of District
*P5b. Description of Photo:
View east *
P6. Date Constructed/Age:
c1920 83 years old estimated

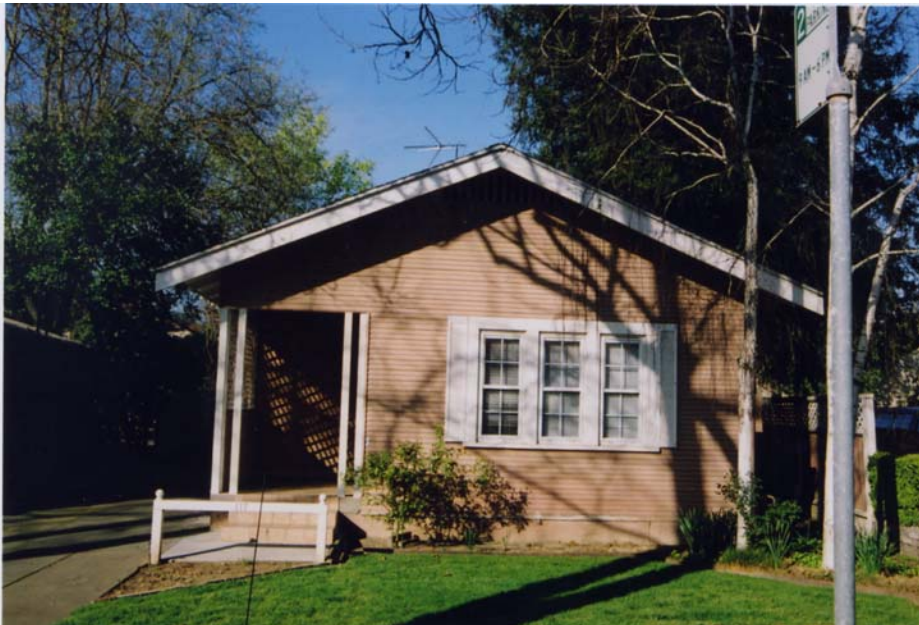
This 1918 Craftsman Bungalow is a relatively unadorned example of its style type. Rectangular in plan, it is surmounted by a moderately pitched front gable roof. Gable and eave overhangs are modest, with the gable trimmed with a plain fascia. A small, cut-in porch is found on the south side of the façade with the gable end supported by paired 4X4 columns. A closed rail runs along the south side of the porch. The entry is located on the side (north) wall of the porch. Fenestration on the front façade consists of a ribbon of narrow, four-over-four double hung windows framed by small faux shutters. Cladding is narrow novelty siding. The building is a good example of its style, retains integrity of design, materials, workmanship, location, setting and association. It appears to contribute to the historic character of the Downtown/ Commercial area of the Conservation District.

*P3b. Resource Attributes: HP2
*P4. Resources Present: Building Structure Object Site District Element of District
P5b. Description of Photo:
View west
*P6. Date Constructed/Age:
1918 85 years old documented

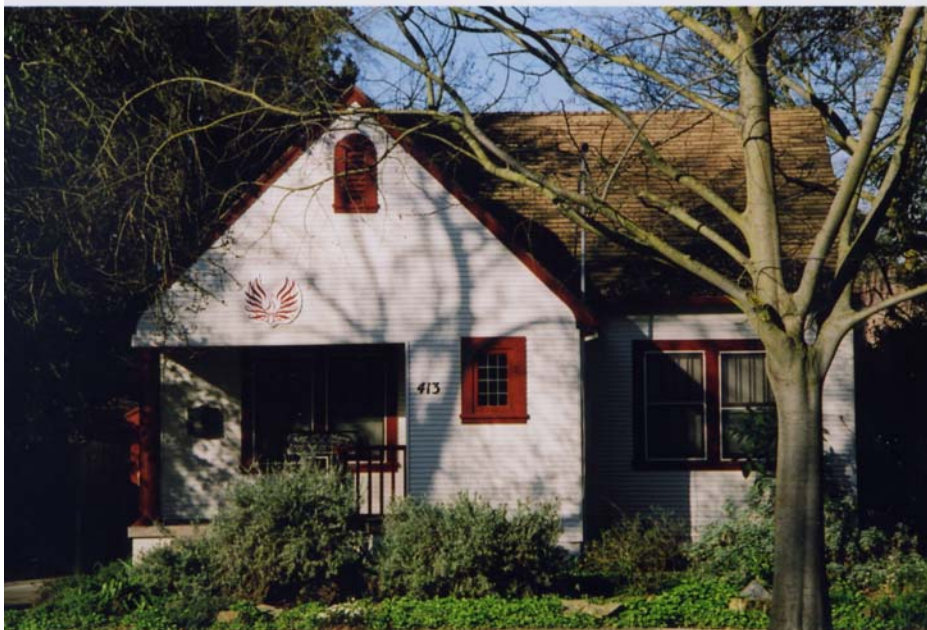
This formerly residential building has been converted to office use. It is a small, English Revival cottage circa 1935. L-shape in plan it has a cross gable roof of steep pitch. Eaves and gables are clipped with an arched, louvered attic vent at the apex of the front facing gable. A cut-in porch is found on the south side of the projecting front gable with the gable end supported at the corner with a Tuscan column. The entry is on the south wall of the porch with a vestibule occupying the north portion of the projecting wing. A decorative leaded window is located in the vestibule wall. Other fenestration consists of paired double hung three-over-one windows. The building retains integrity of design, materials, workmanship, location, setting and association. It appears to contribute to the historic character of the Downtown/ Commercial area of the Conservation District.

*P3b. Resource Attributes: HP2
*P4. Resources Present: Building Structure Object Site District Element of District
P5b. Description of Photo:
View west*
P6. Date Constructed/Age:
c 1935 68years old estimated

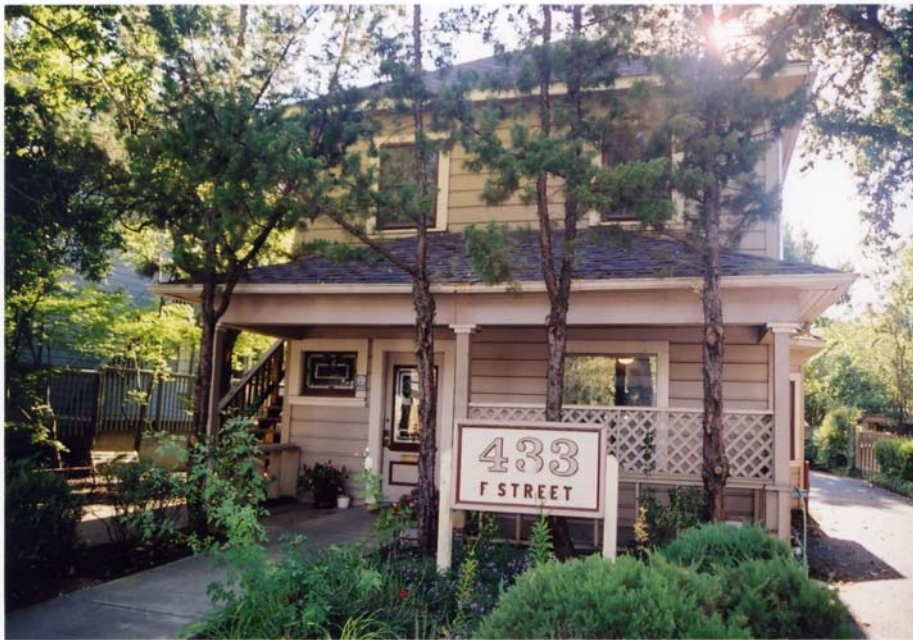
This Victorian Vernacular house is a good example of its style. It is one of the few remaining Victorian houses in the downtown and, like others has been converted from residential to office use. Some of the windows appear to have been replaced in a recent rehabilitation. The entry door may also be a replacement. The building was recognized in the 1996 survey. Despite recent changes, it retains its integrity of design, materials, workmanship, setting and association. The building appears to contribute to the historic character of the Downtown/ Commercial area of the Conservation District. It may also contribute to a potential multiple property district of Davis Victorians.

- *P3b. Resource Attributes: HP2
*P4. Resources Present: Building Structure Object Site District Element of District
*P5b. Description of Photo:
View west *
P6. Date Constructed/Age:
1900 103 years old documented
 Prehistoric Historic

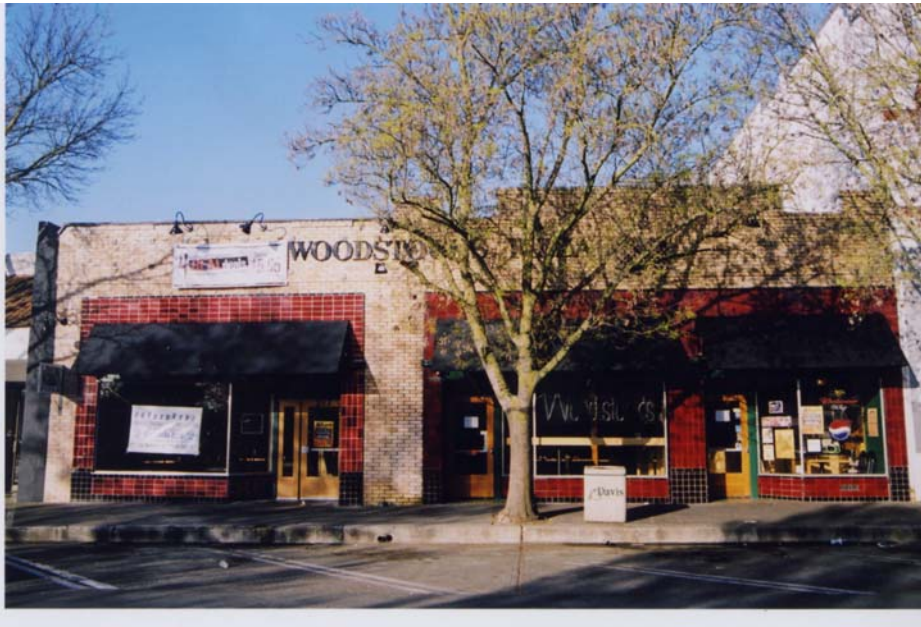
This commercial building is an example of two separate shop spaces that share a common wall. The construction date of the building is unknown, but it appears as early as 1915 in pictures of the downtown. The northern portion of the building appears to have always been occupied by a café, displaying a prominent sign to that effect that projected out from the building. It is now occupied by a pizza parlor. The north building is rectangular, one-story with a flat roof and a crenelated parapet. The south building, is similar in plan but with straight parapet. Large plate glass windows fill much of the front facades, separated by three entry doors. On the north building the windows and doors are framed by ceramic tile work which may have been added in the 1920's or 30's. The tile on the south building is part of a recent "restoration" and does not match the earlier tile as well as it might. The brick on the south building also appears to have been altered to some degree. The conjoined buildings are a good example of small town commercial buildings of the early 20th century. In the 1933 assessment records it is noted as the Louie Young restaurant. Although the buildings have been altered more than once, photographic evidence indicates that they retain overall design and materials, as well as integrity of location, setting, association and use. The buildings appear to contribute to the historic character of the Downtown/ Commercial area of the Conservation District. They also might be considered for designation by the City of Davis either individually or as part of a historic commercial district.

*P3b. Resource Attributes: HP2
 *P4. Resources Present: Building
 Structure Object Site District Element of District
P5b. Description of Photo:
 View west *
P6. Date Constructed/Age:
 C 1915 88 years old estimated
 Prehistoric Historic
 Both
***P7. Owner and Address:**

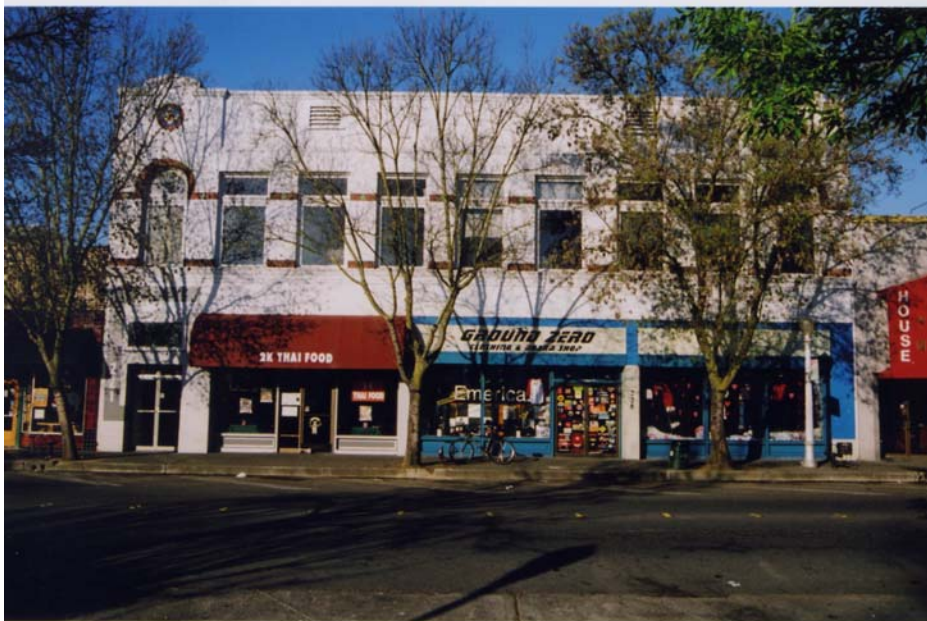
This building, a two-story Masonic Lodge Building is one of the largest and most imposing of the historic commercial buildings located on G Street. The Masonic facilities were located on the second story with commercial rental space below. The Renaissance Revival building was recognized in the 1880 and 1996 City surveys. It is a Resource of Merit designated by the City of Davis. Although it appears much as it did at the time of the most recent survey, the glazing of the upper story windows has been unsympathetically replaced. The absence of a unified lower story façade treatment by the occupying shops also detracts from the buildings historic appearance. Despite these issues, the building retains its integrity and remains one of the most important remaining non-residential historic structures in the City. It contributes to the historic character of the Downtown/ Commercial Conservation District. It may be individually eligible for listing on the California Register because of its City designation and may contribute to a downtown commercial historic district.

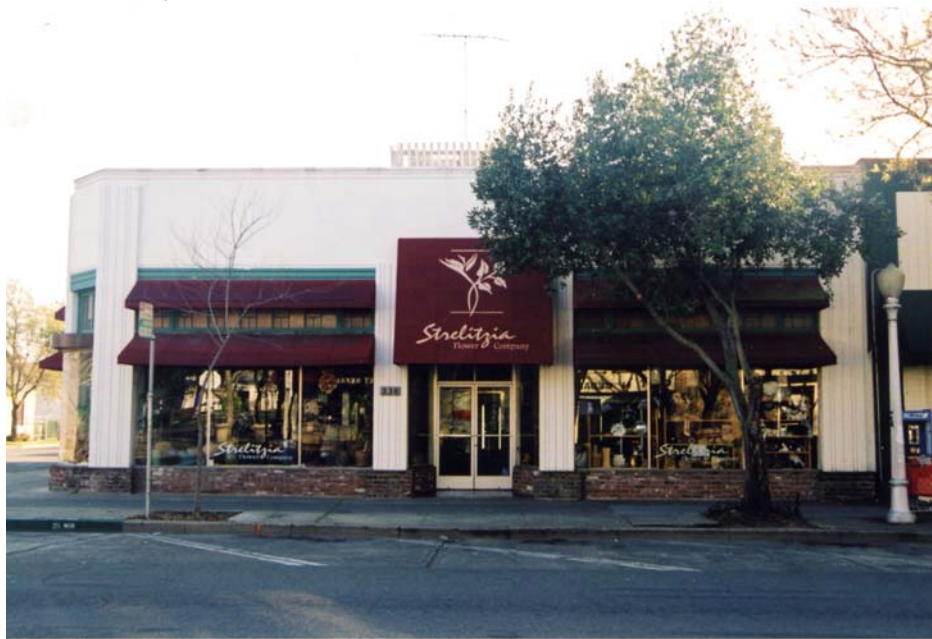
P5. Photograph or Drawing (Photograph required for buildings, structures, and objects.)

This Streamline Moderne Style commercial building is an excellent example of what architectural historians, Herbert Gottfried and Jan Jennings, have termed the "modern broad-front storefront" This building type represents a distinct break with the design of earlier retail buildings. It is characterized by a double width façade made possible by steel beam and column construction. The façade 238 G is open with large panels of glass, subdivided by thin muntins that facilitate window display. The building is linear and single story, and abandons the upper story office or living space that often characterized earlier commercial buildings. Single story, it has a flat roof and parapet. A divided transom forms a band across the top of the display windows. The double entry is positioned in the center of the building and is slightly recessed allowing for side glass panels in the entry. The entry and curved corner of the building are highlighted by streamline engaged columns. Constructed in 1937, the lower façade wall was originally faced with ceramic tile, but is now covered with a brick facing. A handsome building, it is one of the few Streamline Modern style buildings in Davis and one of the few commercial buildings of this construction type. It appears to contribute to the historic character of the Downtown/ Commercial area of the Conservation District. It should be considered for historical resource designation by the City as one of the few remaining historic buildings in the original City commercial district, and one of the only ones remaining on the east side of the street.

- *P3b. Resource Attributes: HP2
- *P4. Resources Present: Building
 Structure Object Site District Element of District
- P5b. Description of Photo:
View east *
- P6. Date Constructed/Age:
1937 66 years old documented
 Prehistoric Historic
 Both
- *P7. Owner and Address:
- *P8. Recorded by:
Carol Roland
Roland-Nawi Associates
4829 Crestwood Way
Sacramento, CA 95822
- *P9. Date Recorded: 04/07-10/2003
- *P10. Type of Survey: Intensive
 Reconnaissance Other
Describe: Determination of
- *P11. Report Citation: none
- *Attachments: NONE Map Sheet Continuation Sheet

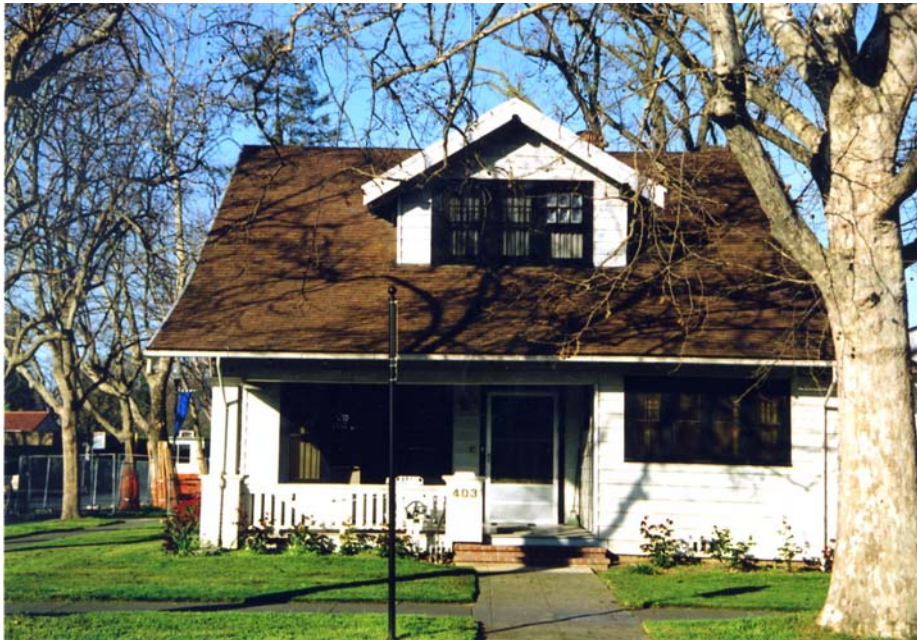
P5. Photograph or Drawing (Photograph required for buildings, structures, and objects.)

- *P3b. Resource Attributes: HP2
*P4. Resources Present: Building Structure Object Site District Element of District
P5b. Description of Photo:
View west *
P6. Date Constructed/Age:
1914 89 years old documented
 Prehistoric Historic
 Both
*P7. Owner and Address:

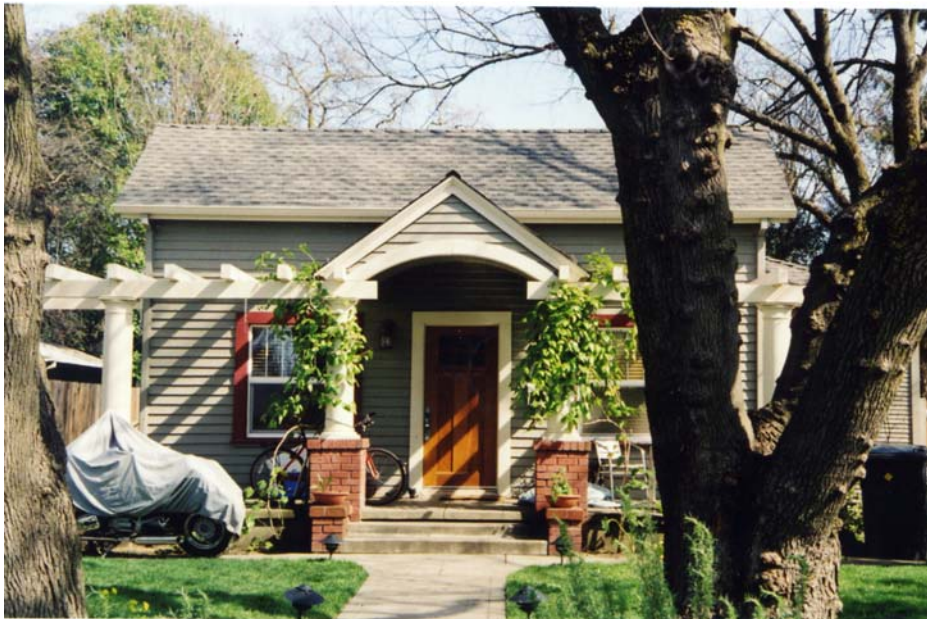
P5. Photograph or Drawing (Photograph required for buildings, structures, and objects.)

This handsome side gabled residence has a side gable roof, with a hipped addition on the south side, all clad in asphalt shingles. The fenestration is replacement metal sash with false muntins. The house has a full porch formed by a concrete floor, with a shelter over the center entrance and pergola over the sides. The shelter is front gabled, with a decorative circular inner curve. Brick pedestals support Doric columns. The house is clad in horizontal shiplap siding. The front door features 3/2 fixed panes. One column remains of what was apparently a porte cochiere on the north façade. A large second structure at the rear of the residence is currently being built. The 1933 tax assessor record indicates that the house is more than 50 years old. This would place the original construction in the 1880s. The proportions of the central building block tend to support this possibility, however, the front doorway, porch and pediment have been remodeled in such a way as to suggest a Revival Style cottage circa 1920s. It is unclear if these changes were actually made in the 1920's, or more likely, are of fairly recent origin. The evolution of this house should be evaluated and documented more thoroughly. It contributes to the character of the neighborhood.

View east

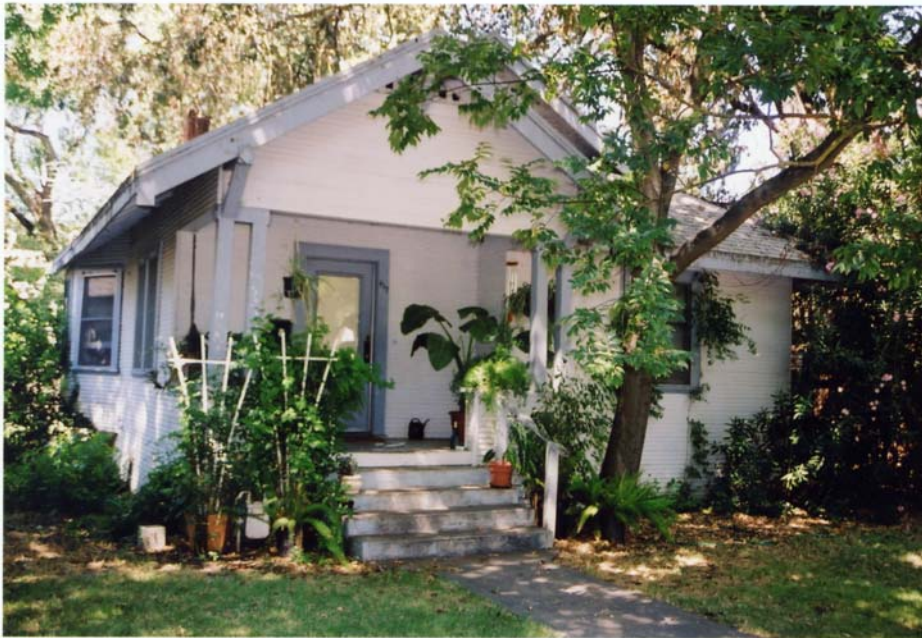
P5. Photograph or Drawing (Photograph required for buildings, structures, and objects.)

This L-plan bungalow has a cross gable roof of moderate pitch. A second gable projects to cover a half porch. The porch gable is supported on knee brace brackets with the gable end supported on double wooden posts that rest on the closed porch rail. A bay is found on the south façade. Fenestration consists of one-over-one double hung windows. The entry door is partially glazed. Cladding is stucco. The house retains all aspects of its integrity. It contributes to the character of the neighborhood.

- *P3b. Resource Attributes: HP2
*P4. Resources Present: Building Structure Object Site District Element of District
*P5b. Description of Photo:
View west
*P6. Date Constructed/Age:
c. 1915 88 years old estimated
 Prehistoric Historic
 Both

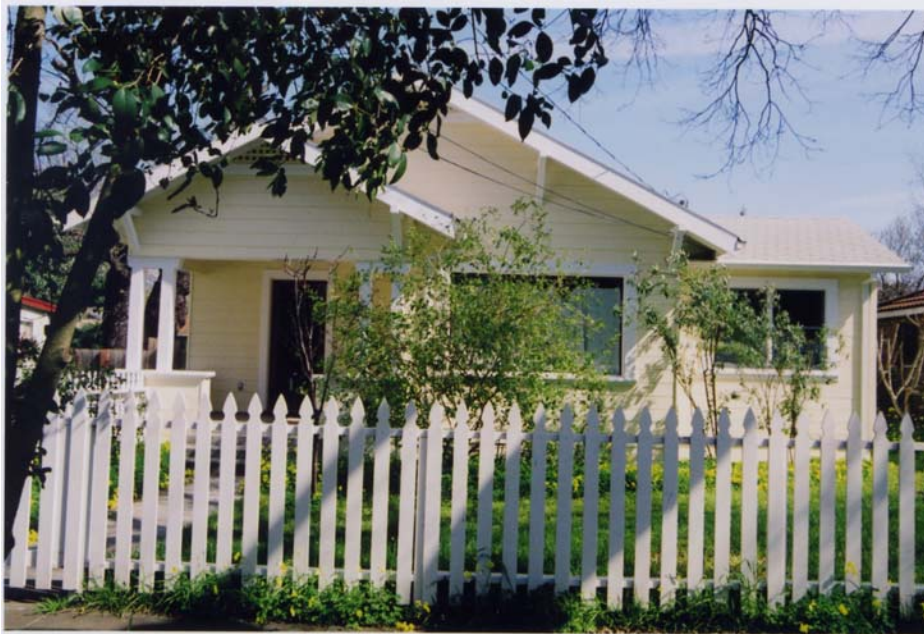
P5. Photograph or Drawing (Photograph required for buildings, structures, and objects.)

This small Craftsman residence has a front gabled roof clad in asphalt shingles. The walls are covered in horizontal siding. It sits on a poured concrete perimeter foundation. Its fenestration is composed of one-over-one double hung windows. The entry is accessed by a short set of concrete steps into a porch, sheltered by an offset front gabled element. The porch shelter and main roof feature latticed vents. The low pitch roof eaves feature simple brackets. The porch has a half height walls, with simple twin-post supports. There is a large fixed pane window on the front façade; the remaining windows appear to be one-over-one double hung sash. There is a detached building at the rear of the residence, not visible from the street.

- *P3b. Resource Attributes: HP2
*P4. Resources Present: Building Structure Object Site District Element of District
*P5b. Description of Photo:
View east
*P6. Date Constructed/Age:
1915 88 years old documented

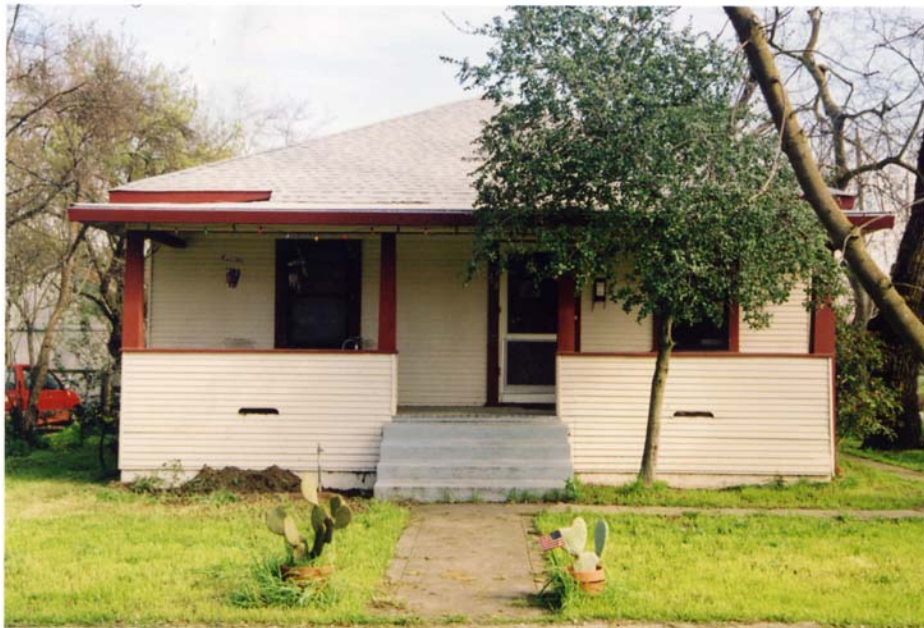
P5. Photograph or Drawing (Photograph required for buildings, structures, and objects.)

This simple Craftsman residence is topped by a hipped, asphalt shingle-clad roof with a shed extension over the full façade porch supported by posts, with a half wall. Access to the porch is provided by concrete steps. The walls are clad in horizontal novelty siding. Fenestration is composed of one-over-one double hung windows, which appear to be original. The house sits on a concrete perimeter foundation. The house has a rectangular footprint. The house retains its integrity of design, materials, workmanship, location, Setting and association. It contributes to the character of the neighborhood.

- *P3b. Resource Attributes: HP2
*P4. Resources Present: Building Structure Object Site District Element of District
*P5b. Description of Photo:
View east
*P6. Date Constructed/Age:
1912 91years old documented
 Prehistoric Historic
 Both

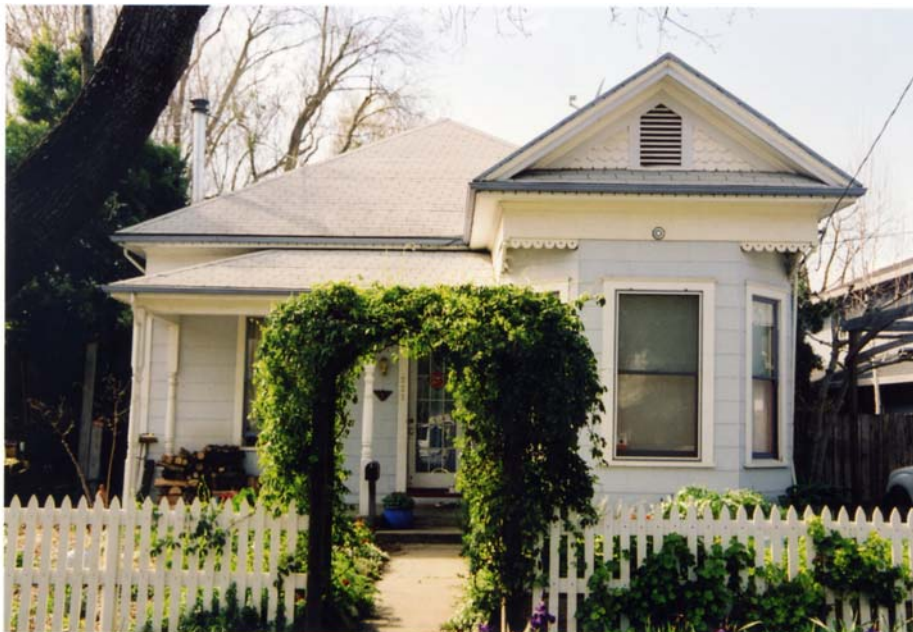
P5. Photograph or Drawing (Photograph required for buildings, structures, and objects.)

*P3a. Description:
The classic Queen Anne cottage is an excellent example of its type and period. It was noted in the surveys of 1980 and 1996. The house continues to retain its integrity. It contributes to the character of the neighborhood and may contribute to a multiple property district composed of Victorian period residences in the City of Davis.

*P3b. Resource Attributes: HP2
*P4. Resources Present: Building Structure Object Site District Element of District
*P5b. Description of Photo:
View east
*P6. Date Constructed/Age:
1897 106 years old documented
 Prehistoric Historic
 Both

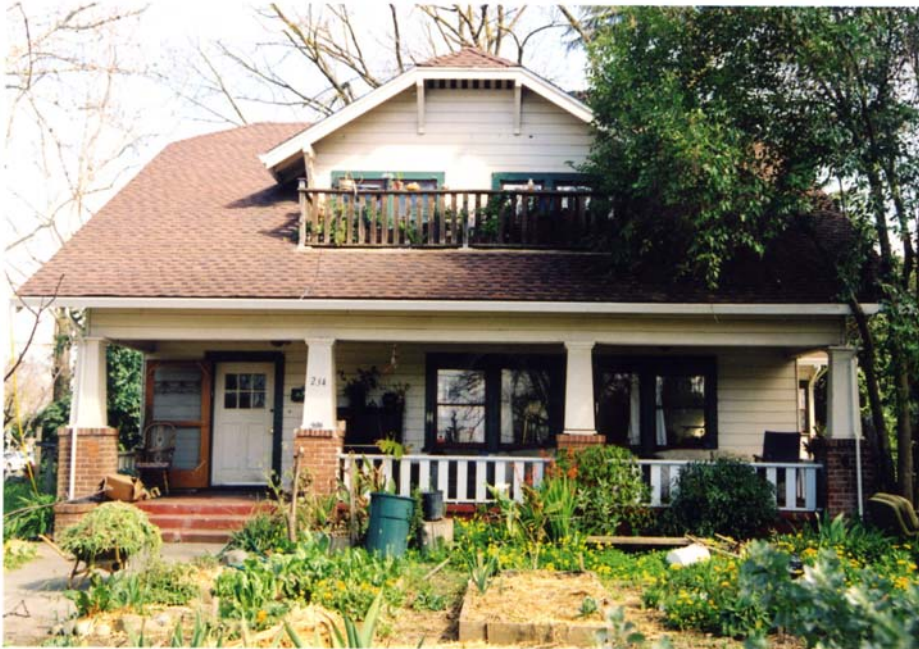
P5. Photograph or Drawing (Photograph required for buildings, structures, and objects.)

This jerkinhead gable roof Craftsman house is one of the larger and more detailed examples of its type in Davis. It is recognized in both the 1980 and 1996 surveys. At the time of the 1996 survey it appears that the upper story, dormer balcony had been removed. This appears to have been replaced in kind, but has not been painted. Although the landscape around the house has been much altered, the exterior of the house continues to retain its integrity. It contributes to the character of the neighborhood. Because it is one of largest and most detailed bungalows in Davis, it should be considered for local listing as an historic resource.

*P3b. Resource Attributes: HP2
*P4. Resources Present: Building Structure Object Site District Element of District
*P5b. Description of Photo:
View east
*P6. Date Constructed/Age:
1924 79 years old documented
 Prehistoric Historic
 Both

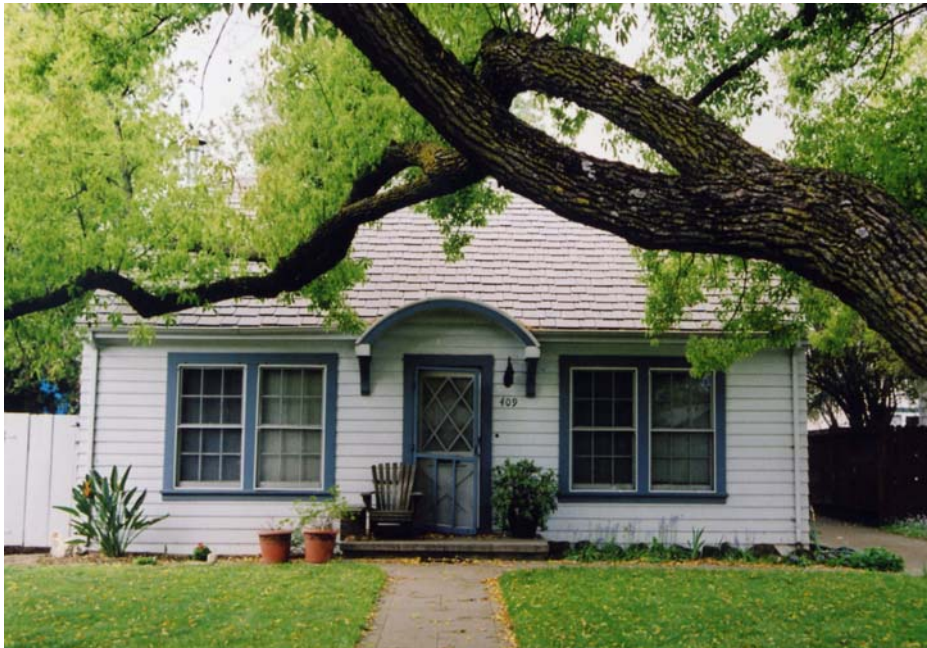
P5. Photograph or Drawing (Photograph required for buildings, structures, and objects.)

This rectangular plan, single story residence is a Cape Cod Revival with a moderately pitch front gable roof. Entry is made via a cement stoop centered on the front façade. The entry door is partially glazed and is probably a replacement. The entry is sheltered by a barrel arch element supported on knee brace brackets.. The walls are clad with clapboard. Fenestration is composed of six-over-six light double hung windows. On the front façade these are arranged symmetrically in pairs on either side of the entry door. This house contributes to the character of the neighborhood.

- *P3b. Resource Attributes: HP2
*P4. Resources Present: Building Structure Object Site District Element of District
*P5b. Description of Photo:
View west
*P6. Date Constructed/Age:
1928 75 years old documented
 Prehistoric Historic
 Both
