CENTRAL DAVIS HISTORIC CONSERVATION DISTRICT

CITY OF DAVIS

HISTORICAL RESOURCES SURVEY

AUGUST 2003

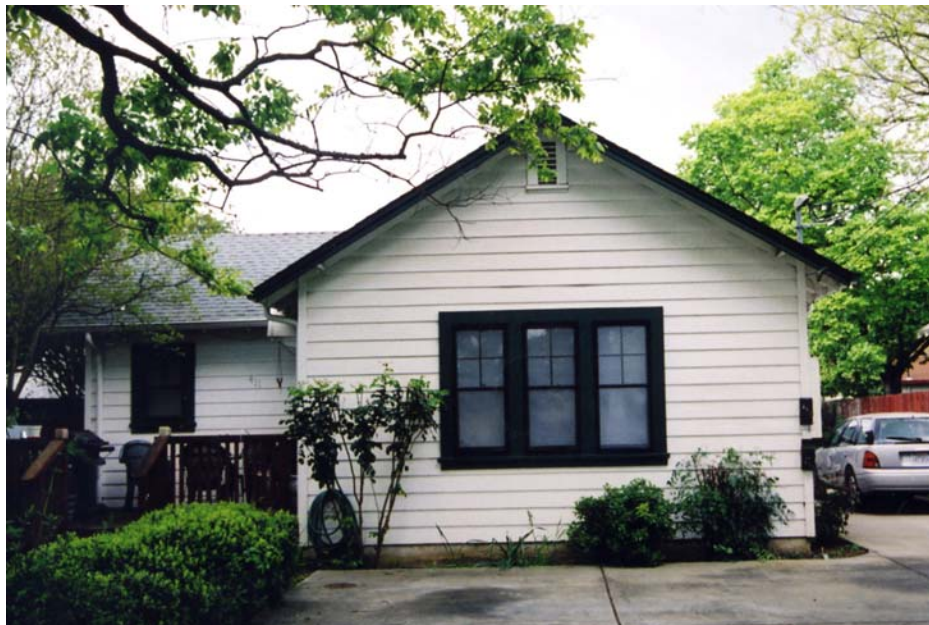
P5. Photograph or Drawing (Photograph required for buildings, structures, and objects.)

This L-shaped, moderate pitch front gable single story residence can be classified as a late Craftsman Bungalow or is a Minimal Traditional style building. Entry is made via a modern wooden deck with half height balustrade. The entry is sheltered by a barrel arch element. The walls are clad with horizontal siding, either drop or metal. Fenestration is composed of 2/1 double hung and 1/1 double hung, some of which appear to be modern replacements. There is an interior stove pipe clad in siding that is sited near the gable peak. A detached building of similar building materials and general design is sited to the rear of the original residence. The modern deck detracts from the historic appearance of the house, but is not a structural change. The house continues to retain its integrity. It contributes to the character of the neighborhood.

*P3b. Resource Attributes: HP2
*P4. Resources Present: Building Structure Object Site District Element of District
P5b. Description of Photo:
View west
*P6. Date Constructed/Age:
c. 1925 78 years old estimated

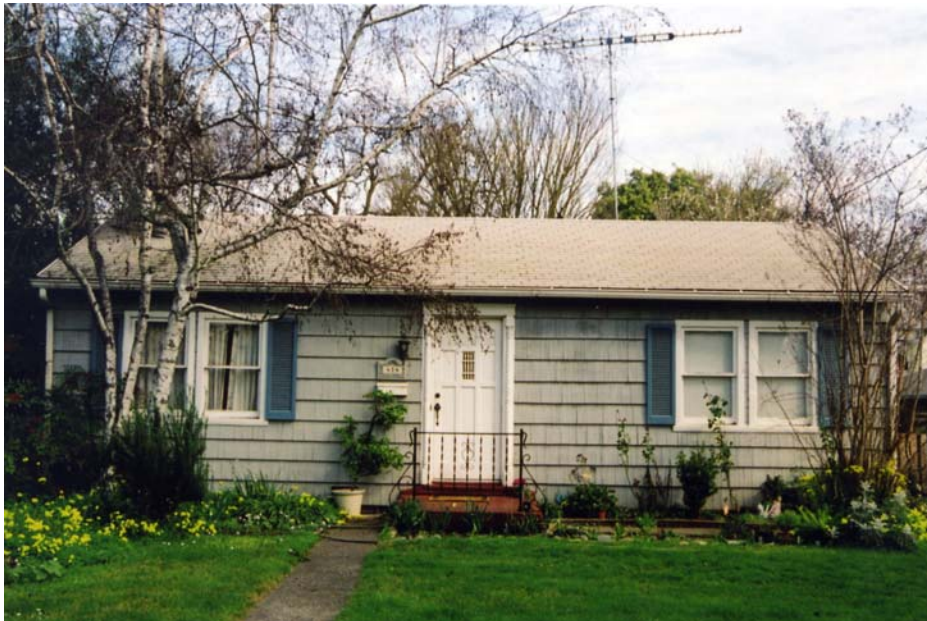
P5. Photograph or Drawing (Photograph required for buildings, structures, and objects.)

This simple one-story Colonial Revival has a moderate pitch side gable roof with virtually no eaves. The walls are clad with wood shingles, with vertical wooden siding in the gable peaks. There is a louvered vent at the gable peak. The entry is placed in the center of the front façade, and features decorative trim. There is no shelter over the entry door. It is flanked by two sets of two double hung windows, and the fenestration of the house in general is one-over-one double hung. The house sits on a poured concrete perimeter foundation. A detached side gable garage with addition sits at the rear the yard. It contributes to the character of the neighborhood.

- *P3b. Resource Attributes: HP2
*P4. Resources Present: Building Structure Object Site District Element of District
P5b. Description of Photo:
View west
*P6. Date Constructed/Age:
c 1935 68 years old documented
 Prehistoric Historic

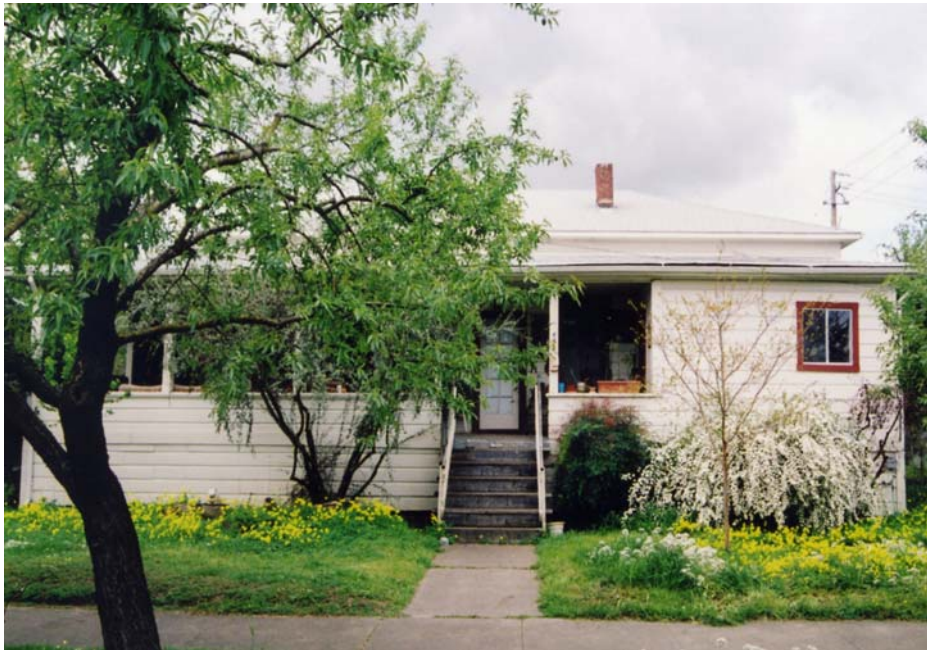
- View west
*P6. Date Constructed/Age:
1885 118 years old documented
 Prehistoric Historic
 Both
*P7. Owner and Address:
*P8. Recorded by:
Carol Roland
Roland-Nawi Associates
4829 Crestwood Way
Sacramento, CA 95822
*P9. Date Recorded: 04/07-10/2003
*P10. Type of Survey: Intensive
 Reconnaissance Other
Describe: Determination of
Local District Eligibility
*P11. Report Citation: none
*Attachments: NONE Map
Sheet Continuation Sheet
Building, Structure, and Object Record
Linear Resource Record
Archaeological Record District Record
 Milling Station Record Rock Art
Record
 Artifact Record Photograph Record

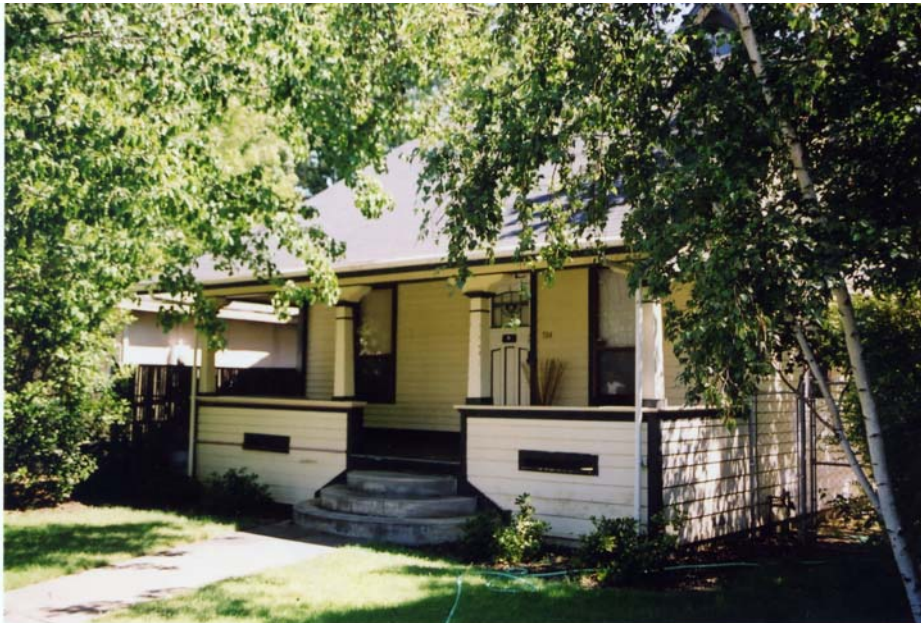
This simple Craftsman residence has a side gable, asphalt clad roof that extends over a full length front porch. The porch is supported by four rectangular columns, one at each end and two flanking the entry. Access to the porch is provided by four simple, semicircular concrete steps. The porch has a half height wall, with drainage slots. The walls are clad with horizontal siding. The windows are 1/1 double hung, which flank the entry within the porch. The house sits on a poured concrete foundation. There is a recently constructed two story addition at the rear, somewhat wider than the original house, with a relatively steeply pitched roof that is visible from the street. Although there is no documentation regarding the date of this residence, some details indicate that it was an early craftsman that incorporates some aspects of late Victorian style. These features include the pitch of the roof, the treatment of the front windows, and the design of the porch posts. The recent rear addition is out of keeping with the style of the building, in both its massing and design characteristics. However, heavy vegetation at the front of the lot masks the addition from view from the street. Although its integrity has been impaired, the house contributes to the character of the neighborhood.

P5b. Description of Photo:
View east
*P6. **Date Constructed/Age:**
c 1910 93 years old estimated
 Prehistoric Historic
 Both
*P7. **Owner and Address:**

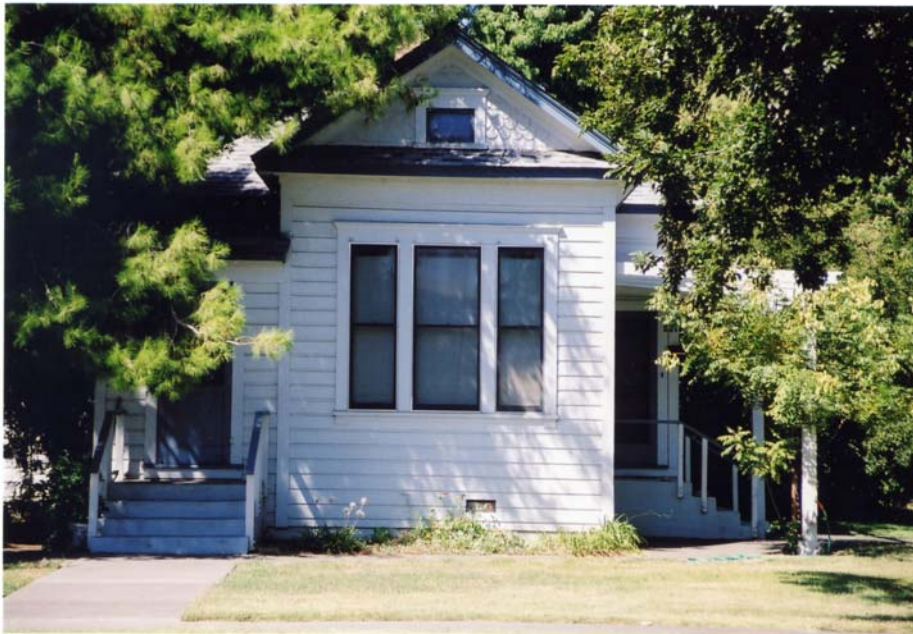
- *P3b. Resource Attributes: HP2
*P4. Resources Present: Building Structure Object Site District Element of District
*P5b. Description of Photo:
View west and south
*P6. Date Constructed/Age:
1905 98 years old documented
 Prehistoric Historic
 Both

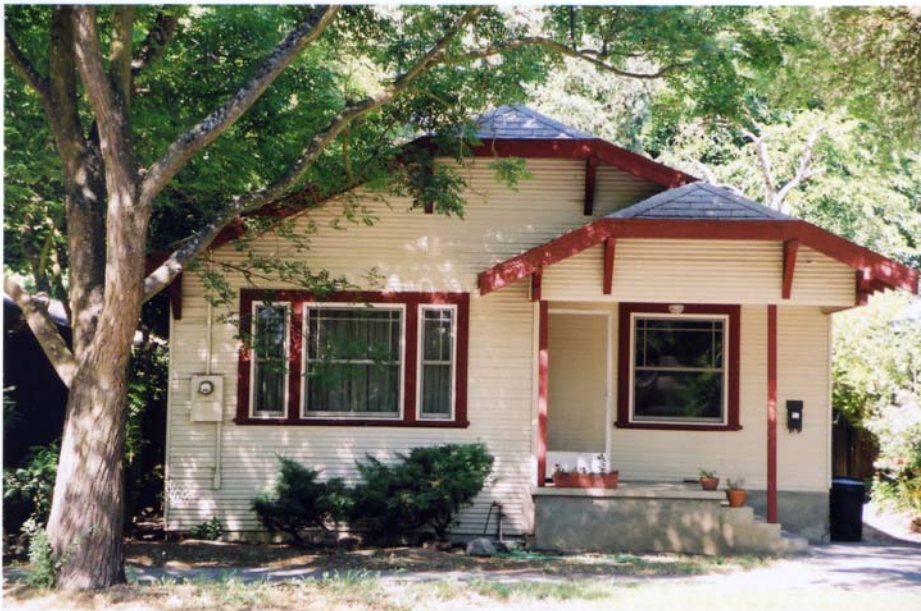
This rectangular plan bungalow is surmounted by a jerkinhead roof with a front facing gable. The principal roof is supported on knee brace brackets and is low pitched. A cut-in porch on the north side of the front façade is covered by a projecting jerkinhead which mirrors the design of the principal roof. The porch gable is supported on 4X4 posts that may be replacements. These extend full length from floor to roof. The porch is enclosed with a closed rail clad in the same material as the house. Fenestration consists of double hung windows with wood casement and sash. The window on the front façade has a large central panel with a decorative upper glazing pattern and narrow, double hung, four-over-one side lights. The house is clad with a composition shingle that replaces the original siding. A small, original, single car garage is found on the north side of the house at the rear of the lot. Although the siding replacement results in a loss of integrity of materials, the other aspects of integrity are in tact and the house clearly conveys its bungalow style. It contributes to the character of the neighborhood.

View westast
*P6. Date Constructed/Age:
c 1920 83years old estimated
 Prehistoric Historic
 Both
*P7. Owner and Address:

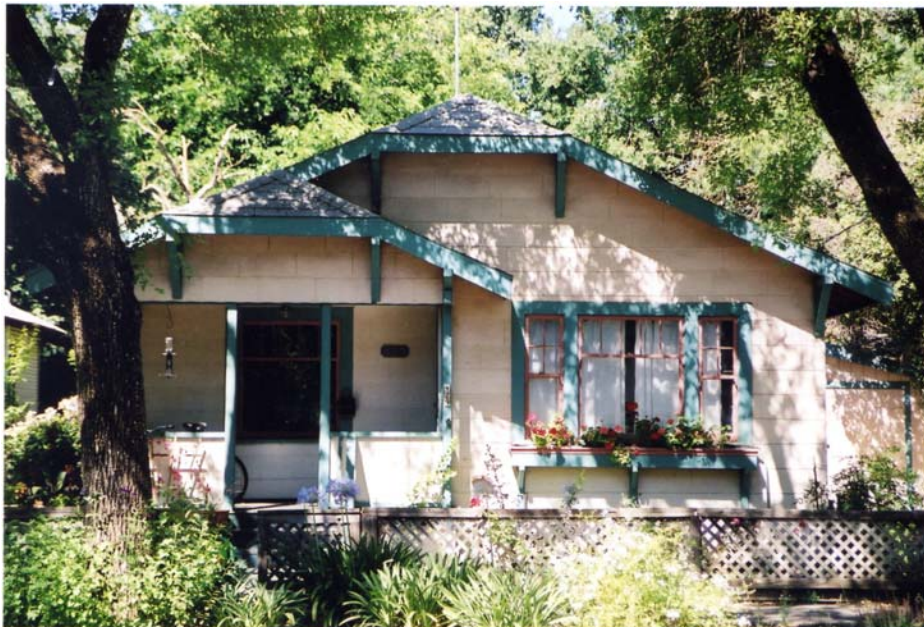
This rectangular plan bungalow is surmounted by a jerkinhead roof with a front facing gable. The principal roof is supported on knee brace brackets and is low pitched. A cut-in porch on the south side of the front façade is covered by a projecting jerkinhead which mirrors the design of the principal roof. The porch gable is supported on 4X4 posts that may be replacements. These extend full length from floor to roof. The porch is enclosed with a closed rail clad in the same material as the house. Fenestration consists of double hung windows with wood casement and sash. The window on the front façade has a large central panel with a decorative upper glazing pattern and narrow, double hung, four-over-one side lights. The house is clad with a composition shingle that replaces the original siding. A small, original, single car garage is found on the north side of the house at the rear of the lot. Although the siding replacement results in a loss of integrity of materials, the other aspects of integrity are intact and the house clearly conveys its bungalow style. It contributes to the character of the neighborhood.

- View west
*P6. Date Constructed/Age:
c 1920 83years old estimated
 Prehistoric Historic
 Both
*P7. Owner and Address:

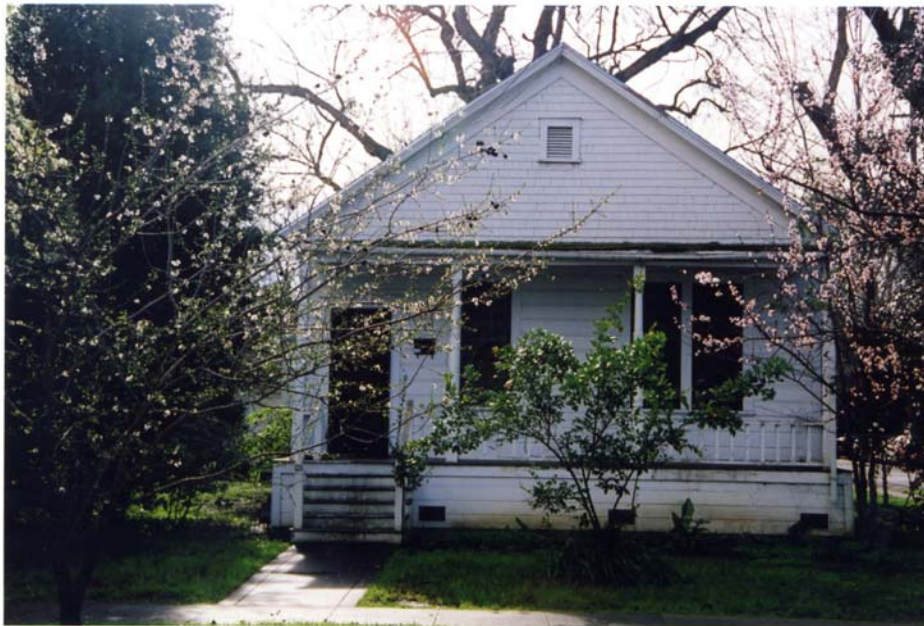
- *P3b. Resource Attributes: HP2
*P4. Resources Present: Building Structure Object Site District Element of District
*P5b. Description of Photo:
View south

- *P6. Date Constructed/Age:
1870 133 years old
documented
 Prehistoric Historic
 Both
*P7. Owner and Address:
*P8. Recorded by:
Carol Roland
Roland-Nawi Associates
4829 Crestwood Way
Sacramento, CA 95822
*P9. Date Recorded: 04/07-10/2003
*P10. Type of Survey: Intensive
 Reconnaissance Other
Describe: Determination of
Local District Eligibility
*P11. Report Citation: none
*Attachments: NONE Map
Sheet Continuation Sheet
Building, Structure, and Object Record
Linear Resource Record
Archaeological Record District Record
 Milling Station Record Rock Art
Record
 Artifact Record Photograph Record

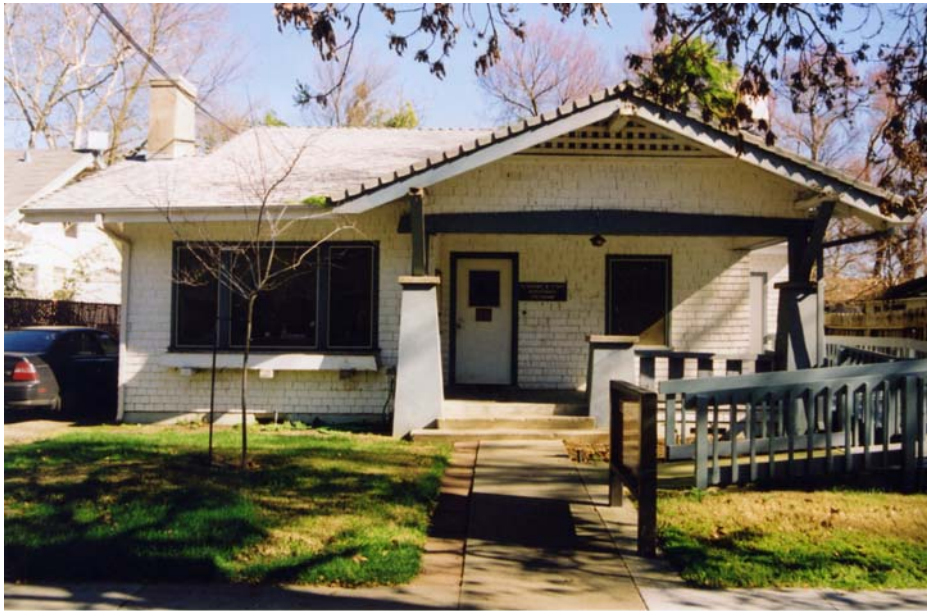
***P3a. Description:**
 This 1912 house is designed in the Prairie Style. Never as popular in California as it was in the Mid-West, Davis has only one or two examples of this style type. The house is basically rectangular in plan with a square bay on the south façade. The roof is low pitched, side gabled with wide overhangs. A partial cut-in porch is found on the south side of the front façade. It is covered by a low pitched front gable. The gable is trimmed with a fascia, exhibits exposed purlins, and is supported by large knee brace brackets which rest on tall, battered piers. There is an open rail across the front of the porch, while the side rail has been removed to accommodate a handicap ramp. Fenestration consists of double hung windows, with the front window resting on a prominent, heavy wooden sill supported on projecting beams. A low, broad stucco chimney is located on the north façade. The house is clad with rustic shingles. The house retains its integrity of design, materials, workmanship, setting, location, feeling and association. It contributes to the historic character of the neighborhood.

View east
***P6. Date Constructed/Age:**
 1912 91 years old documented
 Prehistoric Historic
 Both
***P7. Owner and Address:**

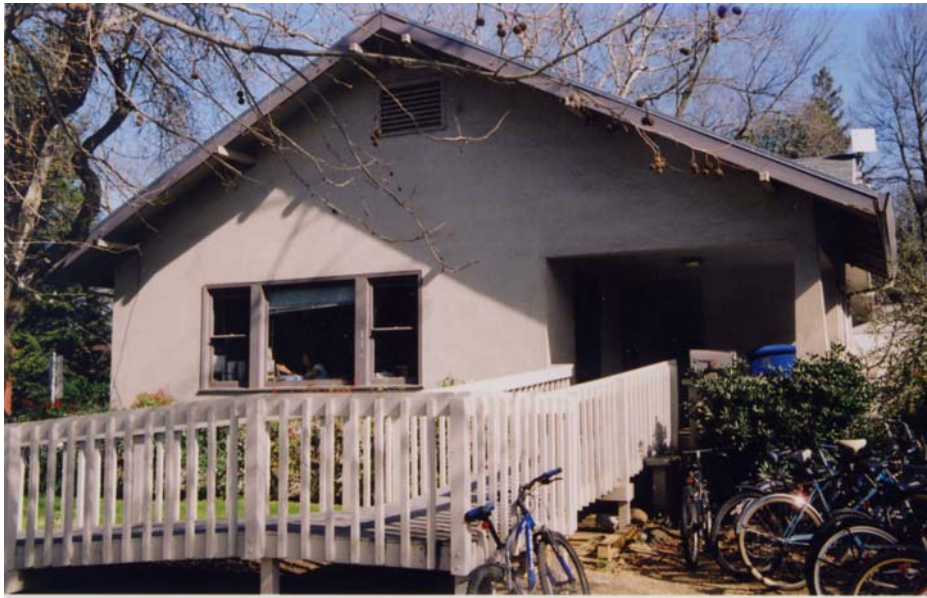
This is a front gable Craftsman Bungalow with a moderately pitched roof. Gables and eaves have wide overhangs with the gable supported on exposed purlins. A horizontally emphasized louvered vent accentuates the apex of the gable wall. A cut-in side porch is found on the south side of the façade, with the entry door on the side wall facing south. The south end of the gable is supported on a battered column and an open rail is found on the south side of the porch, but has been removed on the front of the porch to accommodate a handicap ramp. This ramp visually obscures the front façade but is lightly attached and can be removed. A ramp entering from the south side of the porch would be more compatible with the historic appearance of the house. A single central fixed window with one-over one double hung sidelights occupies the center of the front façade. Other fenestration consists of double hung windows. Cladding is stucco. The house retains its integrity of materials, workmanship, setting, location, feeling and association. It contributes to the historic character of the neighborhood.

View east

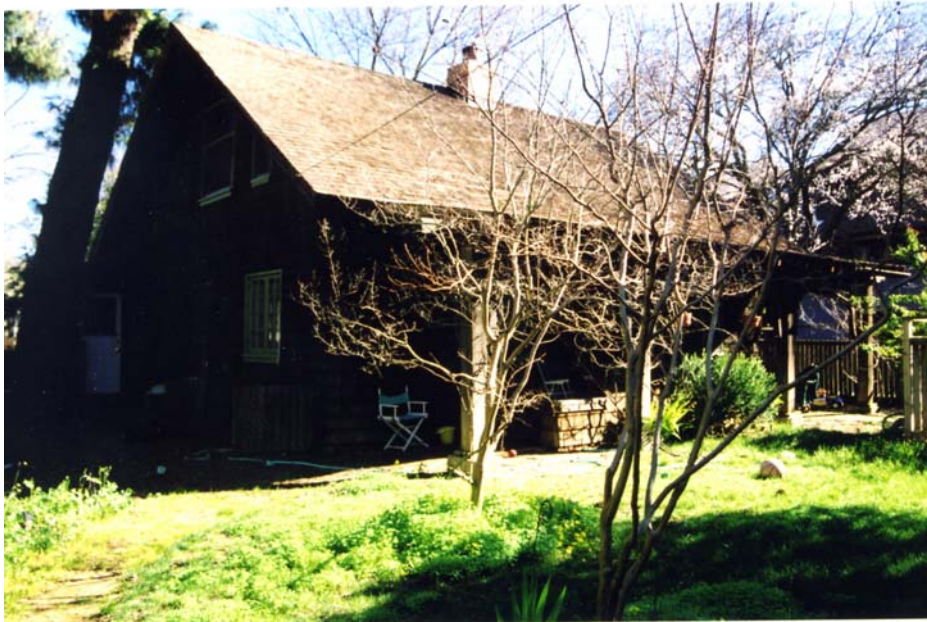
*P3a. Description:
 This 1911 house is one of the earliest residences adjacent to the University. It is an example of a rustic Craftsman house, unusual in Davis. The house is associated with the Grieves, a pioneer Davis family. The house was identified in the 1980 and 1996 city survey and retains its integrity of materials, workmanship, setting, feeling and association. It was moved to its present location from an adjacent lot to save it from demolition. Despite this fact, it contributes to the historic character of the neighborhood. It is recognized by the City as a Merit Resource. It is eligible for the California Register of Historical Resources based on its local designation and its association with an important pioneer family.

*P3b. Resource Attributes: HP2
 *P4. Resources Present: Building Structure Object Site District Element of District
 P5b. Description of Photo:
 View east
 *P6. Date Constructed/Age:
 1911 103 years old documented
 Prehistoric Historic

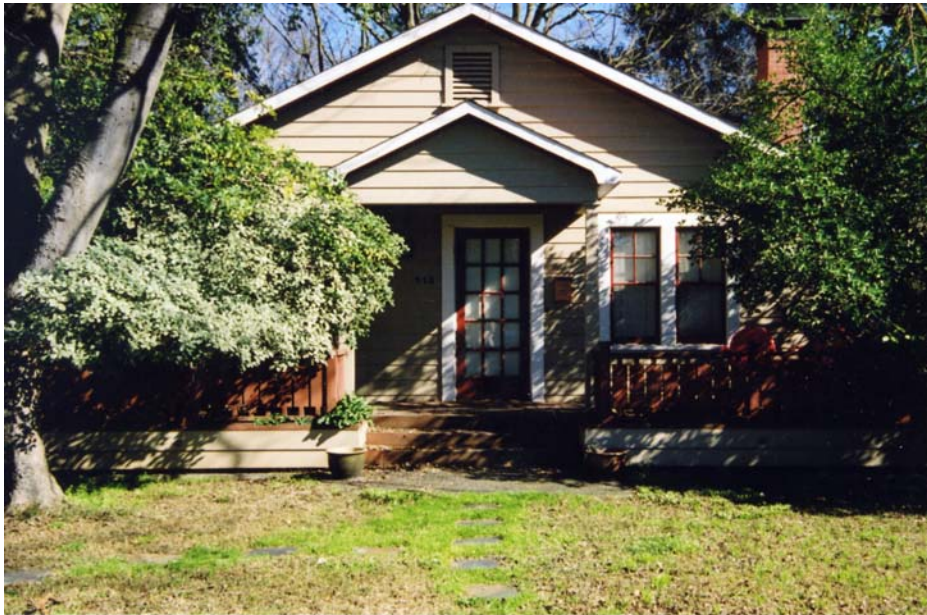
This is a front gable, rectangular plan Craftsman Bungalow constructed circa 1935. The roof is moderately pitched with a small gable and eave overhang. The gable is trimmed with a fascia and the gable end exhibits a vertically emphasized louvered attic vent. A slightly elevated, cement porch spans the full length of the front façade and is enclosed with an open, possibly replacement, rail. The centrally placed door is covered by a projecting gable supported on slim Doric columns. The porch gable fascia has a return. The placement and detailing of the porch roof suggests a Colonial Revival influence, although the massing and form of the house clearly derives from the bungalow tradition. Fenestration consists of paired, vertically emphasized, four-over-one double hung windows in a wide wood casing. The entry is multi-light glazed. Cladding is of clapboard and a brick chimney is located on the south façade. The house retains its integrity of materials, workmanship, setting, location, feeling and association. It contributes to the historic character of the neighborhood.

View east
 *P6. Date Constructed/Age: c. 1930s 70 years old estimated
 Prehistoric Historic
 Both
 *P7. Owner and Address:
 *P8. Recorded by: Carol Roland
 Roland-Nawi Associates
 4829 Crestwood Way
 Sacramento, CA 95822
 *P9. Date Recorded: 04/07-10/2003
 *P10. Type of Survey: Intensive
 Reconnaissance Other
 Describe: Determination of Local District Eligibility
 *P11. Report Citation: none
 *Attachments: NONE Map Sheet Continuation Sheet Building, Structure, and Object Record Linear Resource Record Archaeological Record District Record Milling Station Record Rock Art Record Artifact Record Photograph Record

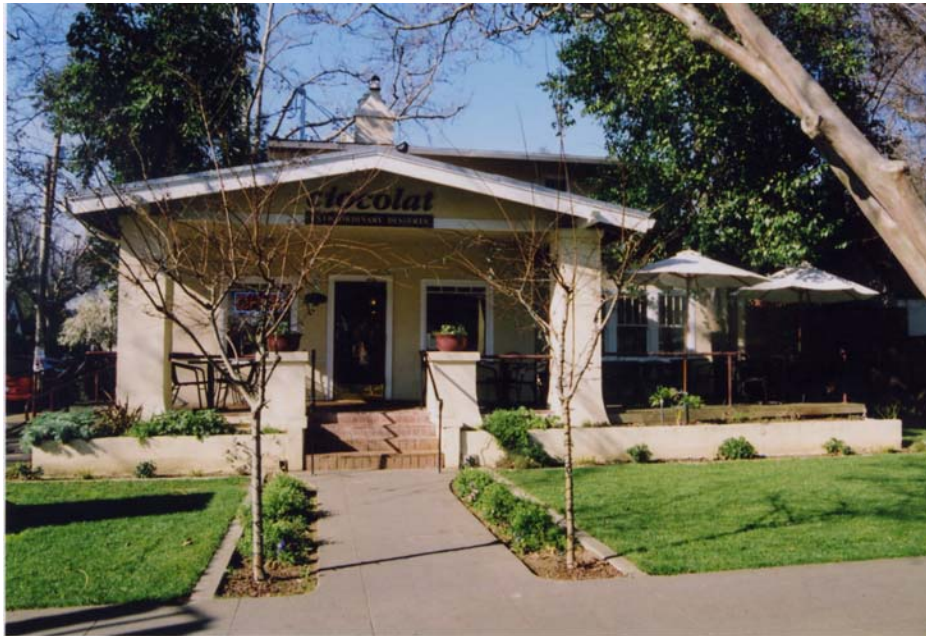
*P3b. Resource Attributes: HP2
*P4. Resources Present: Building Structure Object Site District Element of District
*P5b. Description of Photo:
View west
*P6. Date Constructed/Age:
1922 81 years old documented
 Prehistoric Historic

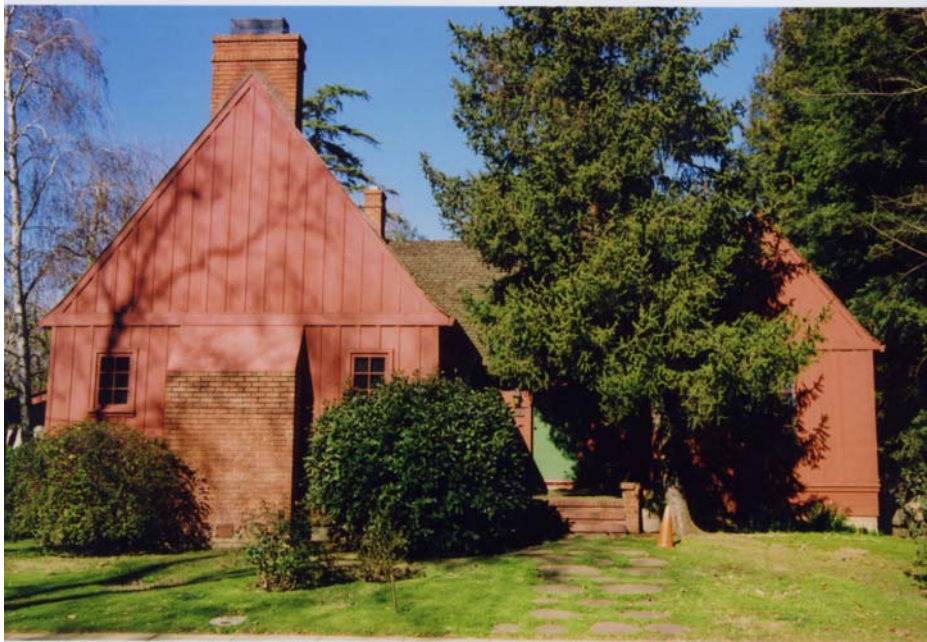
This unusual Davis residence appears to be an adaptation of the Berkeley Arts and Crafts style. It is executed in board and batten with a steeply pitched, multi-gable roof and prominent brick chimney. The house conveys a strong impression of rusticity. It is associated with John Gilmore, a professor of viticulture at the University Farm. The house was identified in the 1996 City survey and retains its integrity of design, materials, workmanship, setting, location, feeling and association. It contributes to the historic character of the neighborhood.

- *P3b. Resource Attributes:** HP2
***P4. Resources Present:** Building Structure Object Site District Element of District
P5b. Description of Photo:
View north
***P6. Date Constructed/Age:**
1932 67 years old documented
 Prehistoric Historic
 Both

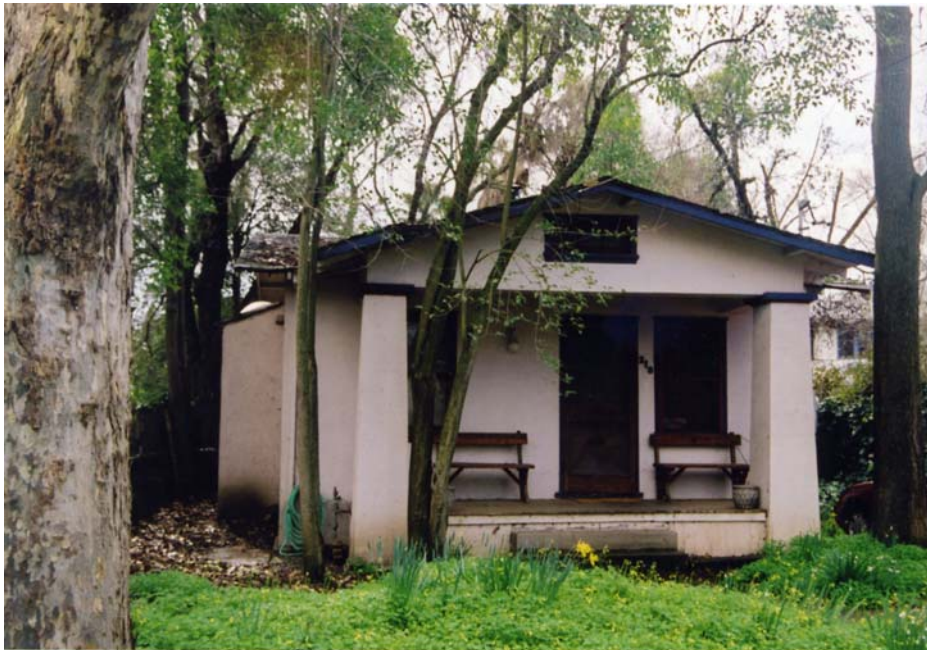
This Peddar Bungalow is similar in design to the other houses designed and executed by AR Peddar, the developer of the Bowers Addition in Old North Davis. There are several examples of this bungalow found in Old North, all are rectangular in plan with a low, front facing gable. A three quarter-length porch supported on battered columns and an asymmetrically arranged façade are characteristic features of this highly recognizable house. This is the only example of the house executed in the University area. The house was most likely built in 1918 when Peddar constructed the majority of these houses. The house retains its integrity of design, materials, workmanship, setting, location, feeling and association. It contributes to the historic character of the neighborhood.

c 1918 85 years old estimated
 Prehistoric Historic

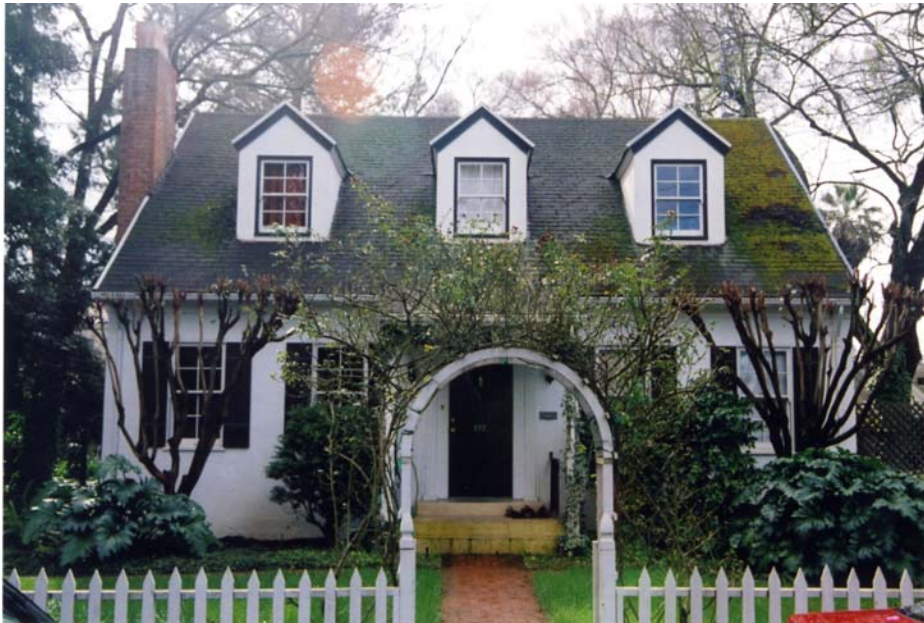
- *Resource Name or Address 222 Rice Lane
- P1. Other Identifier:** None
- *P2. .Location: *a. County Yolo
- b. Address 222 Rice Lane
- *c. City Davis Zip 95616
- d. UTM: N/A
- e. USGS Quad: Davis Quadrangle
- *f. Other Locational Data (APN #): 070-067-001
- *P3a. Description:
- This charming Colonial Revival cottage was identified in the 1996 City survey. It remains unchanged and retains its integrity of design, materials, workmanship, setting, location, feeling and association. It contributes to the historic character of the neighborhood.
- *P3b. Resource Attributes: HP2
- *P4. Resources Present: Building Structure Object Site District Element of District
- P5b. Description of Photo:**
View south
- *P6. Date Constructed/Age:
c 1935 68 years old estimated
 Prehistoric Historic
 Both
- *P7. Owner and Address:

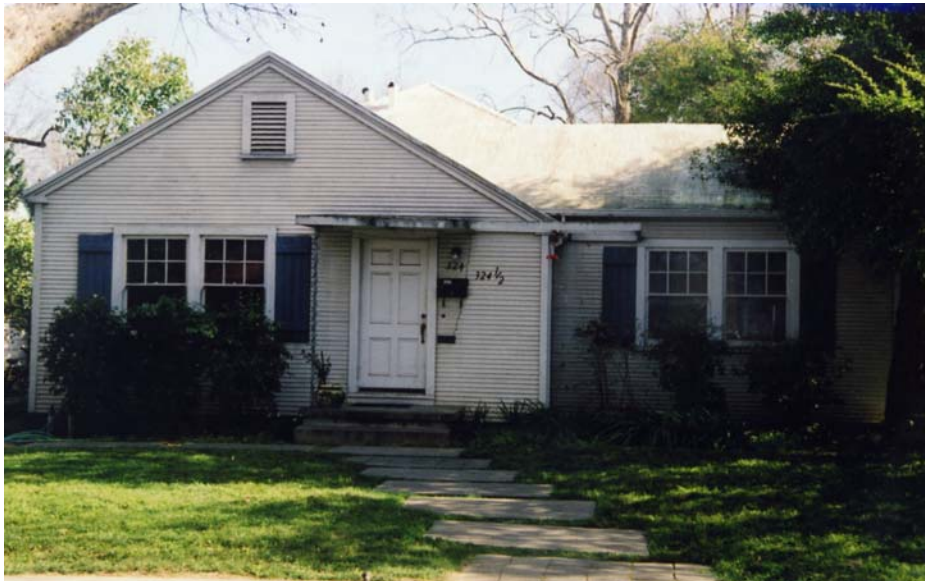
This modest, single story house has an irregular rectangular plan and has sustained significant alterations and enlargement. Roof forms are gables except for a small hipped area that forms the roof's apex, and appear to be covered with composition shingles. Siding is narrow novelty siding. A non-original, L-shaped pergola is located near the entry door. Street façade windows appear to be original wooden double-hung four-over-one with original vertical plank shutters. The entry door is a replacement and the configuration of the entry is not consistent with the style of the house. It appears that an earlier, probably original, porch cover has been removed. Although not maintained in very good condition the house its integrity of materials, workmanship, setting, location, feeling and association. Its integrity of design has been impacted by the alteration of the front entry. It does not appear to contribute to the character of the neighborhood.

View east

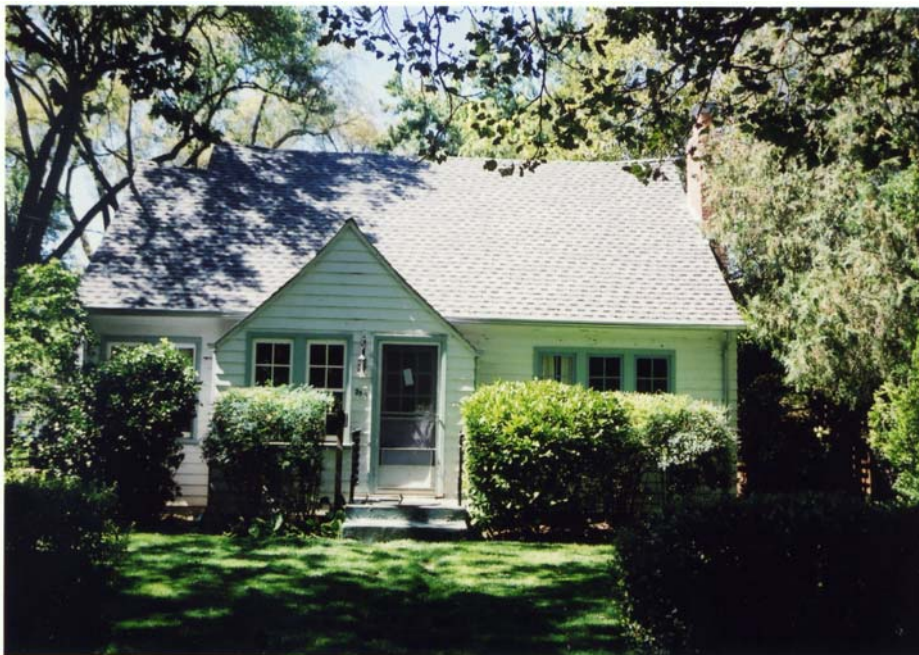
The details of this simple one and one-half story house suggest a Tudor revival influence. It has a primary side-gabled form, with roof ridges "flared" at the gable ends to suggest a thatched roof. A small cross-gable over the entry door terminates at an usually low eave. Siding is 6" exposure wooden lap; window and door casings have stepped profiles. Windows are an apparent mix of original wooden four-over four double-hung windows and one-over-one replacement windows with simulated divided lights. There is a small concrete stoop with wrought iron railings. A tapered brick chimney is located at the north side gable. The house appears to be in good condition. It retains its integrity of materials, workmanship, setting, location, feeling and association. It contributes to the historic character of the neighborhood.

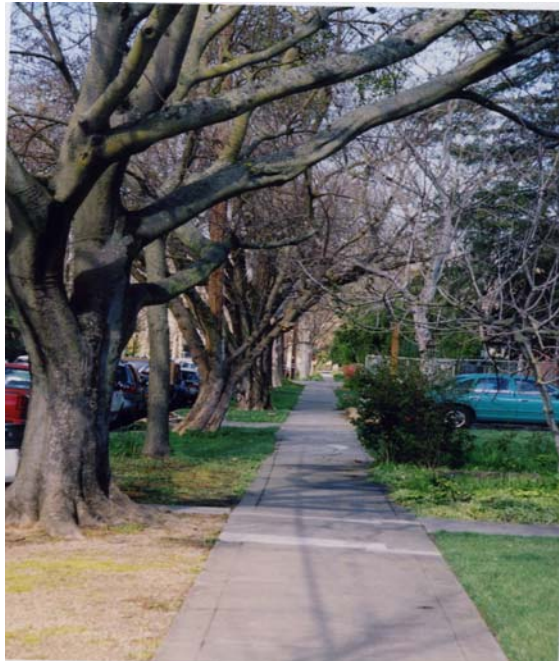
Figure 2 The tree plantings along the public strip between the street and sidewalk create a sheltered environment.

Now mature, these trees form a wide canopy that stretches across the streets in summer, creating an uninterrupted shaded allee extending the full length of most blocks. Deciduous, they allow the maximum of sun light into yards during the foggy Valley winter. Setbacks allowed for ample landscaping in front yard areas and these additional plantings contribute to a park-like-streetscape. Although Old North does not include a park, it is directly adjacent to the City's central park.

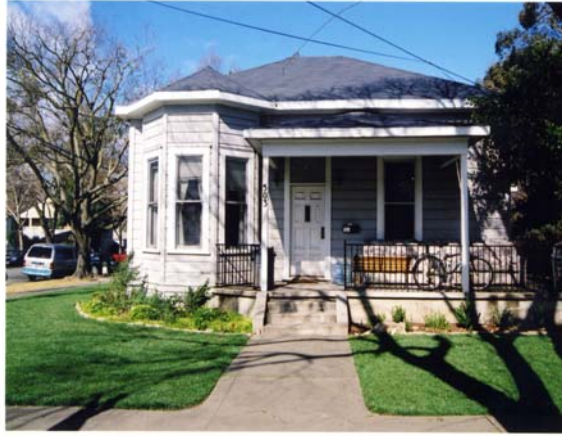
Figure 1 503 5th Street The only surviving house that predates the subdivision development in Old North

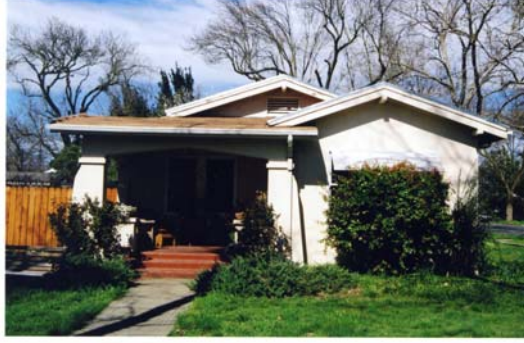
Figure 5 621 6th Street Prairie Style Bungalow

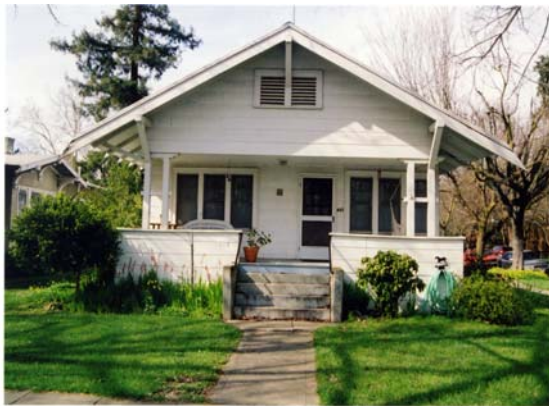
Figure 8 647 F Street Front Gable Bungalow

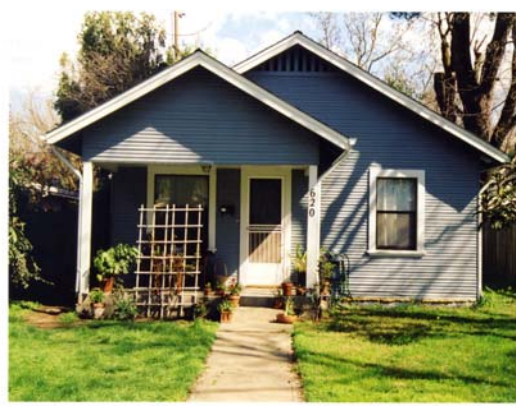
Figure 9 620 F Street Double Gable Bungalow

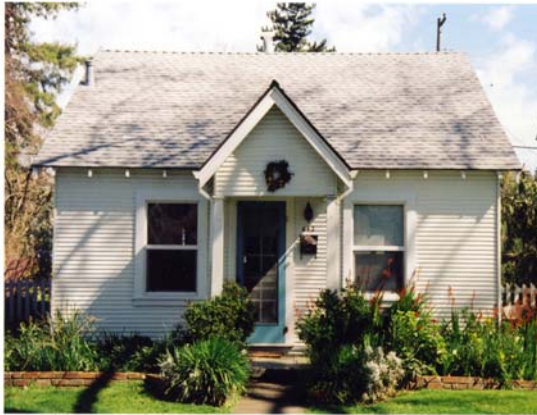
Figure 10 650 E Street Simplified Bungalow

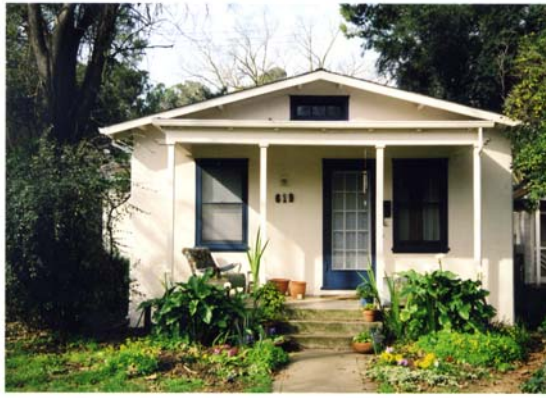
Figure 12 519 C Street Pedder Bungalow

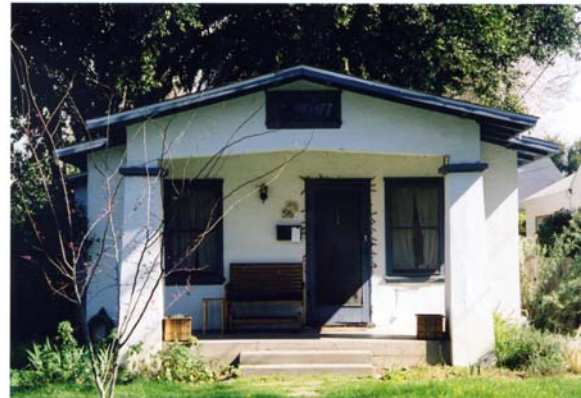
Figure 13 516 E Street Pedder Bungalow

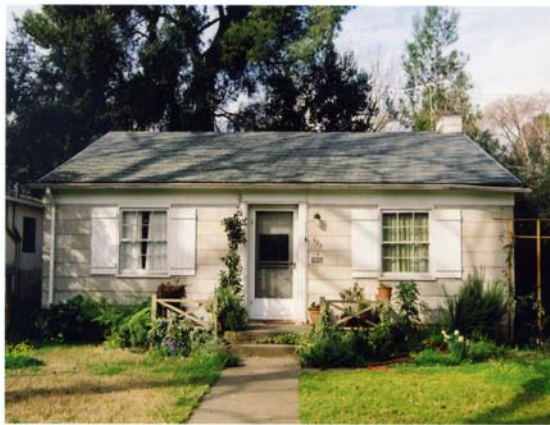
Figure 14 623 C Street Colonial Revival

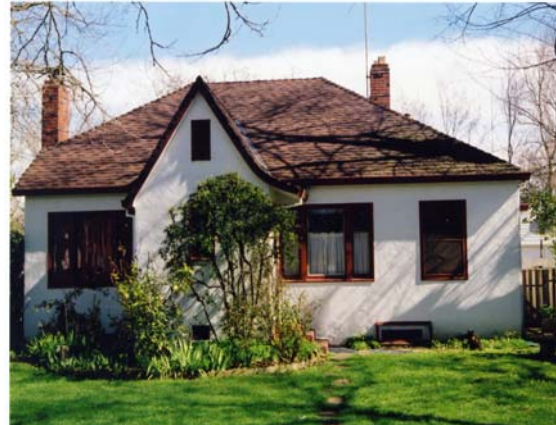
Figure 15 536 C Street English Cottage Revival

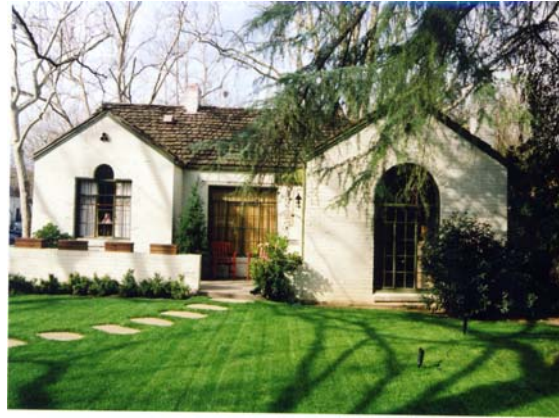
Figure 16 639 E Street Tudor Revival

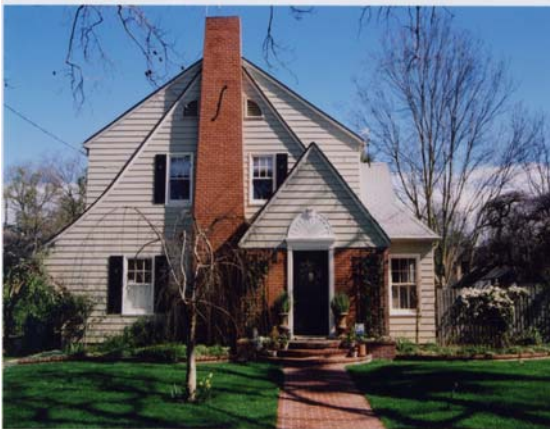
Figure 17 601 D Street Mediterranean Revival

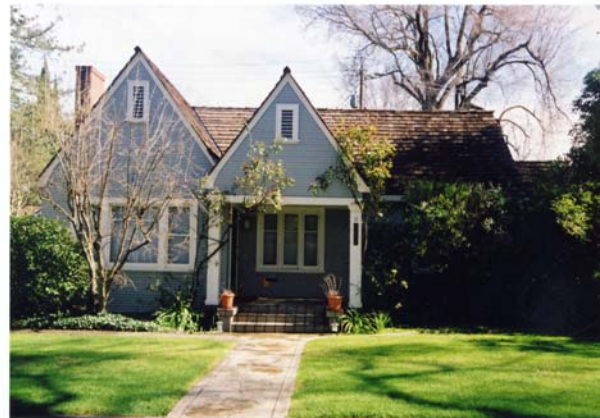
Figure 18 528 D Street Dutch Revival

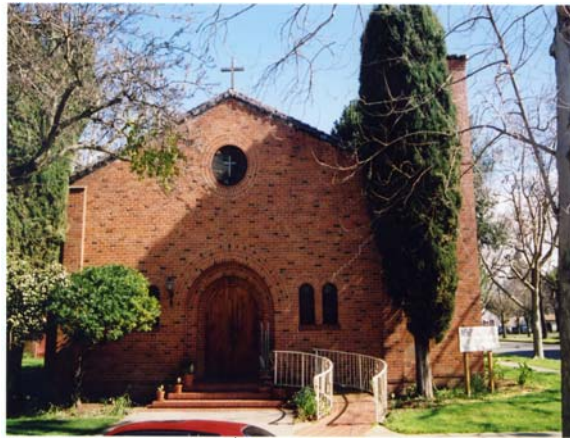
Figure 24 514 5th Street St. James Church

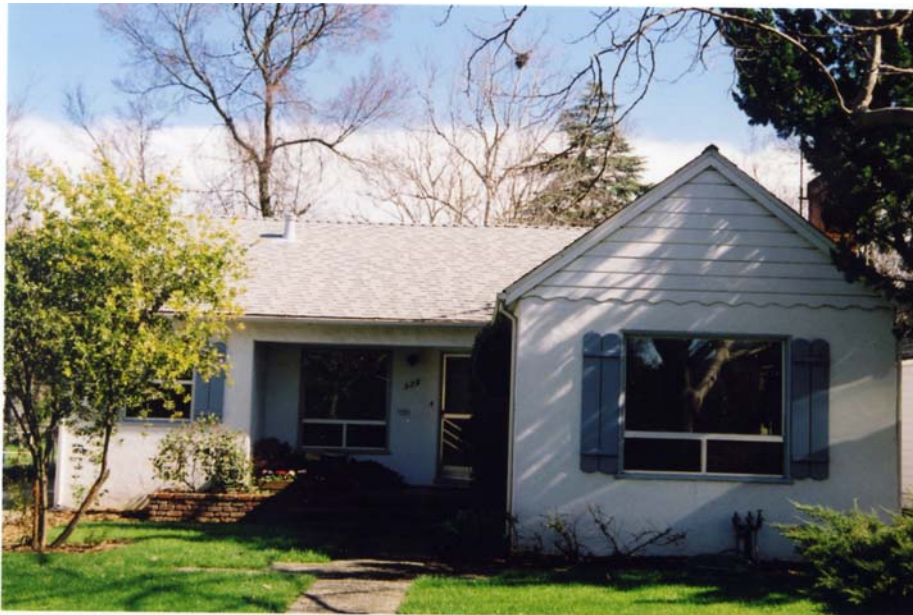
*P3a. Description:
 This asymmetrical, U-shape plan house is very similar in design to its neighbor at 522 C Street. The house has a moderately pitched cross gable roof with a central porch cut in under the eaves. There is a prominent front projecting, gabled wing on the south side of the façade. It is trimmed with decorative clapboard siding, finished at the bottom with a scalloped pattern. Gable and eaves are clipped. The porch is constructed of replacement brick with a built in planter extending partially across the front façade. The original fenestration has been replaced in the original openings and are flanked by rustic, vertical plank shutters which appear original. The building is clad in stucco. The replacement of the porch and the fenestration has had a significant effect on the integrity of this very simply designed house. While it retains its original form and some elements of detailing (particularly the gable end trim and shutters) it has lost integrity of design, materials, and to some degree workmanship. It appears not to contribute to a district eligible for the California Register.

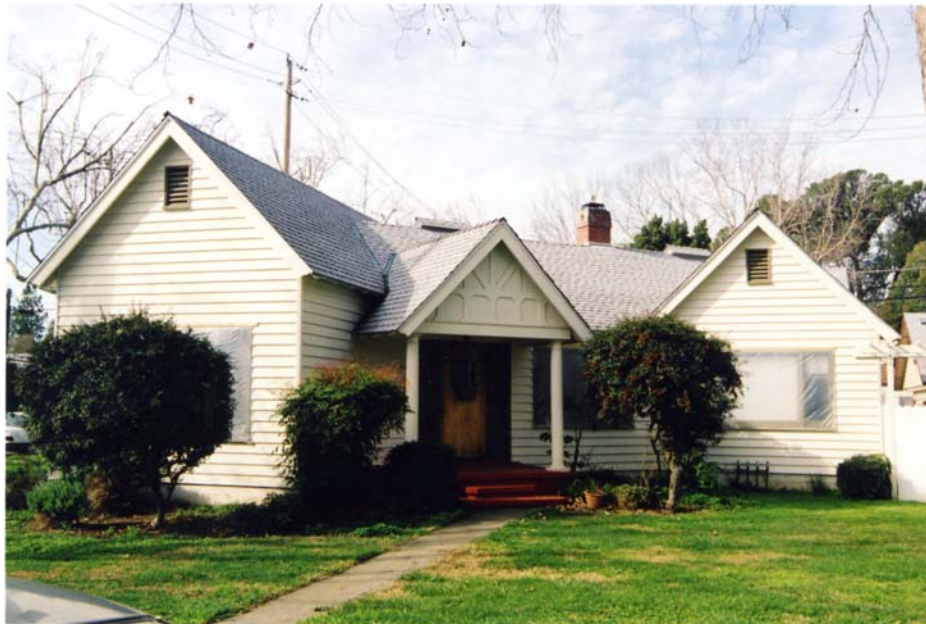
This unusual house is sited at an angle on its large corner lot. A central rectangular block connects two cross-gabled wings on either side. A prominent gable roofed porch is set at an angle to the intersection of the south gable wing and the central block of the house. The roof is moderately pitched, with slight gable overhangs finished with a fascia and a decorative attic vent. Eaves are also short, with exposed rafter tails. Front fenestration consists of cottage style windows, with a broad, central fixed panel and narrow sidelights. These cottage windows also occur on the north cross wings rear gable wall and on the eave wall of the south cross wing. Both of these "rear" facades are exposed to 5th Street where they are connected by a long screened-in, shed roof porch that backs on the central block. Other fenestration consists of paired casements. A brick chimney is located on the south cross wing eave wall. The house is eclectic in style. The projecting porch gable is finished with faux half-timbering frequent on Tudor Revivals, but the porch roof is supported on slim, cylindrical pillars which suggest a Colonial Revival influence. The house is clad with clapboard. Plastic weatherproffing material applied over all the windows distracts from the house's historic appearance, but is easily reversible. The house retains its integrity of design, materials, workmanship, setting, feeling and association. It appears to contribute to a district eligible for the California Register.

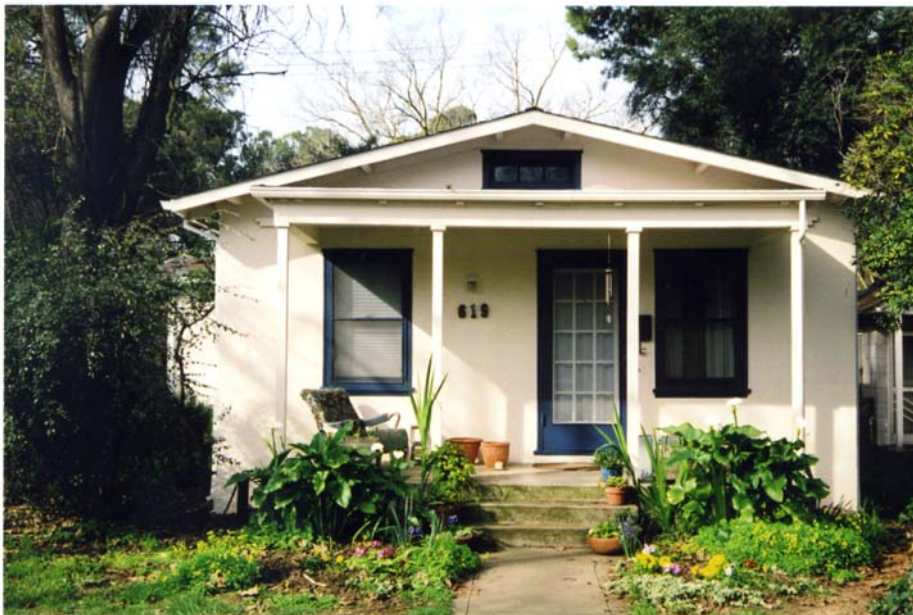
One of four "Pedder" bungalows on C Street, it was designed and constructed by AR Pedder, one of the developers of the Old North area. The house is a typical example of the style that is associated with him. Rectangular in plan, it has a very low, front facing gable roof. The roof has modest eave and gable overhangs, with the latter supported on extended purlins. The gable end is decorated with a horizontally emphasized, glazed attic vent. The raised porch is centered and extends across three-quarters of the front façade. It is covered by a shed roof, with the end supported on 4X4 posts. These are replacements of the original, probably battered, columns. The front door and windows are asymmetrical, unusual in this simple bungalow form. The door is partially glazed and the windows are one-over-one double-hung. The house is clad in stucco. Lofland dates the house to 1919 and believes that it was moved to its current location in the 1920s to make way for the Community Church at C and 4th. The Sanborn Maps show a structure of similar footprint at the corner of C and 4th in 1911 and 1921. If this is the same house, it actually was constructed c. 1910 and moved sometime after 1921. This move was well within the period of significance. Despite the alteration of the porch posts, the house retains its integrity of design, materials, workmanship, setting, feeling and association. It appears to contribute to a district eligible for the California Register.

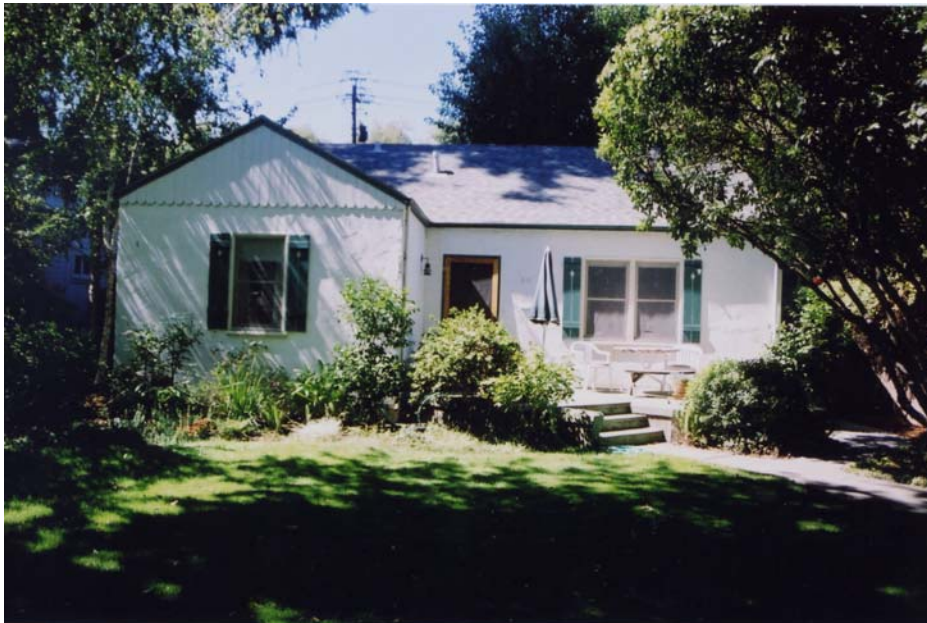
P5. Photograph or Drawing (Photograph required for buildings, structures, and objects.)

This minimal traditional house is L-shape in plan with a projecting wing on the south side of the main building block. The cross gable roof is moderately pitched with clipped eaves and gables. The front wing gable end is trimmed with vertical stickwork with scalloped edges. Windows are one-over one double hung. On the main block of the house they are paired, and on the front wing wall single. The windows are framed by rustic plank shutters with a decorative design. A cement porch and stair angle out from the doorway. Cladding is stucco. The house retains its integrity of design, workmanship, setting, location, feeling and association. It contributes to a district eligible for the California Register.
