CENTRAL DAVIS HISTORIC CONSERVATION DISTRICT

CITY OF DAVIS

HISTORICAL RESOURCES SURVEY

AUGUST 2003

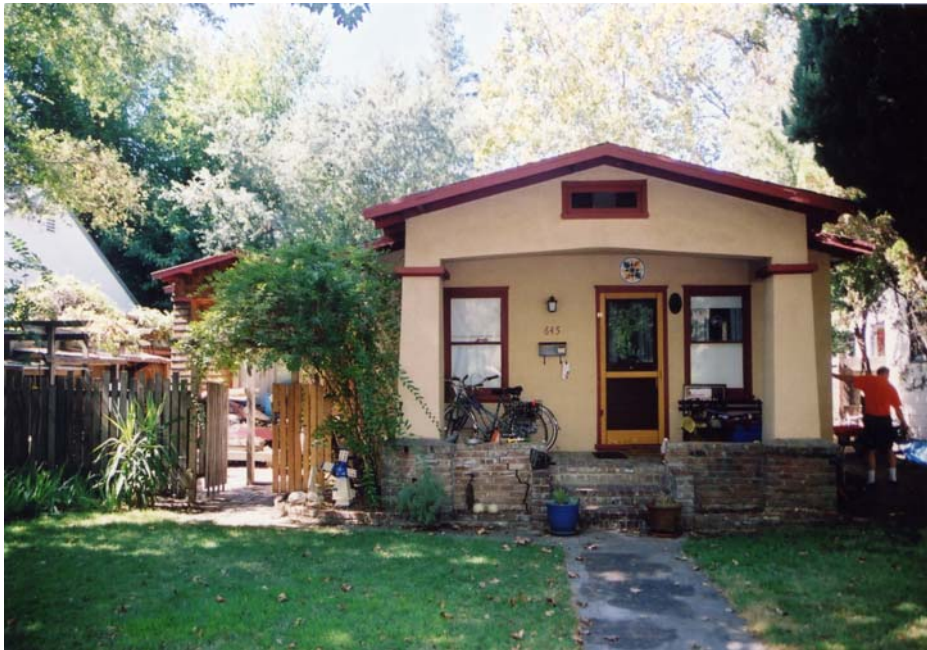
P5. Photograph or Drawing (Photograph required for buildings, structures, and objects.)

This is a Pedder Bungalow, one of several buildings constructed circa 1919 in the Bowers Subdivision by the project manager, AR Pedder. It is similar in design with the other examples of this building type. Rectangular in plan, it exhibits a low front gable roof with a front gable projecting porch. Gables and eaves are overhung with exposed rafter tails. A horizontal, glazed vent provides a decorative detail at the center of the porch gable. The porch roof is supported on wide battered columns. The slightly elevated brick porch is probably replacement in materials, although it follows the original design. The entry door is partially glazed and set off-center. Fenestration consists of one-over-one double hung windows. Cladding is stucco. An addition, rectangular in plan, with a low front gable roof and shingle cladding is located to the south of the original structure and is stepped well back from the façade. It is loosely connected to the house and is sympathetic in design, at the same time that it is distinguished as new construction. The house retains its integrity of design, workmanship, setting, location, feeling and association. It contributes to a district eligible for the California Register.

View west

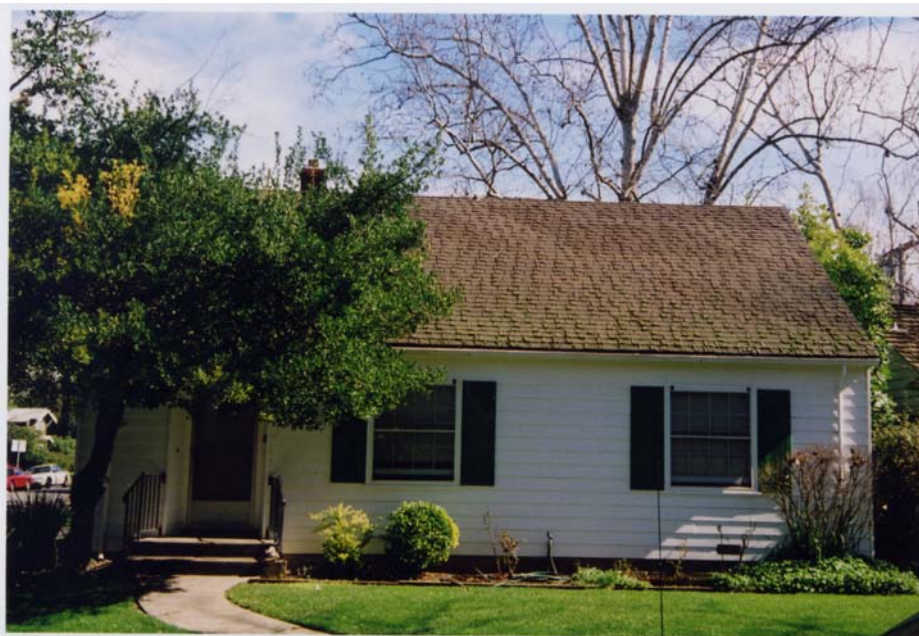
P5. Photograph or Drawing (Photograph required for buildings, structures, and objects.)

A rectangular plan building with a moderately pitched, wood shingle side gable roof, this 1938 house is very simple in design. In its form and massing it exhibits the characteristics of a minimalist traditional house, but the treatment of the windows and doors suggest Colonial Revival influences. The roof has closely cropped gables and eaves with a small, brick chimney piercing the roof ridge. Fenestration consists of one-over-one double hung windows with wood casings and sills. Rustic shutters flank the front windows. The entry is located on the north side of the front façade and is cut-in with a small cement stoop and stair. Cladding is clapboard. Although minimal in its design and decorative elements, the house is typical of the simplified small residences, of which there are several examples in Old North Davis, that bridged the period between the revival styles of the 1920s and early '30s and the full emergence of the California Ranch House. It appears to retain its integrity of design, materials, workmanship, setting, feeling and association. It appears to contribute to a district eligible for the California Register.

View east

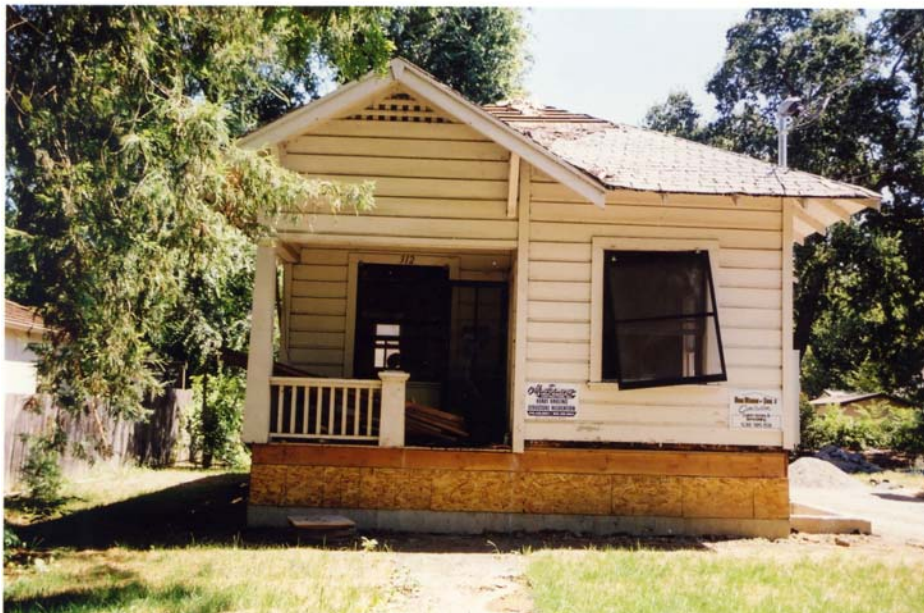
P5. Photograph or Drawing (Photograph required for buildings, structures, and objects.)

This hip roof, rectangular plan house with a cut-in porch on the north side According to local sources this house was originally on the historic school block (3rd, B and C Streets). Circa 1918-19 it was moved to 312 D Street because of the construction of a larger school in 1918. It was purchased in 1999 and moved to its present site, a vacant lot at 516 D Street. In its present condition the house consists of the exterior shell of the building which retains its original design, form and cladding. The house is important for its architectural style, early Craftsman Bungalow. Its siting, orientation and setting are consistent with its former location. If restored sympathetically it would contribute to an Old North Historic District.

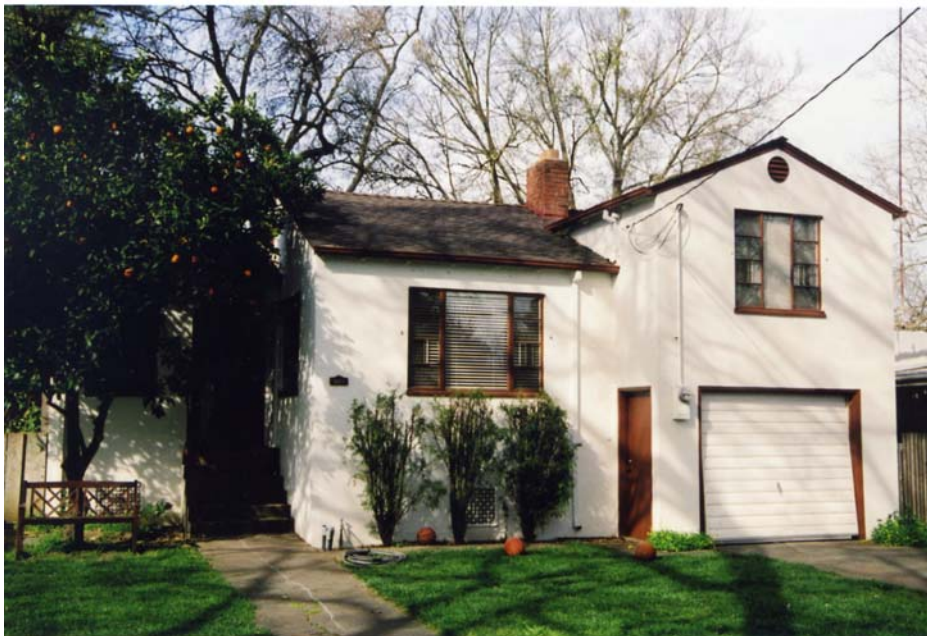
P5. Photograph or Drawing (Photograph required for buildings, structures, and objects.)

This complex plan house is a one and one-half-story, stucco clad building with a moderately pitched cross gable roof. A unique feature of the house is its attached garage, an example of early attempts to integrate the garage into the principal structure, and an indication of the growing prominence of the automobile in suburban life. The placement of the garage in the projecting north façade, with living space above, foreshadows later “snout-house” designs where the garage becomes a principal focus of the front façade. The original garage doors, probably wooden, have been replaced with an aluminum tilt-up. The original doors, by virtue of their placement, were a prominent decorative element and their removal diminishes the integrity of a visually important façade. The cross gable roof is shingle with closely cropped gable ends and eaves. Fenestration consists of metal casement windows with single light central panels and multi-light sidelights. The front façade steps back in three parts, creating three distinct bays with a cut in entry located between the center and south bay. The house is relatively unembellished by decorative detail and might be categorized as either highly simplified Mediterranean Revival or Minimal Traditional in style. Although the garage door replacement diminishes the integrity of design and materials to some degree, the house is otherwise unaltered and appears to retain sufficient integrity of design, materials, workmanship, setting, feeling and association to contribute to a district eligible for the California Register.

*P3b. Resource Attributes: HP2
*P4. Resources Present: Building
 Structure Object Site
District Element of District
P5b. Description of Photo:
View west
*P6. Date Constructed/Age:
1940 63 years old documented
 Prehistoric Historic
 Both
*P7. Owner and Address:

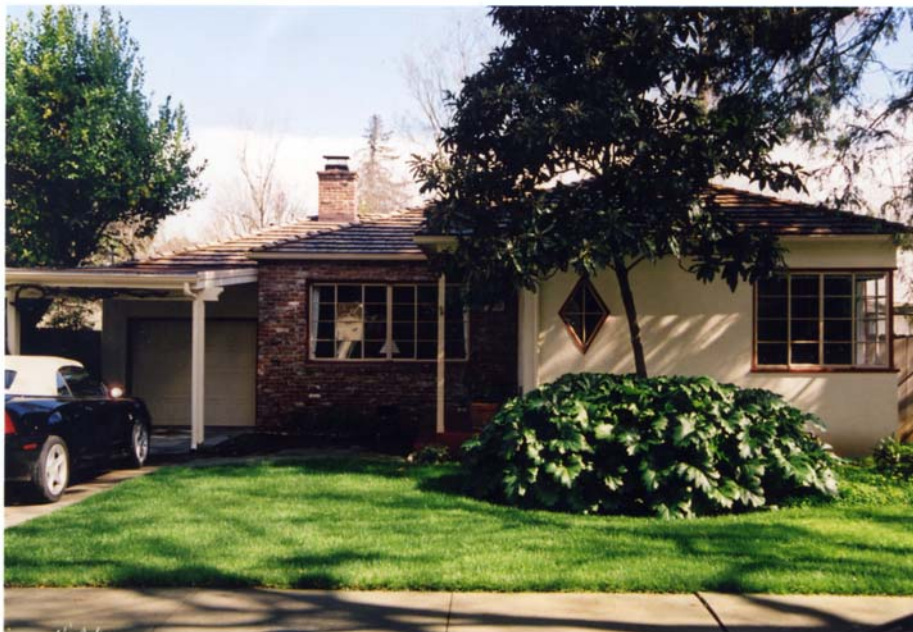
- P5. Photograph or Drawing (Photograph required for buildings, structures, and objects.)

A Minimalist Traditional house constructed in the early 40's, this residence is a single-story, cross hip roofed structure with an L-shape plan. Like its neighbor at 517 D Street, it is an example of early attempts to integrate the garage into the envelope of the house. Unlike its "snout-house" neighbor, the garage is stepped back from the façade on the north side of the house. Of wood frame construction, the house is predominantly clad with stucco, with one wall of the front façade faced with used brick. Fenestration consists of metal casement, multi-light windows. A wrap-around corner window, of the type that became popular in the early 1940s is found on the south corner of the front facade. A decorative, multi-light triangular window is placed to illuminate the entry vestibule. A porch runs along the north wall of the front façade. It consists of a low concrete stoop covered by an extension of the hip roof supported on one end by a 2X4 post. The entry is oriented toward the driveway, another indication of the growing importance of the car in domestic design. A rectangular, brick chimney pierces the ridge of the rear hip roof. A carport projects from the front of the garage and is a later addition. This nicely maintained home is a good example of its style type and retains its integrity of design, materials, workmanship, setting, feeling and association. It appears to contribute to a district eligible for the California Register.

- *P3b. Resource Attributes: HP2
*P4. Resources Present: Building
 Structure Object Site District
 Element of District
P5b. Description of Photo:
View east
*P6. Date Constructed/Age:
1941 62 years old documented
 Prehistoric Historic
 Both
*P7. Owner and Address:

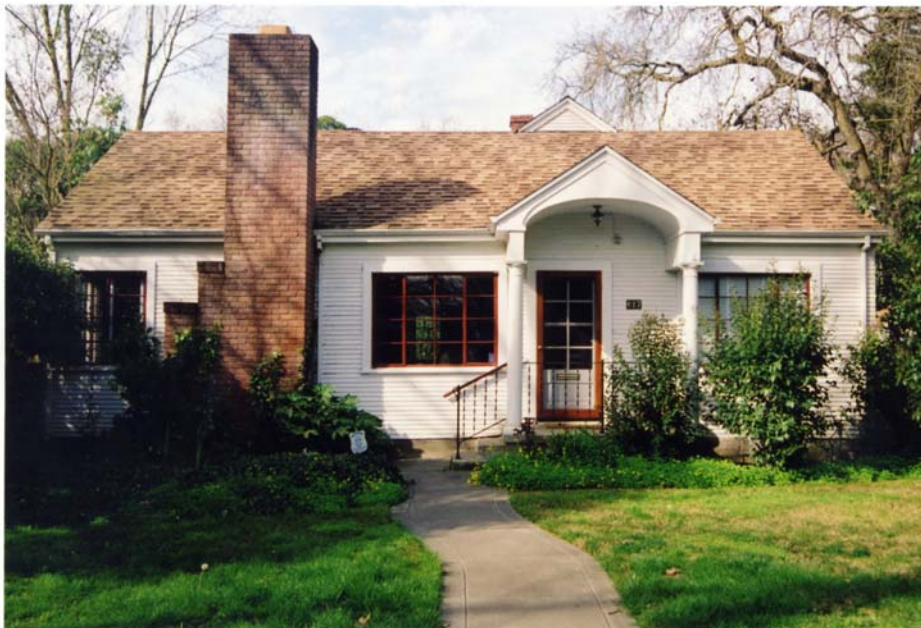
P5. Photograph or Drawing (Photograph required for buildings, structures, and objects.)

This residence is a rectangular plan, Colonial Revival style cottage with a moderately pitched, side gable, shingle roof. A small, asymmetrically placed gable dormer rises from the roof ridge. A tall, stepped brick chimney is located at the south side of the front façade. A projecting pediment, supported on cylindrical colonettes, covers the cement porch stoop on the north side of the façade. Small houses such as this often relied on one or two decorative elements to establish their character and style. In this case the porch is the principal colonial reference. The 1933 assessor's record shows a symmetrically arranged plan with a center porch. This suggests that the chimney and the space south of it may have been added at a later date, although the materials suggest that this addition was within the period of significance. The steps open to the side of the porch; an unusual feature in this style of cottage which was almost invariably oriented to the street. Whether a function of original design or a later addition, the chimney and entry appear to have been intended to balance each other, achieving a symmetry associated with this style of house. The eight-light entry door, a sympathetic replacement, is flanked by eight-light metal casement windows with four-light sidelights. The wooden casements are unembellished. The house is clad with novelty siding. Constructed in 1928, it appears to retain integrity of design, materials, workmanship, setting, feeling and association. It contributes to a proposed Old North District that is eligible for listing on the California Register.

*P3b. Resource Attributes: HP2
*P4. Resources Present: Building
 Structure Object Site District Element of District
*P5b. Description of Photo:
View west
*P6. Date Constructed/Age:
1928 75 years old documented
 Prehistoric Historic
 Both
*P7. Owner and Address:

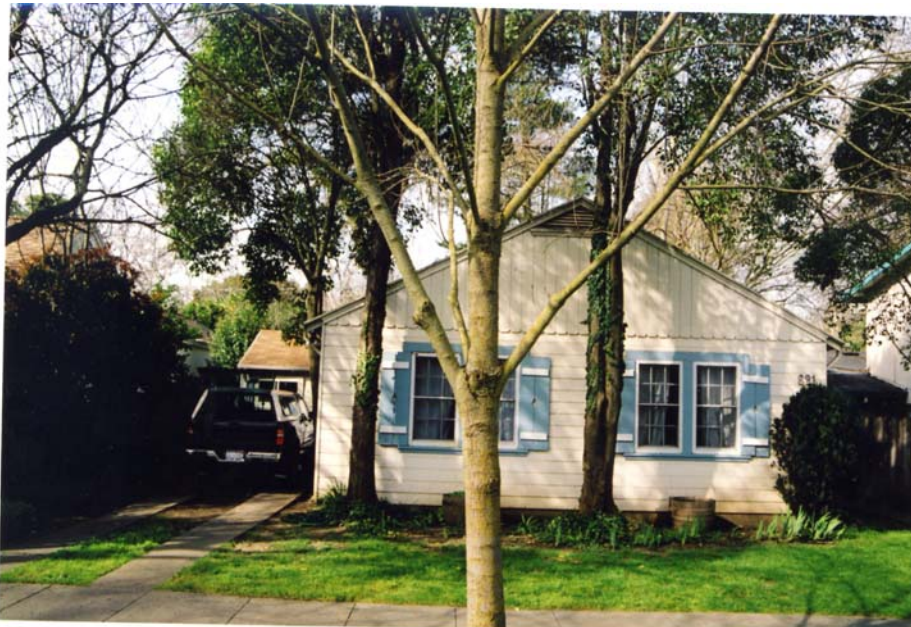
P5. Photograph or Drawing (Photograph required for buildings, structures, and objects.)

This house, constructed in 1938 is a simple, rectangular plan, wood frame building. It appears to be transitional in style between a Colonial Revival and what architectural historian, Lee McAlester, calls "Minimal Traditional." Sited with its entry toward the driveway on the south side of the lot, the front (street-facing) façade presents a gable wall with two symmetrically arranged sets of paired six-over-six light windows with decorative plank shutters of a vaguely rustic design. The orientation of this house results from its origin as a part of the "Irwin Court," a complex of small residences that opened onto a central open space. Demolition and new construction have obscured the original setting and association with the "court." The moderately sloped, side gable roof has clipped eaves and a vertical stickwork finish in the gable end. The house is clad with clapboard siding. From earlier pictures it appears that the original entry was on the north side of the house, while the current entry is cut into the south wall. The house retains its integrity of materials and workmanship, but its integrity of design has been somewhat compromised by the shift in the main entry. However, despite these changes, it appears to contribute to a proposed Old North Davis Historic District eligible for listing on the California Register.

View west

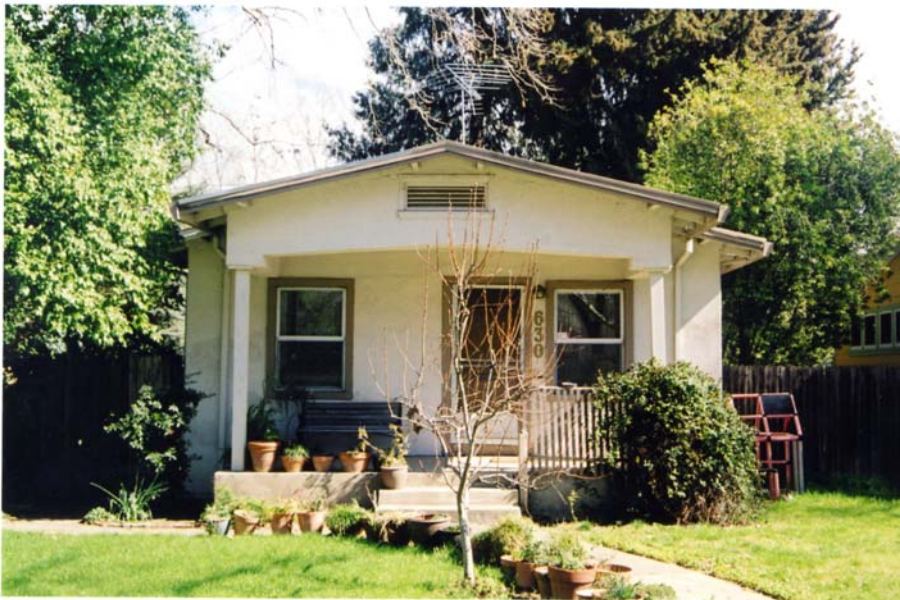
P5. Photograph or Drawing (Photograph required for buildings, structures, and objects.)

This small residence, constructed in 1919, is one of eight small bungalows of this design attributed to AR Pedder, one of the developers of the subdivision that is now known as Old North Davis. It is rectangular in design with a front facing gable roof. A projecting three-quarter length gable roofed porch is centered on the façade. The moderate gable and eave overhangs exhibit exposed purlins and rafter tails respectively. The porch roof is supported on 4X4s, which, judging from other examples of this house type, are replacements for earlier, battered columns. A partial, open rail and baluster are also additions. The entry door is located slightly off-center and is asymmetrically flanked by double hung windows. It is clad in stucco. In form the house is reminiscent of vernacular "shotgun" houses, and in its diminutive scale might be termed a "workingman's bungalow," or what Alan Gowan in the *Comfortable Home* has called a "starter" bungalow. Although the porch is not entirely intact, the house appears to retain its integrity of workmanship, material, setting and association. It contributes to a proposed Old North Davis Historic District eligible for listing on the California Register.

View East

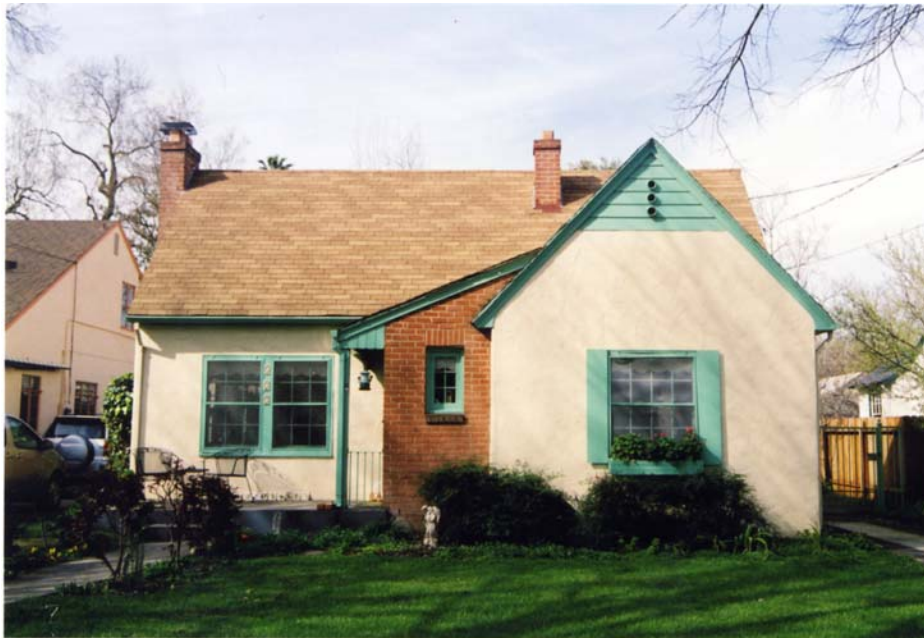
P5. Photograph or Drawing (Photograph required for buildings, structures, and objects.)

This is a simple, English Cottage Revival house which conveys its style through a few carefully crafted details including the roof pitch, gable treatment, and, most significantly, the design of the entry vestibule. The house is L-shape in plan with a cross gable roof. A gabled, front projecting wing occupies the north side of the building. The roof is steeply pitched with clipped gables and eaves. The front projecting gable end is trimmed with horizontal stickwork and terra cotta pipe attic vents. A cement slab porch runs along the north/south front wall and may be a replacement. The front door is oriented to the south (side of the house) and enters into a brick vestibule with a sloped shed roof. This brick entry vestibule is a variation on a commonly used design detail in cottage revival houses intended to suggest old world charm. A brick chimney is located against the south façade and pierces the side gable at the ridge. Fenestration consists of cottage style six-over-six double hung windows arranged singly and in pairs. The house retains its integrity of design, materials, workmanship, setting, location, feeling and association. It appears to be unaltered and it contributes to a district eligible for the California Register.

View west

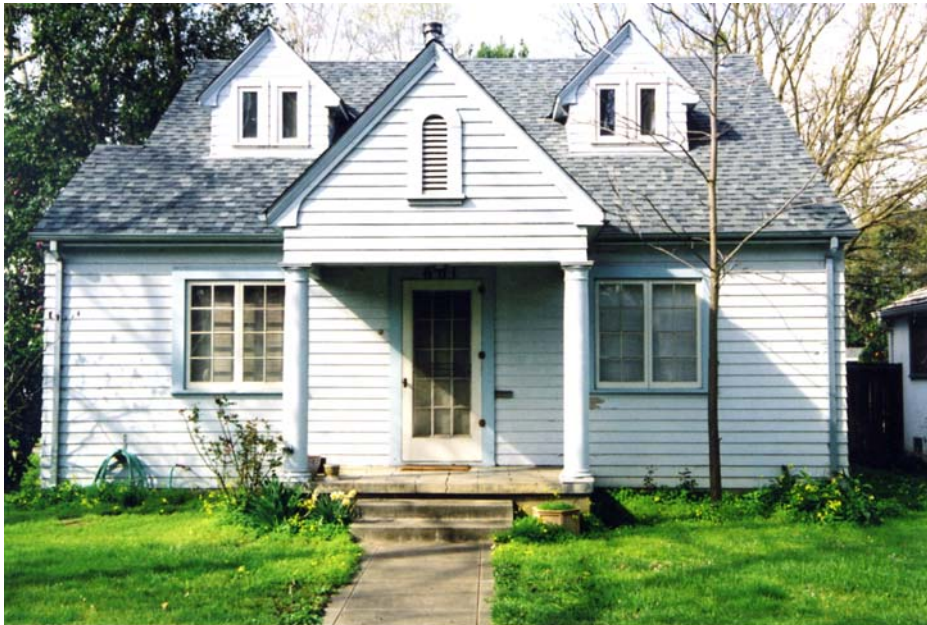
- P5. Photograph or Drawing (Photograph required for buildings, structures, and objects.)

This Colonial Revival house was constructed in 1930. It is rectangular in plan with a steeply pitched side gable roof covered in composition shingle. Two symmetrically arranged dormers project from the front roof slope. These have steep gables and paired, vertically emphasized windows. Multi-light paired casement windows flank the centrally located, multi-light entry door. A centered, raised cement porch is covered by a portico supported on Tuscan columns. The porch gable roof has a return which is located above the gable end. Although the house retains its original form and style, it appears to have been modified to accommodate a second story addition. The 1933 assessment record indicates that the house was originally one story. The dormers appear to have been added to allow light into the upper story. The portico is oddly proportioned and appears to have been extended at the lower edge in an attempt to adjust its proportions to accord with the raised roof. Like most of the Colonial Revivals in this area the house is clad with clapboard. The house retains its integrity of, setting, location, and feeling. Clearly recognizable as a period revival, the addition of dormers and the alterations to the porch compromise the integrity of the original design and workmanship. While the house contributes to the character of the neighborhood, it has been too extensively altered to contribute to a district eligible for the California Register.

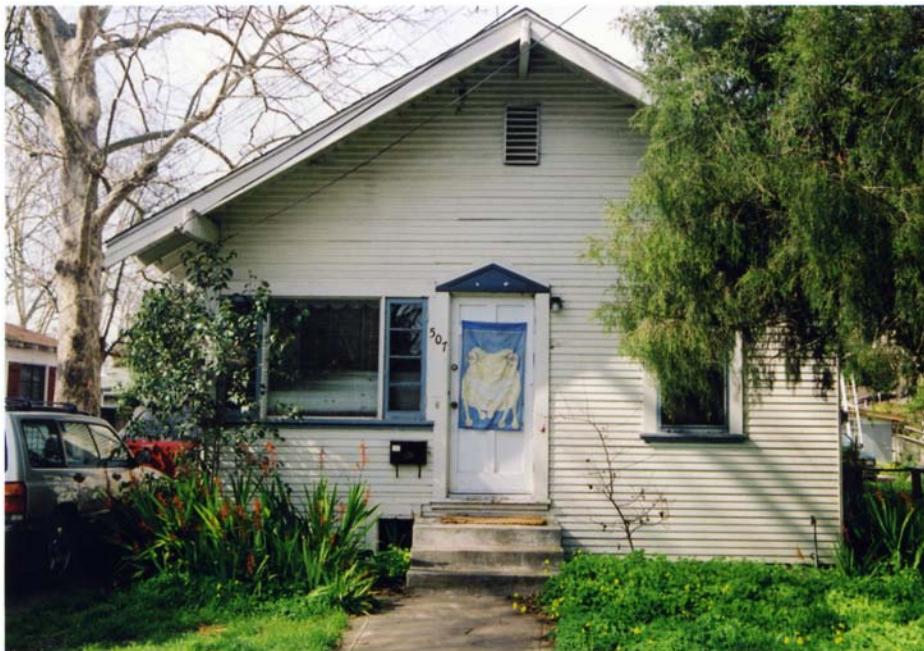
P5. Photograph or Drawing (Photograph required for buildings, structures, and objects.)

This rectangular plan bungalow is surmounted by a moderately pitched front gable roof. The gable overhang is supported by projecting purlins and is trimmed with a plain fascia. There is a small decorative attic vent just below the gable ridge. The exposed rafter tails emphasize the wide eave overhang. The planar front façade of the house appears to result from later alteration which enclosed the original porch, leaving the house with an uncharacteristic cement stoop porch. The entry door and the south window of the front façade are replacement. Other fenestration consists of double hung windows. The building is clad with a narrow novelty siding. Although the craftsman/bungalow origin of the house is still evident in its form, massing and roof treatment, the enclosure of the porch has deprived the building of some of its essential character defining features. The house does not retain its integrity of design, materials, and workmanship and it does not appear to contribute to a district eligible for the California Register.

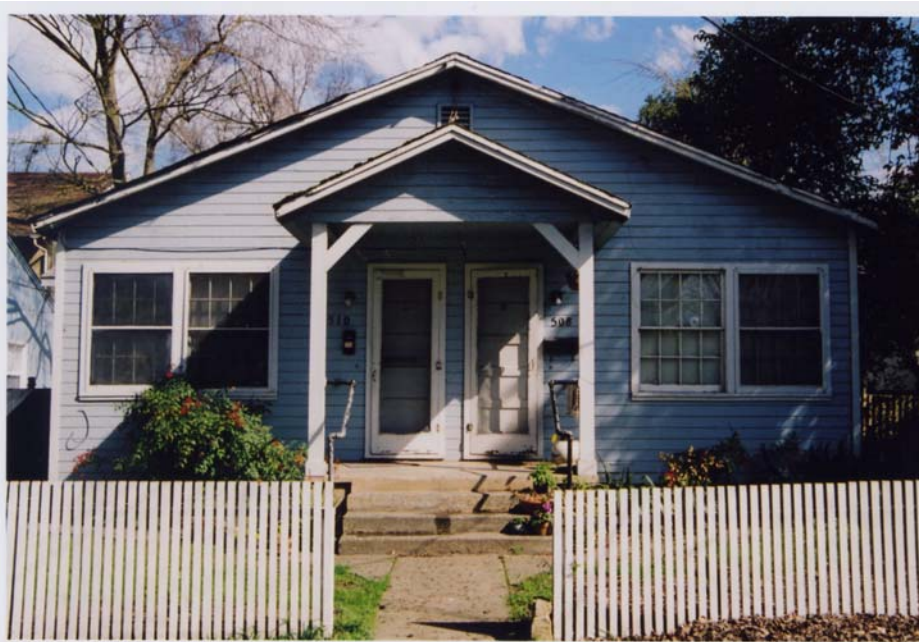
P5. Photograph or Drawing (Photograph required for buildings, structures, and objects.)

According to John Lofland (*Old North Davis*, Yolo County Historical Society, 1999), this double bungalow was originally a single family dwelling constructed in 1929 and converted in 1940. It is rectangular in plan with a moderately pitched front gable roof. Gable and eave overhangs are minimal with clipped ends. This uncharacteristic bungalow treatment may be the result of the later alteration. The gable end is trimmed with a narrow fascia, as is the gable end of the porch roof. A central, gable roofed projecting porch is centered on the façade, framing the side-by-side duplex entry doors. The porch roof is supported on braced 2X4s. The porch appears to be a replacement, possibly added in 1940. It is not possible to discern the configuration of the original porch or if it has been enclosed to create the flat façade that the building presents to the street. Fenestration consists of eight-over-eight double hung windows. The pairing of these windows lends a strong horizontal emphasis to the front façade. The window sash and glazing are original, but it is unclear if their position was changed to accommodate the conversion in occupancy. The conversion of the house and the accompanying alterations to the porch, entry doors, and possibly the front façade, fall within the period of significance. Therefore, the house retains the integrity of the 1940 building. It appears to be unaltered and it contributes to a district eligible for the California Register.

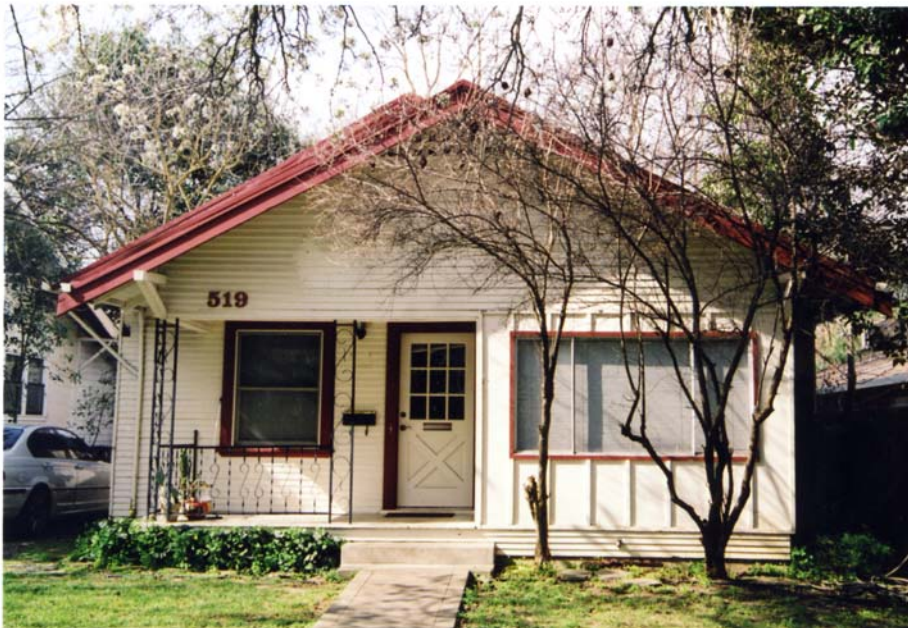
P5. Photograph or Drawing (Photograph required for buildings, structures, and objects.)

This bungalow exhibits double front-facing gables. The projecting front gable is unusually wide and originally covered a full length porch. Overhangs are moderate and are supported in the front and on the sides by knee brace brackets. Exposed rafter tails provide decorative detail on the eaves. Fenestration consists of one-over-one double hung windows, except on the north side of the front façade. The original porch has been enclosed and a large, metal frame window has been inserted. The south half of the porch remains open, but the original porch columns and rail have been replaced with modern wrought iron posts and rail. The enclosed portion of the porch is clad with board and batten, while the rest of the structure, including the gable end, is covered with narrow, novelty siding. The entry door has been replaced with a partially glazed and paneled door of a style typical in 1950s Ranchers. Although the house retains its original massing, form and roof line, the enclosure of the porch, alteration of the front window and removal of porch supports and ornament has substantially affected the integrity of design, materials, and workmanship. The house does not contribute to a district eligible for the California Register.

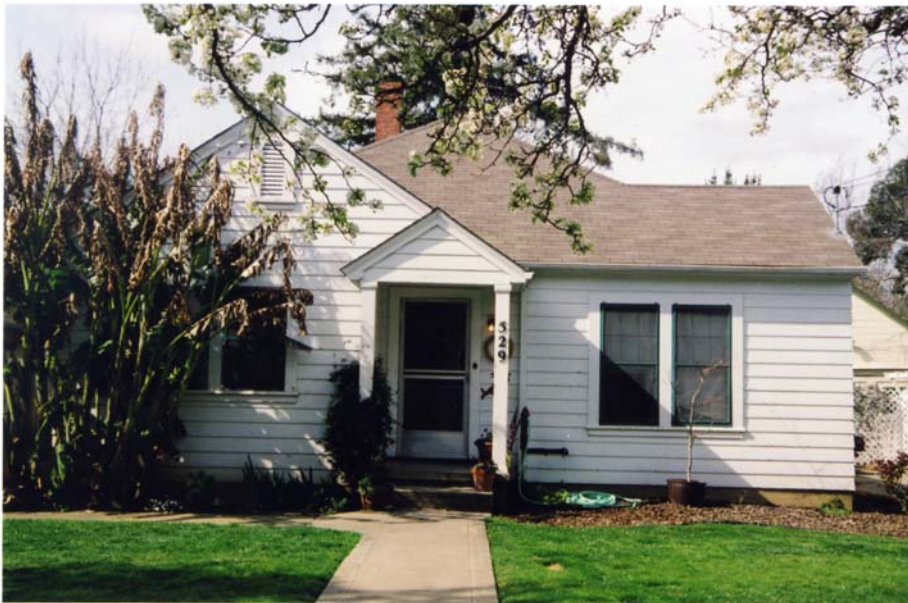
P5. Photograph or Drawing (Photograph required for buildings, structures, and objects.)

This L-plan cottage has a hip on gable principal roof, with a front projecting cross gable on the south side. This multiplicity of roof heights and intersections provides visual interest to the otherwise simple house. Unfortunately the varied roof line is played down by the untextured composition shingle replacement covering. Gables and eaves are clipped. The front projecting gable is finished with a half circle vent and a molded fascia; this latter also found on the projecting porch gable. Both fascia feature returns. This treatment suggests a Colonial Revival influence in a house that otherwise models the form and footprint of the Minimalist Traditional houses popular at the time of its construction. Windows are double hung, multi-light cottage types of varying sizes. Those on the front façade are strongly vertically emphasized and are arranged in pairs. The entry is set back into the L formed by the intersection of the south wing and the principal block of the house. This recession is emphasized by the addition of a slightly projecting porch gable, supported on wooden posts. Cladding is clapboard which also contributes to the Colonial feeling of the house. The integrity of design, materials, workmanship, setting, location, feeling and association are retained. The house contributes to a district eligible for the California Register.

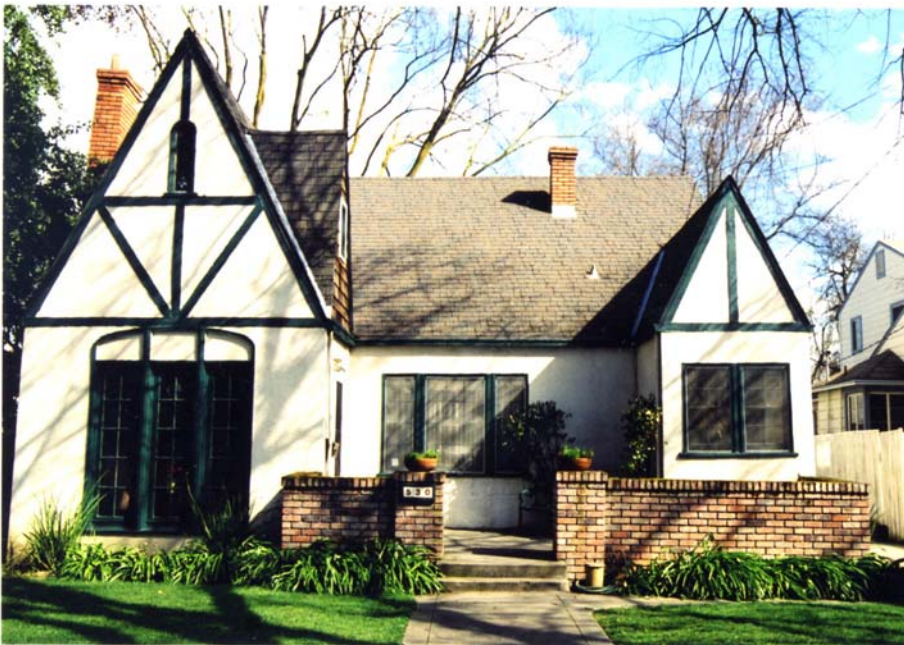
P5. Photograph or Drawing (Photograph required for buildings, structures, and objects.)

This charming Tudor Revival Cottage was constructed in 1925. It is an excellent example of its style type. The house is roughly U-shape in plan, with two cross wings projecting toward the street. The wings are of similar design, but differing size, a factor that enhances the rustic, vernacular quality of the building. The multiple cross gable roof is steeply pitched. The front facing gable ends are trimmed with faux half timbering in a diamond pattern. The wing on the north side is the larger of the two and has a gabled side dormer which is finished with shingles. Gable ends and eaves are clipped. Fenestration is mixed. The north gable wall window consists of three tall, fixed, multi-light panels which are trimmed at the top with an elliptical wooden frame in-filled with stucco. A horizontally emphasized window is found on the center wall, between the two wings. This is a fixed center panel with narrow, multi-light sidelights. The smaller south projecting wing has paired, double hung cottage windows. Other fenestration consists primarily of double cottage windows. A concrete porch fills the area between the projecting wings and extends along the front south wing wall. The porch is enclosed by a low brick wall which is capped with a header row. The house has both an exterior brick chimney, located on the north façade, and an internal brick chimney which pierces the front slope of the principal roof. The house is clad with stucco. It retains its integrity of materials, workmanship, setting, location, feeling and association and contributes to a district eligible for the California Register.

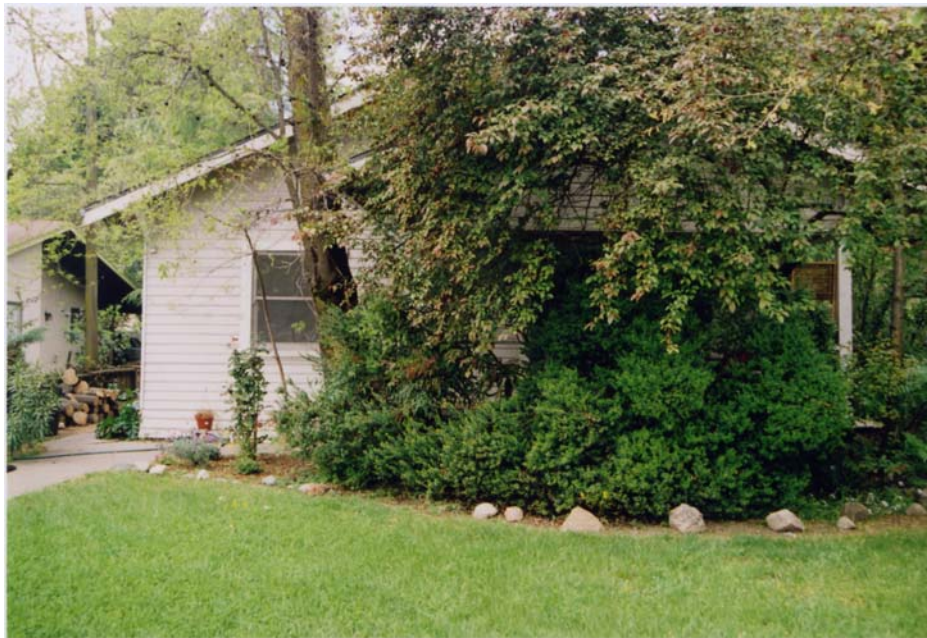
This is an good example of a side gable Craftsman Bungalow with a low, shed dormer. One and one-half story, the house has a low pitched roof with wide overhangs. Rafter tails are exposed. The porch is cut in on the north side of the façade and covered by the principal roof. The corner of the porch roof is supported on paired wooden posts, resting on a solid rail. The entry is oriented to the north, opening from the side wall of the porch. Fenestration largely consists of double hung windows, but the front window is a replacement with solid glazing which has been inserted into the original window opening. Casing and sill are original. Cladding is clapboard. The house retains its integrity of design, workmanship, setting, location, feeling and association. It contributes to a district eligible for the California Register.

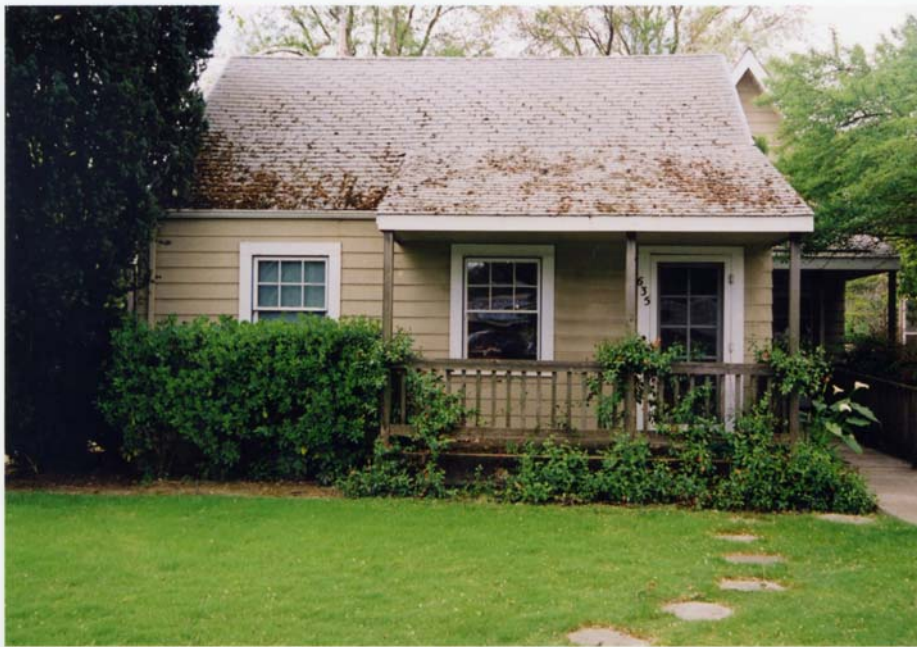
View west

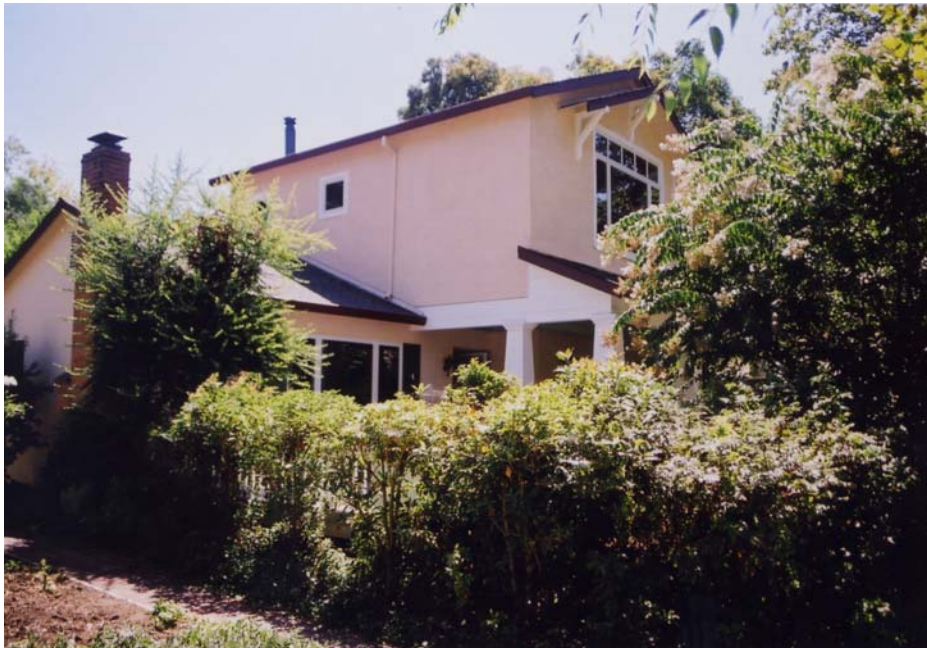
*P3b. **Resource Attributes:** HP2
*P4. **Resources Present:** Building Structure Object Site District Element of District
*P5b. **Description of Photo:**
View southeast *t
P6. Date Constructed/Age:
Remodel 2003
 Prehistoric Historic
 Both
*P7. **Owner and Address:**

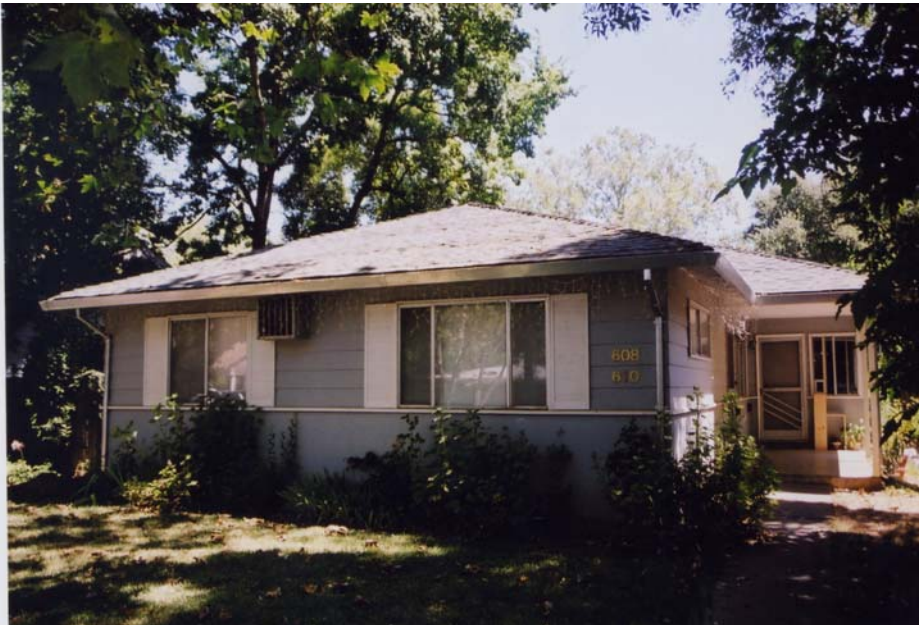
- *P3b. Resource Attributes: HP2
*P4. Resources Present: Building Structure Object Site District Element of District
*P5b. Description of Photo:
View east *t
*P6. Date Constructed/Age:
Post 1953
 Prehistoric Historic
 Both
*P7. Owner and Address:

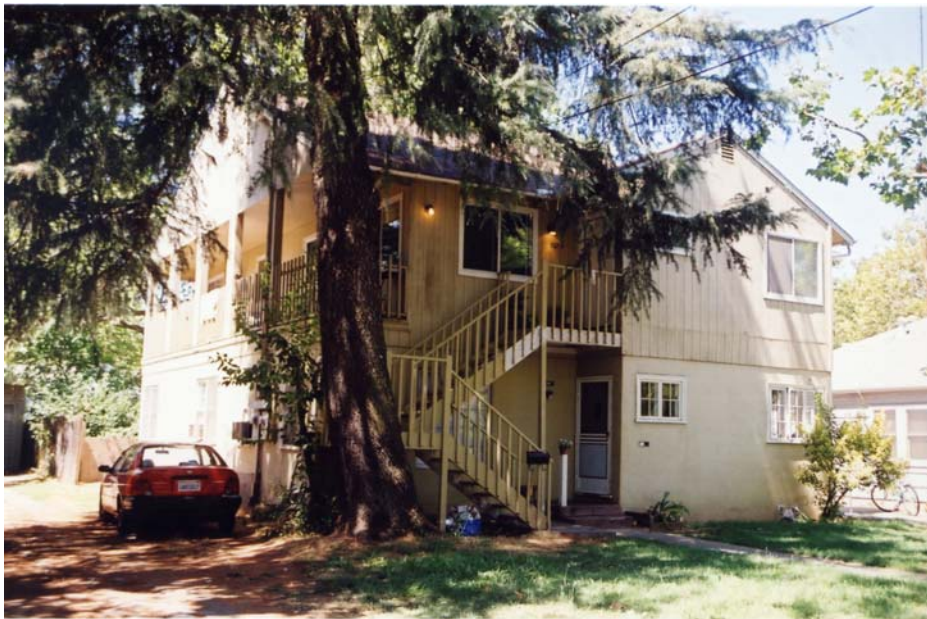
- *P3b. Resource Attributes: HP2
*P4. Resources Present: Building Structure Object Site District Element of District
P5b. Description of Photo:
View west
P6. Date Constructed/Age:
Remodeled 1980
 Prehistoric Historic
 Both
*P7. Owner and Address:

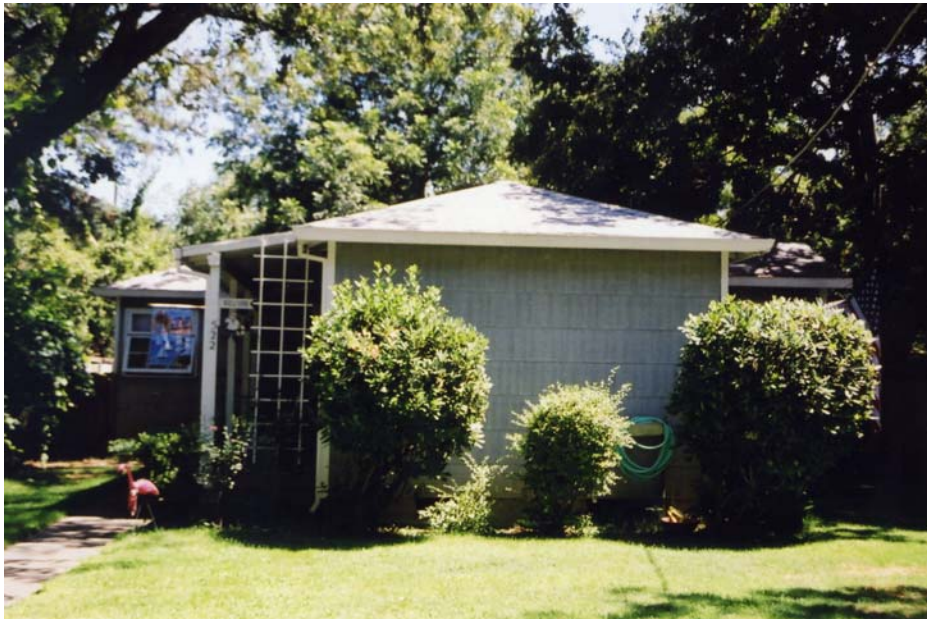
- *P3b. Resource Attributes: HP2
*P4. Resources Present: Building Structure Object Site District Element of District
*P5b. Description of Photo:
View east *†
*P6. Date Constructed/Age:
Post 1953
 Prehistoric Historic
 Both
*P7. Owner and Address:

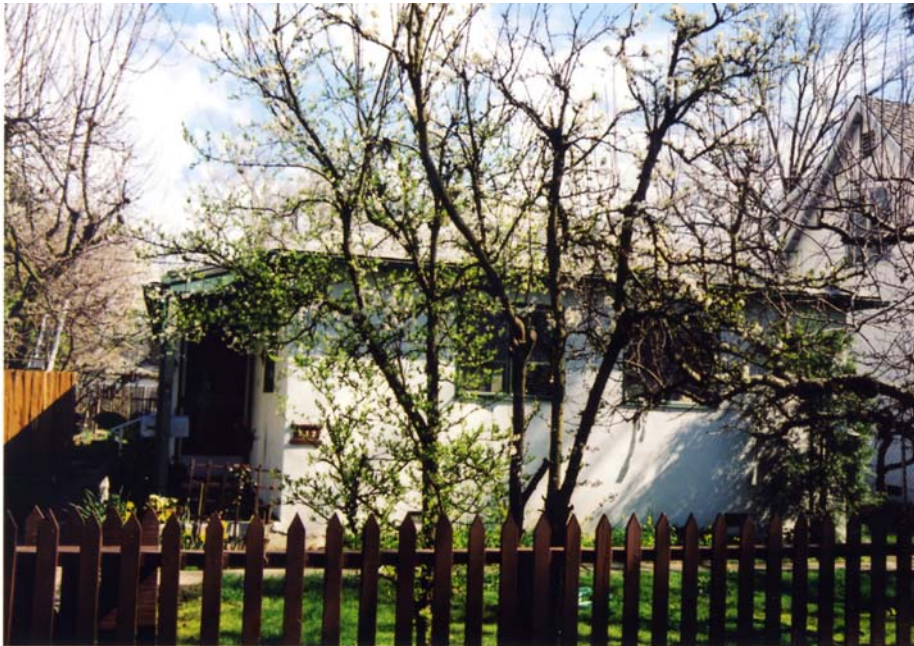
- *P3b. Resource Attributes: HP2
*P4. Resources Present: Building Structure Object Site District Element of District
P5b. Description of Photo:
View east *†
P6. Date Constructed/Age:
Post 1953
 Prehistoric Historic
 Both
*P7. Owner and Address:

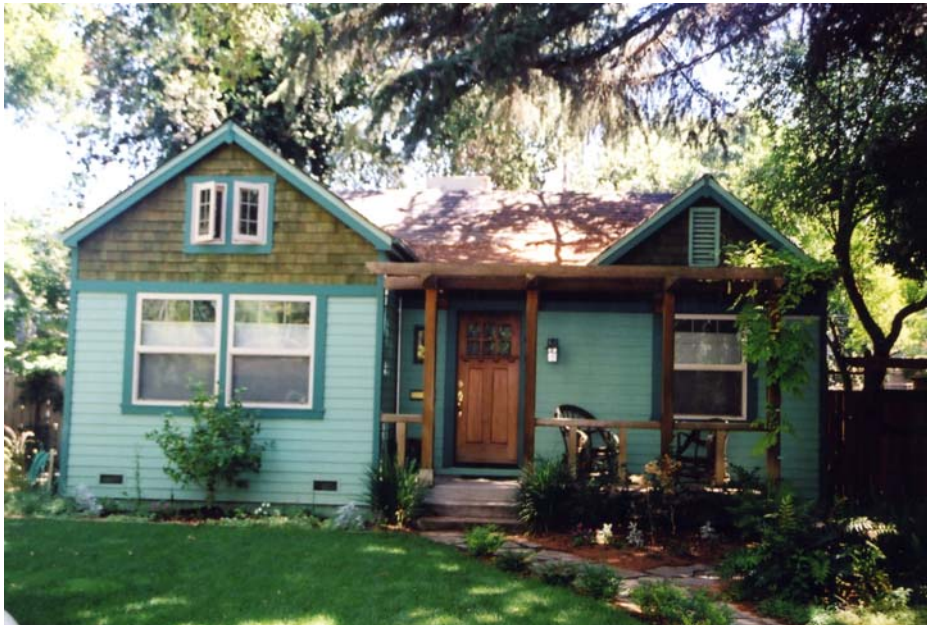
This building has been substantially remodeled and no longer retains its architectural character or integrity. This was originally an early vernacular house that was located on the block where Central Park is now. It was moved to its present location in the 1930s and remodeled in 1936. It has been remodeled recently with the addition of gables, replacement of siding, replacement doors and windows and the addition of a pergola style porch. The house does not contribute to the historic character of Old North Davis or to a historic district eligible for listing on the California Register.

- *P3b. Resource Attributes: HP2
*P4. Resources Present: Building Structure Object Site District Element of District
*P5b. Description of Photo:
View east *
P6. Date Constructed/Age:
1910s/1936/ Remodeled 1990s
 Prehistoric Historic
 Both

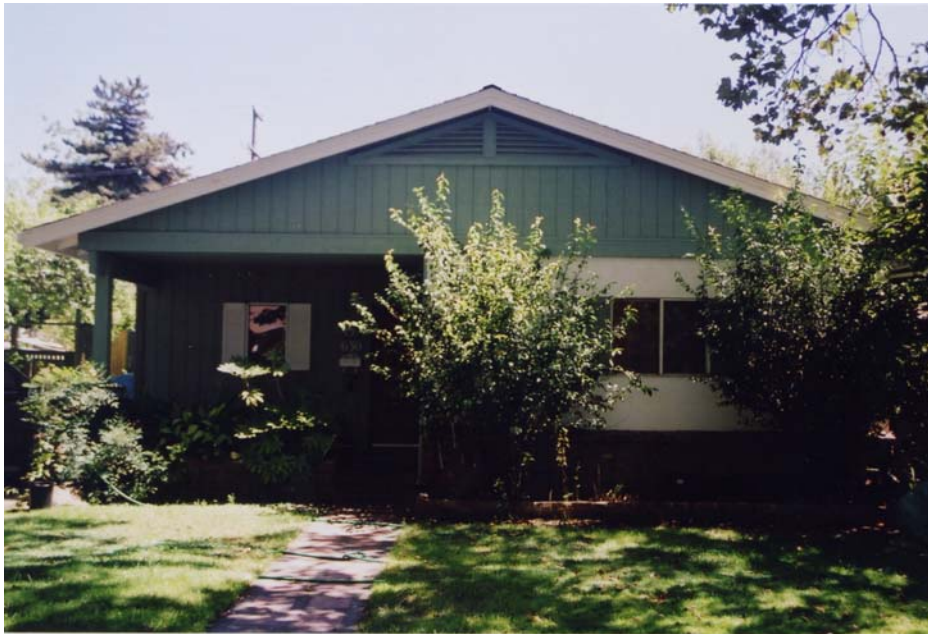
*P3a. **Description:**
This building has been constructed recently and replaces a small bungalow similar in design to the neighboring 650 and 642 E Street. It does not contribute to the historic character of Old North Davis or to a historic district eligible for listing on the California Register.

*P3b. **Resource Attributes:** HP2
*P4. **Resources Present:** Building Structure Object Site District Element of District
P5b. Description of Photo:
View east **
P6. Date Constructed/Age:
Remodel
 Prehistoric Historic
 Both
*P7. **Owner and Address:**

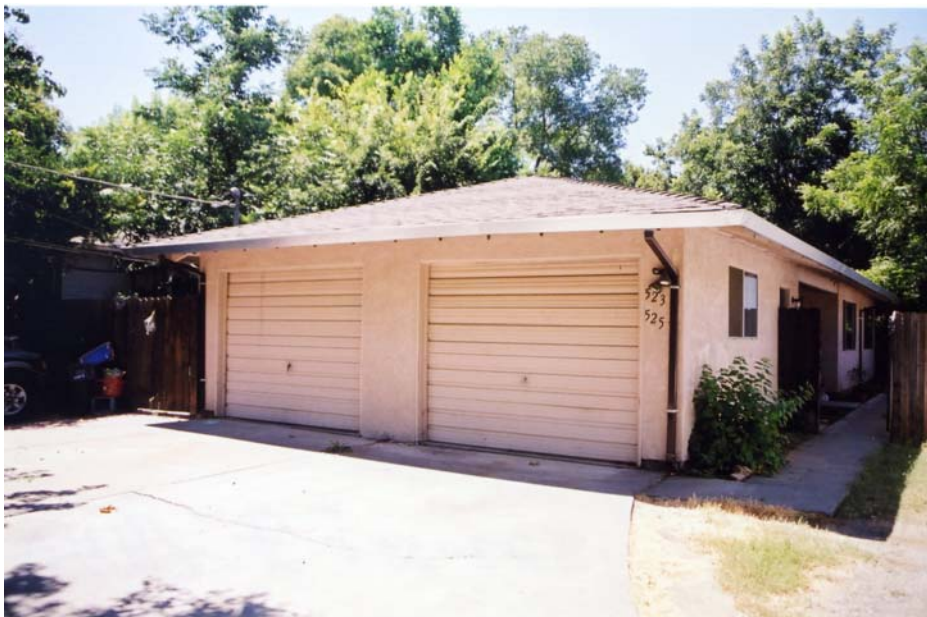
*P3b. Resource Attributes: HP2
*P4. Resources Present: Building Structure Object Site District Element of District
*P5b. Description of Photo:
View North west *t
*P6. Date Constructed/Age:
Post 1953
 Prehistoric Historic
 Both
*P7. Owner and Address:

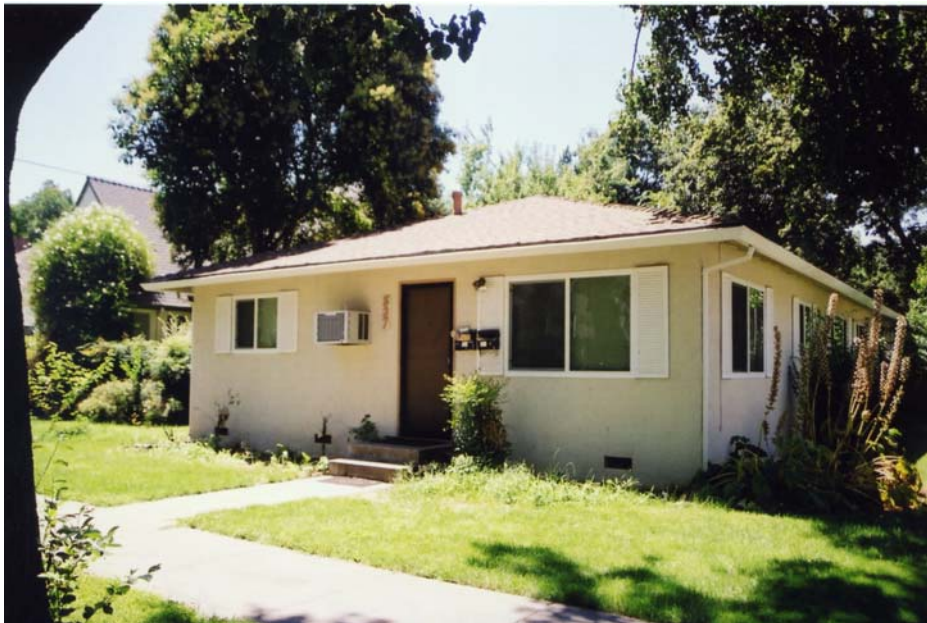
*P3b. Resource Attributes: HP2
*P4. Resources Present: Building Structure Object Site District Element of District
P5b. Description of Photo:
View west *
P6. Date Constructed/Age:
Post 1953
 Prehistoric Historic
 Both
*P7. Owner and Address:
