CENTRAL DAVIS HISTORIC CONSERVATION DISTRICT

CITY OF DAVIS

HISTORICAL RESOURCES SURVEY

AUGUST 2003

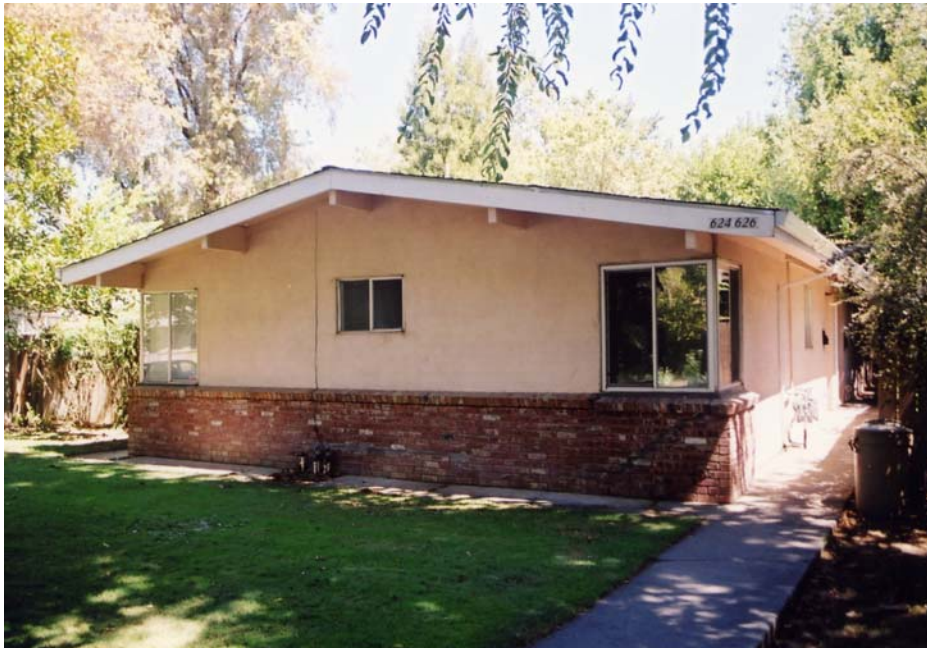
*P3b. Resource Attributes: HP2
*P4. Resources Present: Building Structure Object Site District Element of District
*P5b. Description of Photo:
View west *t
*P6. Date Constructed/Age:
Post 1953
 Prehistoric Historic
 Both
*P7. Owner and Address:

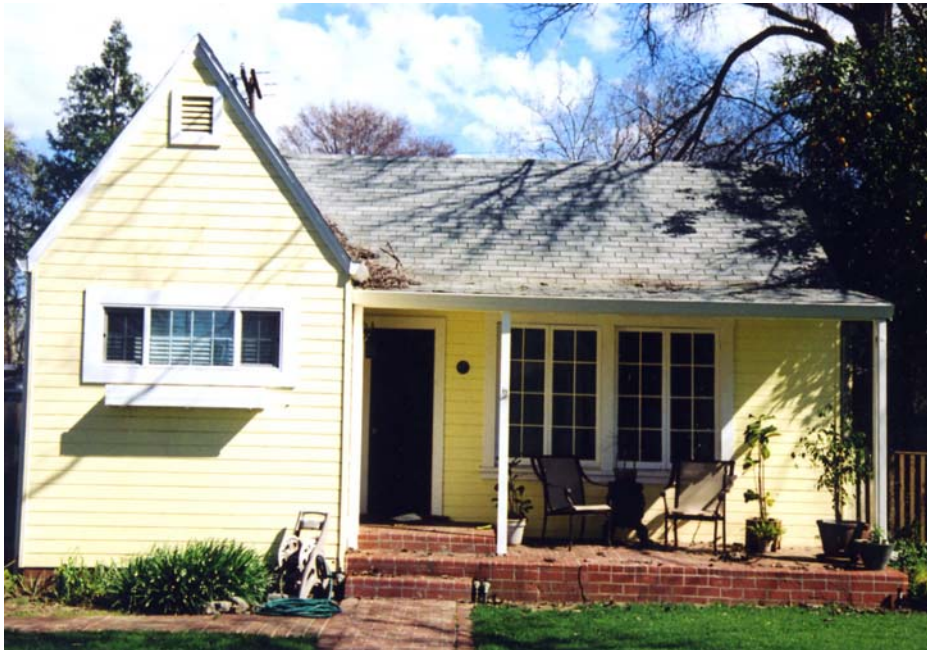
- *P3b. Resource Attributes: HP2
*P4. Resources Present: Building Structure Object Site District Element of District
*P5b. Description of Photo:
View North west *t
*P6. Date Constructed/Age:
Post 1953
 Prehistoric Historic
 Both
*P7. Owner and Address:

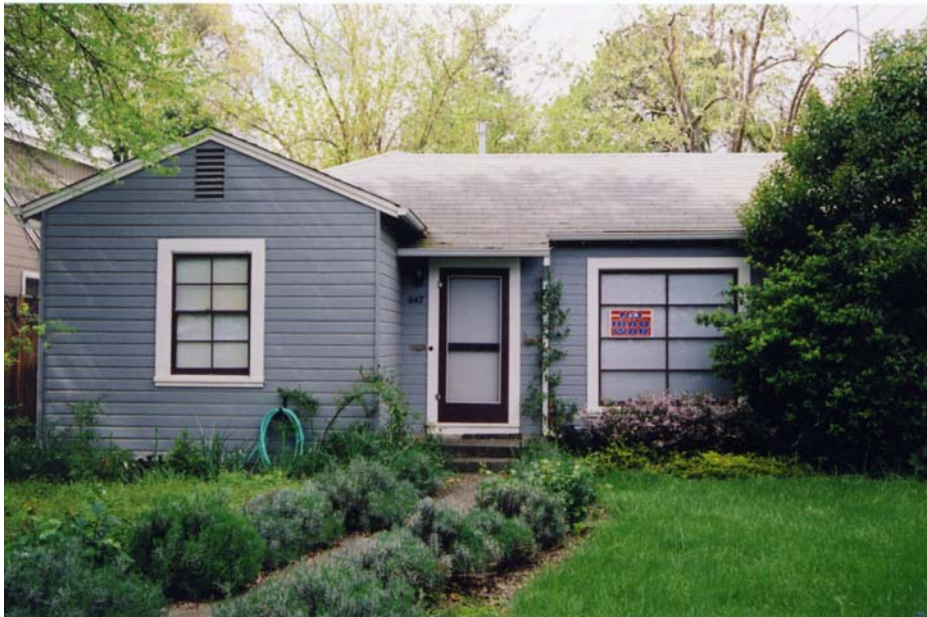
P5. Photograph or Drawing (Photograph required for buildings, structures, and objects.)

This simple L-plan house is an example of the Minimal Traditional style frequently constructed in the late 1930s and 1940s. Unfortunately the original windows have been replaced on the north side of the front façade using a large contemporary, multi-light window inconsistent with the style and architectural character of the house. The window is so large and noticeable that it seriously affects the integrity of design, materials and workmanship of the house. Although the house retains its setting and location, it does not contribute to a district eligible for the California Register.

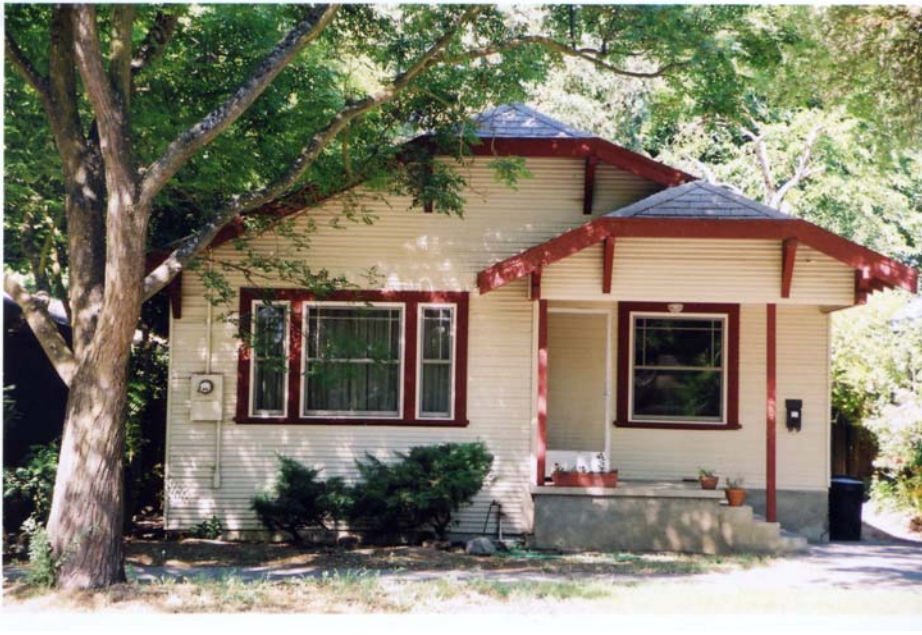
427 K Street Photo

From the Reports for both houses:
"Description: This rectangular plan bungalow is surmounted by a jerkinhead roof with a front facing gable. The principal roof is supported on knee brace brackets and is low pitched. A cut-in porch on the north side of the front façade is covered by a projecting jerkinhead which mirrors the design of the principal roof. The porch gable is supported on 4X4 posts that may be replacements. These extend full length from floor to roof. The porch is enclosed with a closed rail clad in the same material as the house. Fenestration consists of double hung windows with wood casement and sash. The window on the front façade has a large central panel with a decorative upper glazing

pattern and narrow, double hung, four-over-one side lights. The house is clad with a composition shingle that replaces the original siding. A small, original, single car garage is found on the north side of the house at the rear of the lot. Although the siding replacement results in a loss of integrity of materials, the other aspects of integrity are intact and the house clearly conveys its bungalow style. It contributes to the character of the neighborhood." The date is given as circa 1920.

The description above applies to **429 K**, since **427 K** retains its narrow novelty siding, but has suffered a fairly drastic alteration of its porch, with replacement by a concrete stoop (probably due to deterioration of the original wood porch) that doesn't fit well with the original roof configuration (note the strange porch post placement). Also, the **427 K** front window panes have been replaced with new double hung sashes, changing the pattern of the small panes evident in the original **429 K** configuration (above)

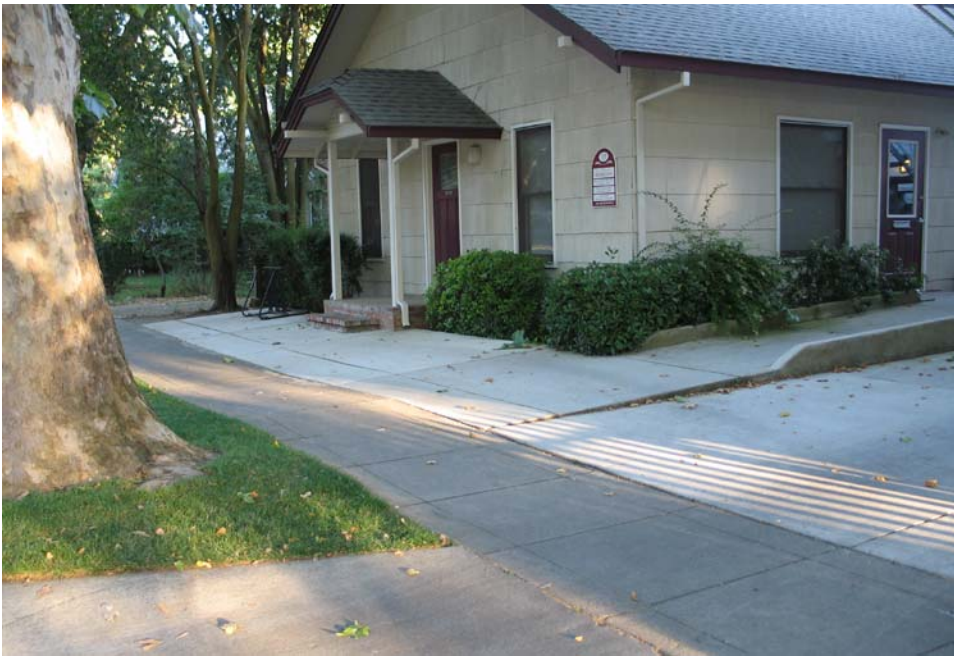
This Old North property was omitted from the survey. The cottage on the left was the original structure at the address 603 G Street (Lot 1, Bowers Addition, 600 block G Street) It was placed at the back of the lot, adjacent to the alley, fronting 6th Street. The front part of the lot was occupied by a garden. Circa the late 60's or early 70's the house was converted to a business office by Attorney John Beede, then owner/resident of 607 G Street, replacing a circa 1963 home office at 607 G. In 2000 a new 2-story pseudo "Victorian" residence was constructed, occupying the front of

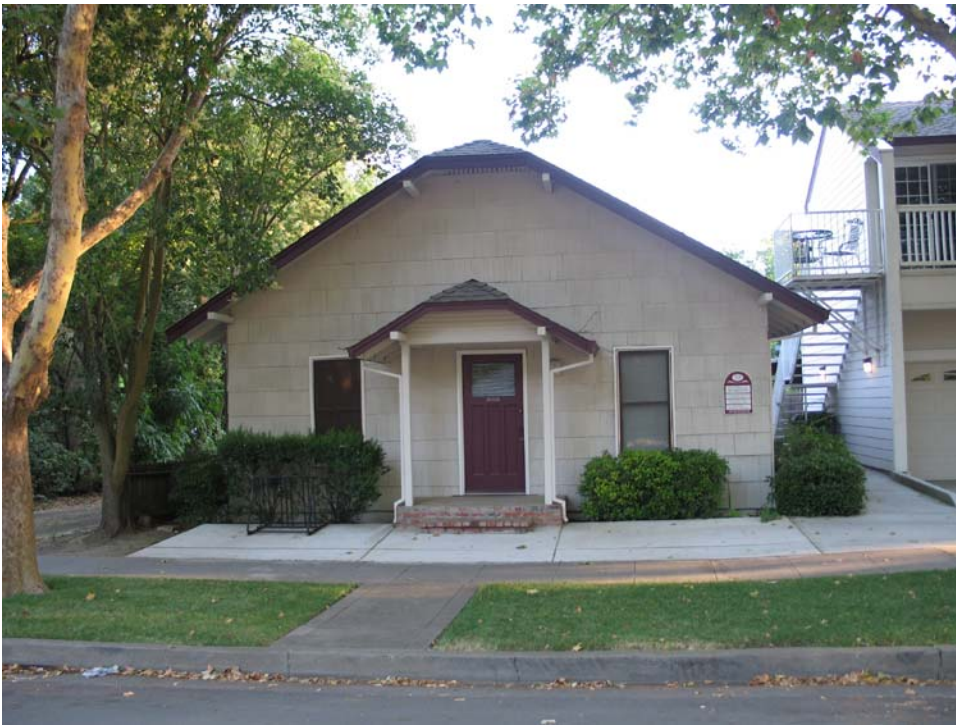
The house was originally clad in narrow novelty wood siding characteristic of the oldest Old North bungalows; the siding is retained in the gable of the porch, and I have seen it underneath the replacement composition siding when repairs were being made 2 or 3 years ago. The basic configuration of the exterior and roof is unaltered except for the new entry door and windows on the east side. Entry to the current business is via that newer east side door, as the original entry (under the little porch facing 6th) opens now directly into a private office, and is only opened sometimes for ventilation. The brick stoop/porch may also be a replacement, but the porch roof, which matches the main roof jerkinhead gable is original. The jerkinhead gable is a rarity in Old North & the Bowers subdivisions and in Old East Davis as well.

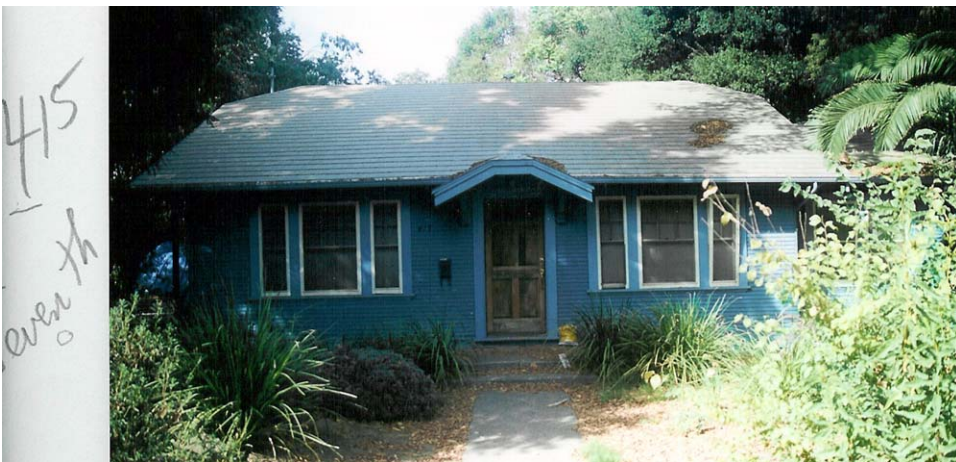
In this respect, I include a photo (courtesy John Lofland) of 415 7th Street, which although oriented parallel to the street, is strikingly similar in size to 715 5th (was 603 G), with the narrow novelty siding and jerkinhead gables for both the main roof and porch/stoop roof. 415 7th was among the first 5 or 6 houses built along the north side of 7th Street in the Bowers Acres subdivision, and is one of few surviving today. It appears on the
