Anderson Bank Building Background

Anderson Bank Building Brief Alterations & Applications Background 203 G / 719 2nd Streets

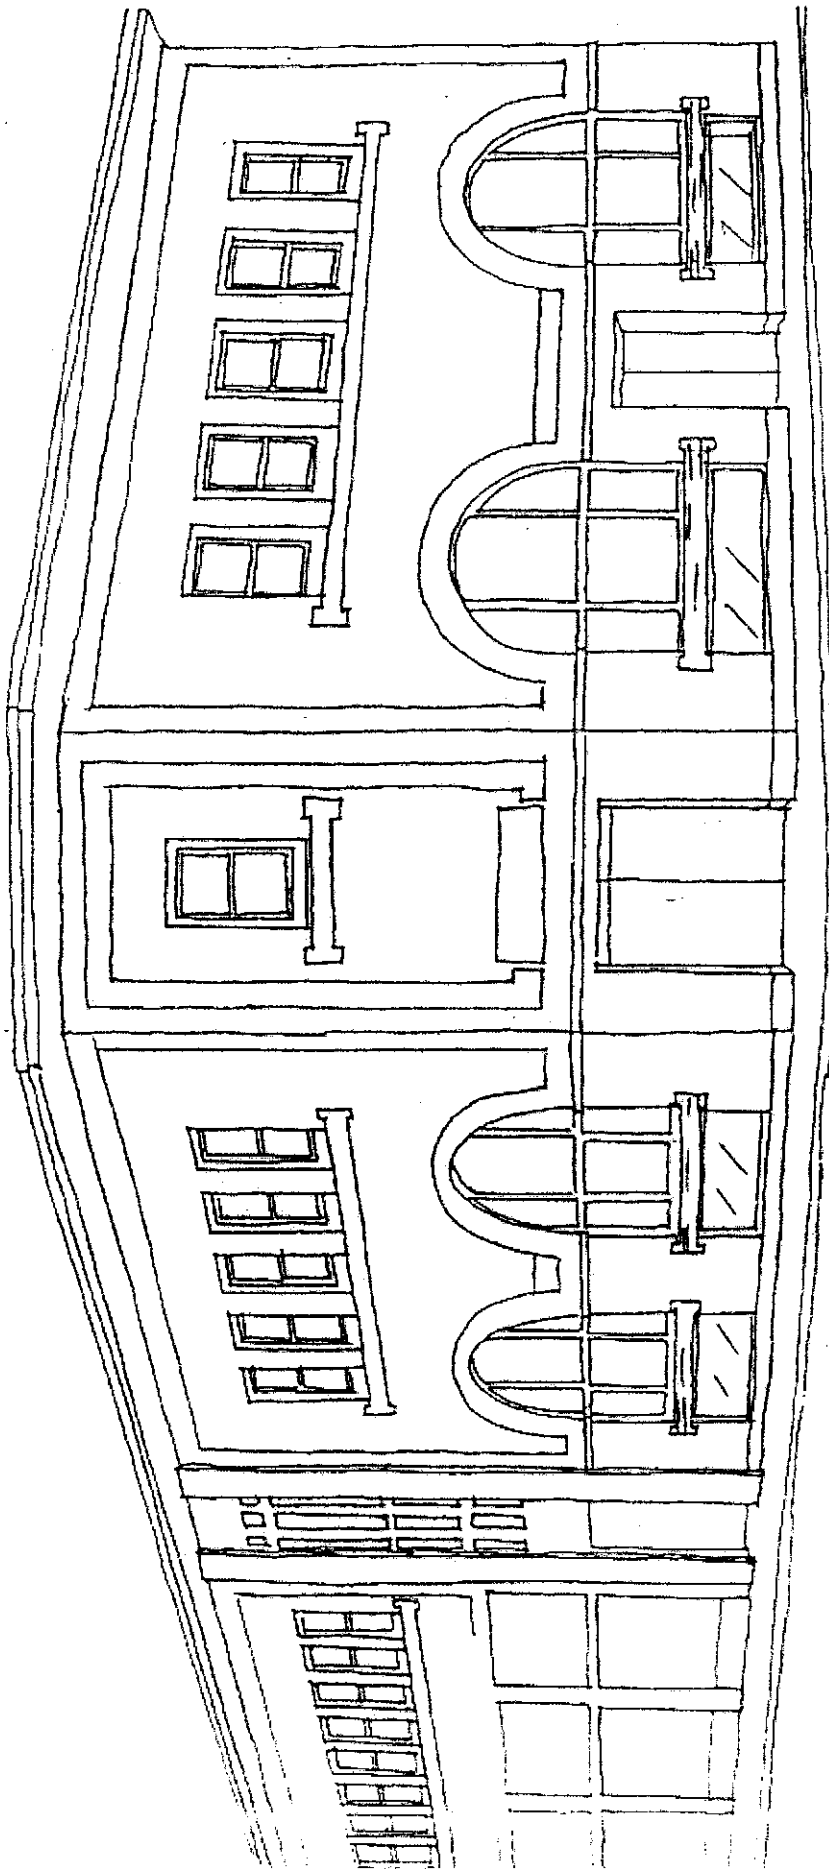
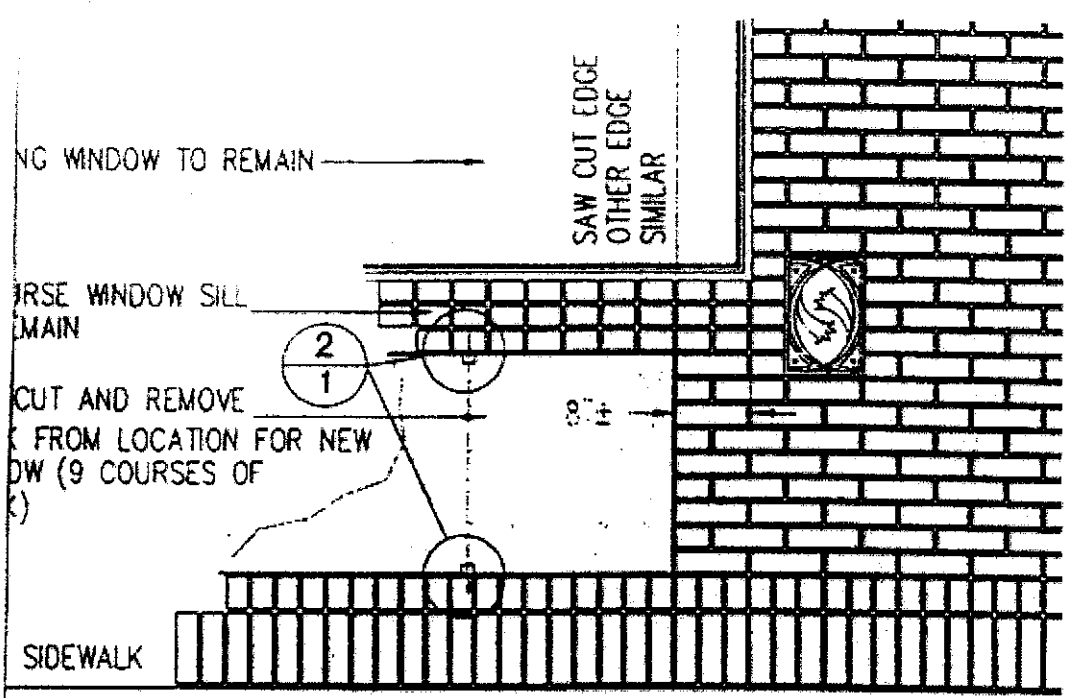
SAW CUT BRICK WINDOW SILL **1**

By placing the glass at the plane of the brick, it occurs in a different plane than the glass of the existing windows above it. By reducing the treatment of the glass to a frameless condition, the new glazing does not mimic the existing wood framed windows. The glass appears, instead, to become a substitute for the removed brick.

SECTION **B** 1/2'-1'-0'

Windows without perimeter frames is clearly of modern construction, compared to the existing conditions. In this way they are differentiated from the old.

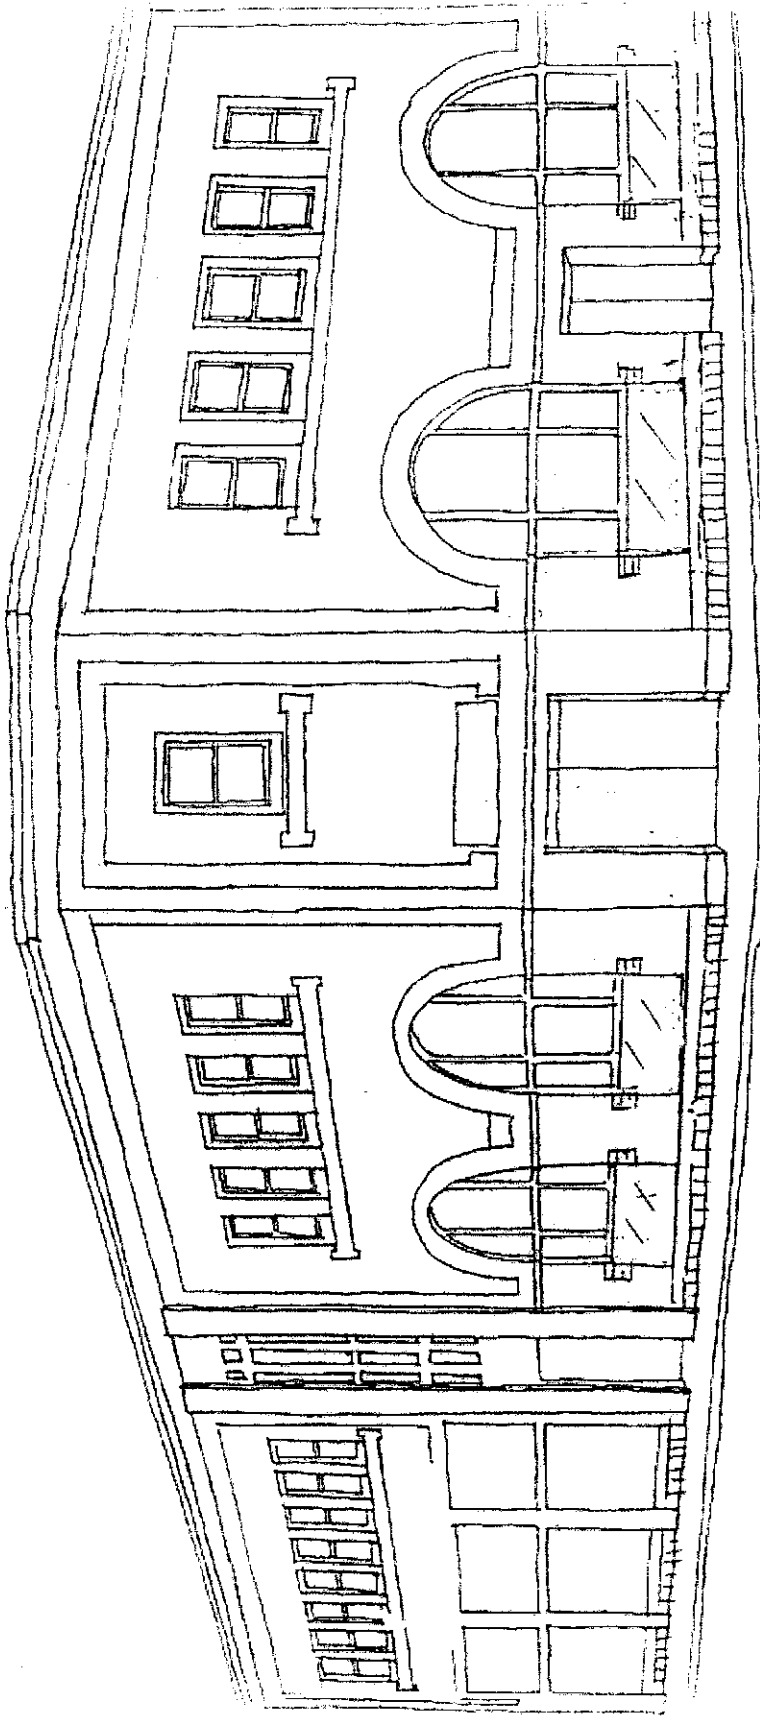
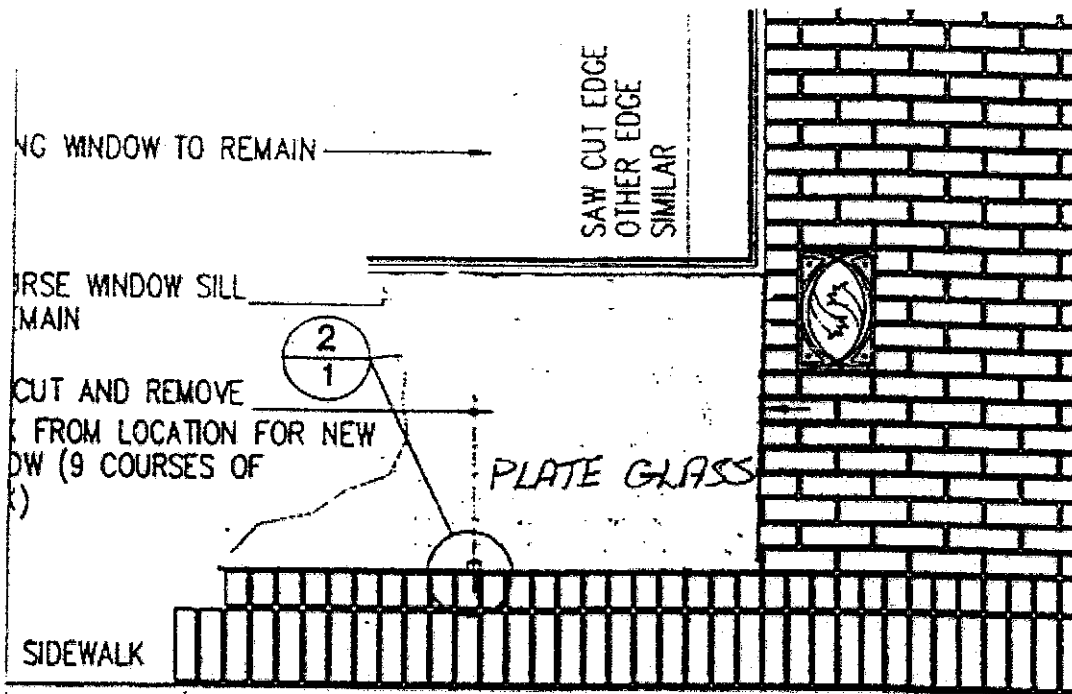
SAW CUT BRICK WINDOW SILL **2**

SECTION **B** 1/2'-1'-0'
